# Case Histories with EPS Geofoam Fills from Eastern Norway

Tseday Damtew, Norwegian Public Roads Administration  
Jan Vaslestad, Norwegian Public Roads Administration  
Geir Refsdal, Norwegian Public Roads Administration

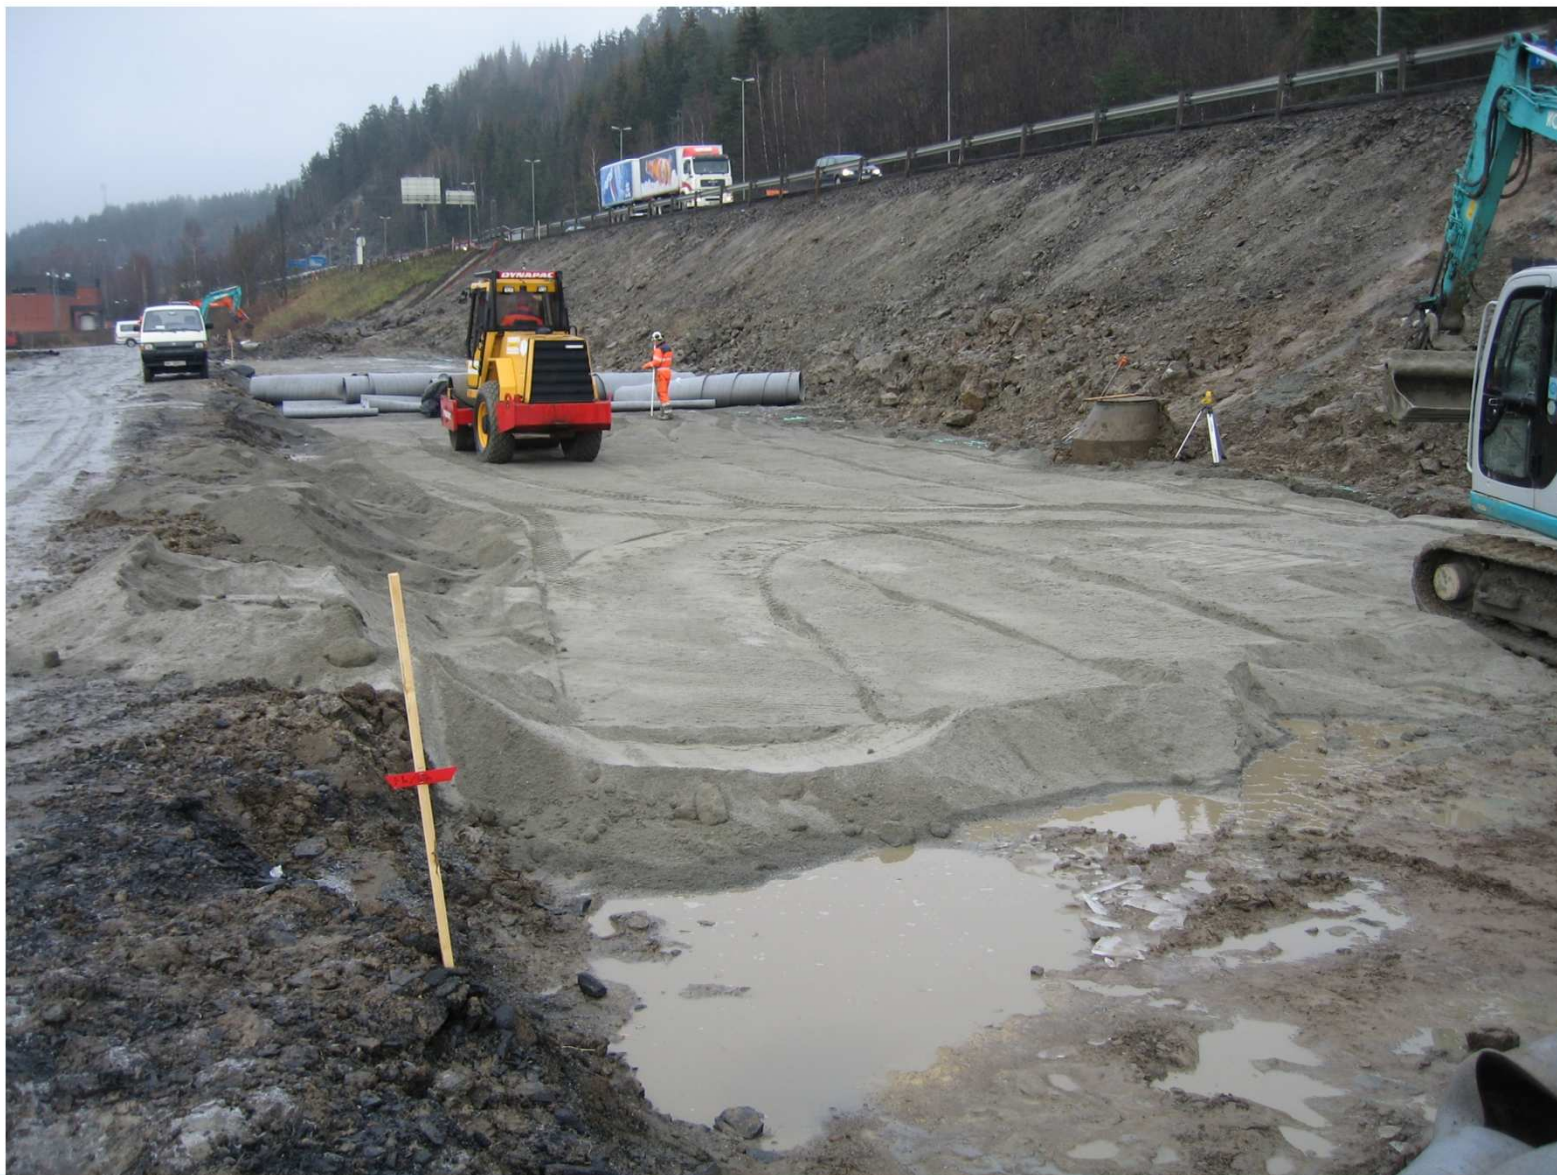
## Construction- Site Preparation – levelling layer

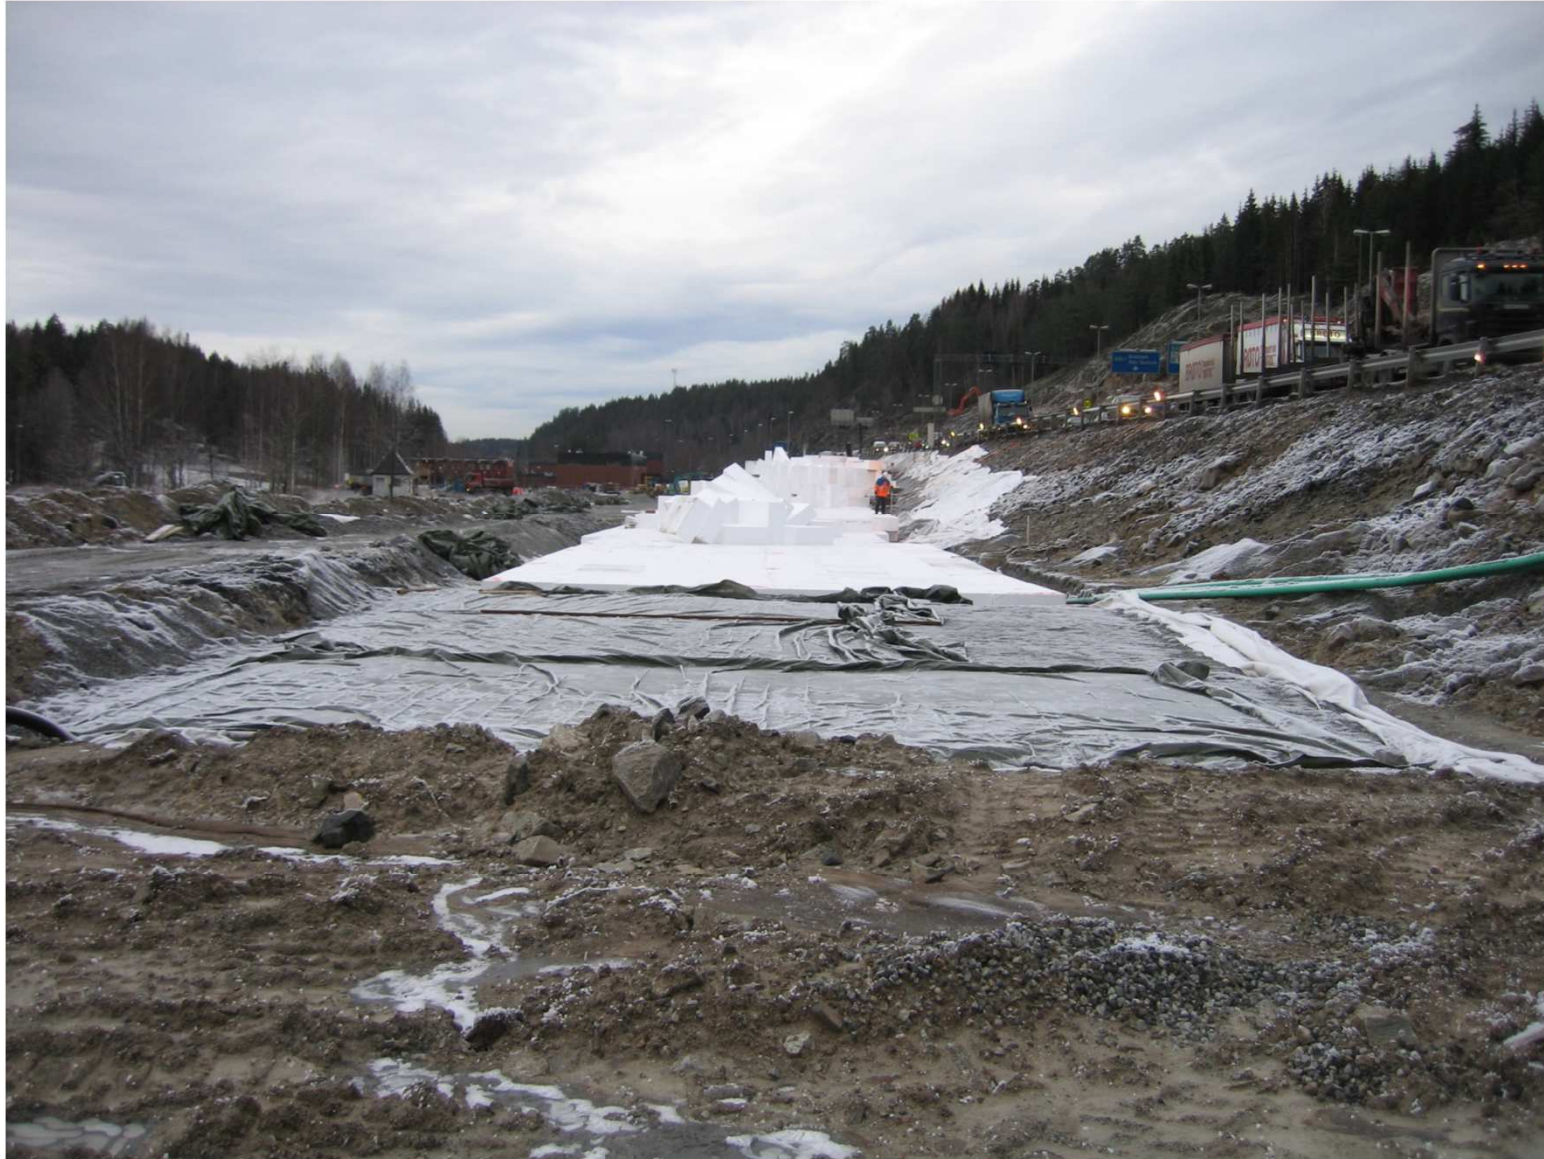
Construction- laying EPS geofoam blocks

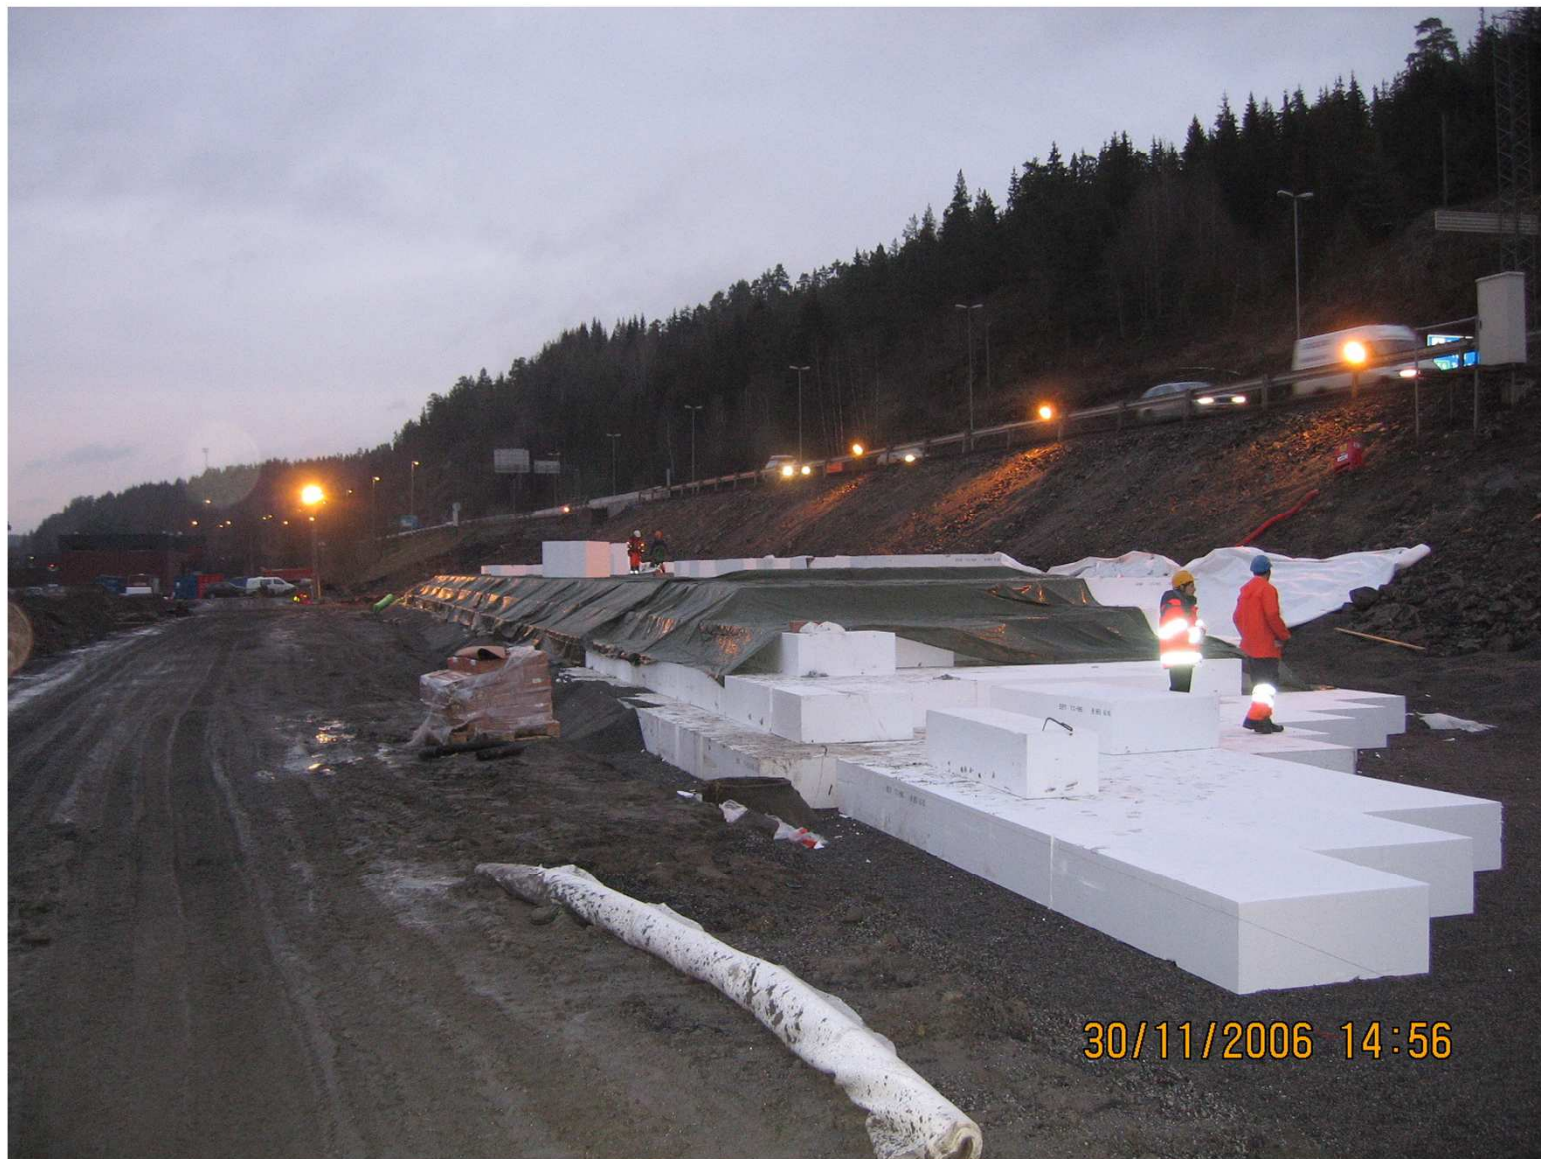
Construction- laying EPS geofoam blocks

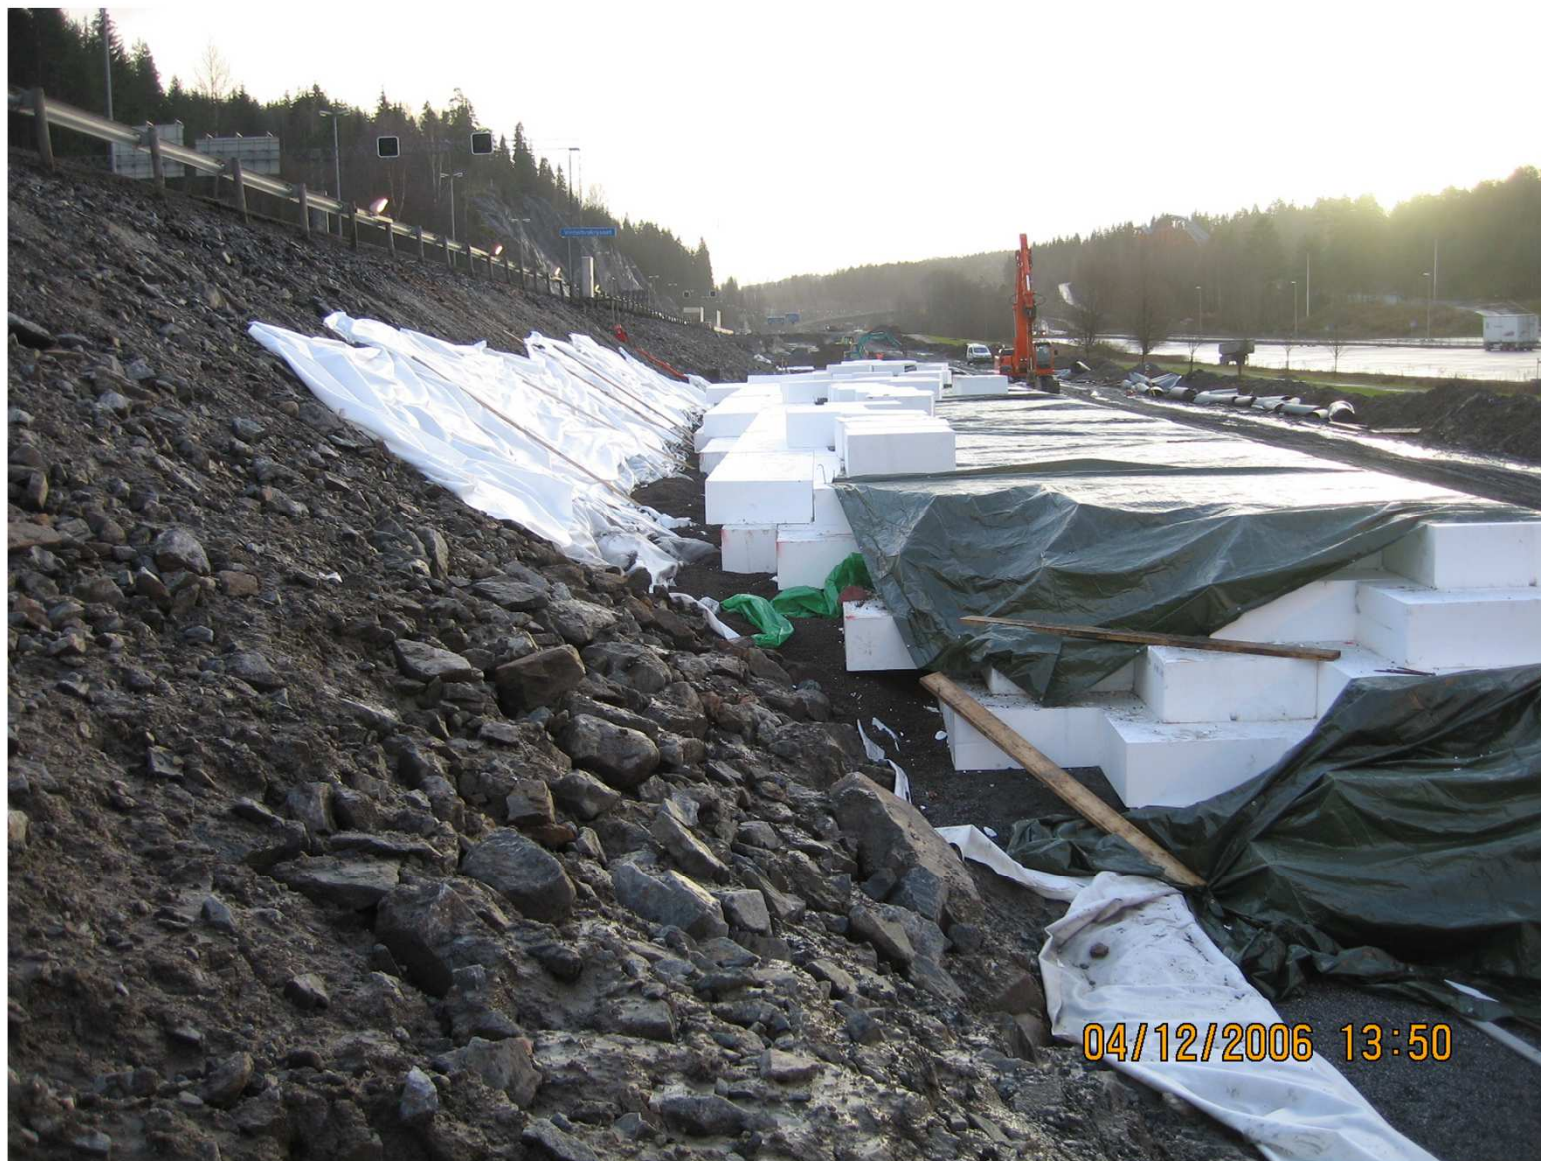
Construction- laying EPS geofoam blocks

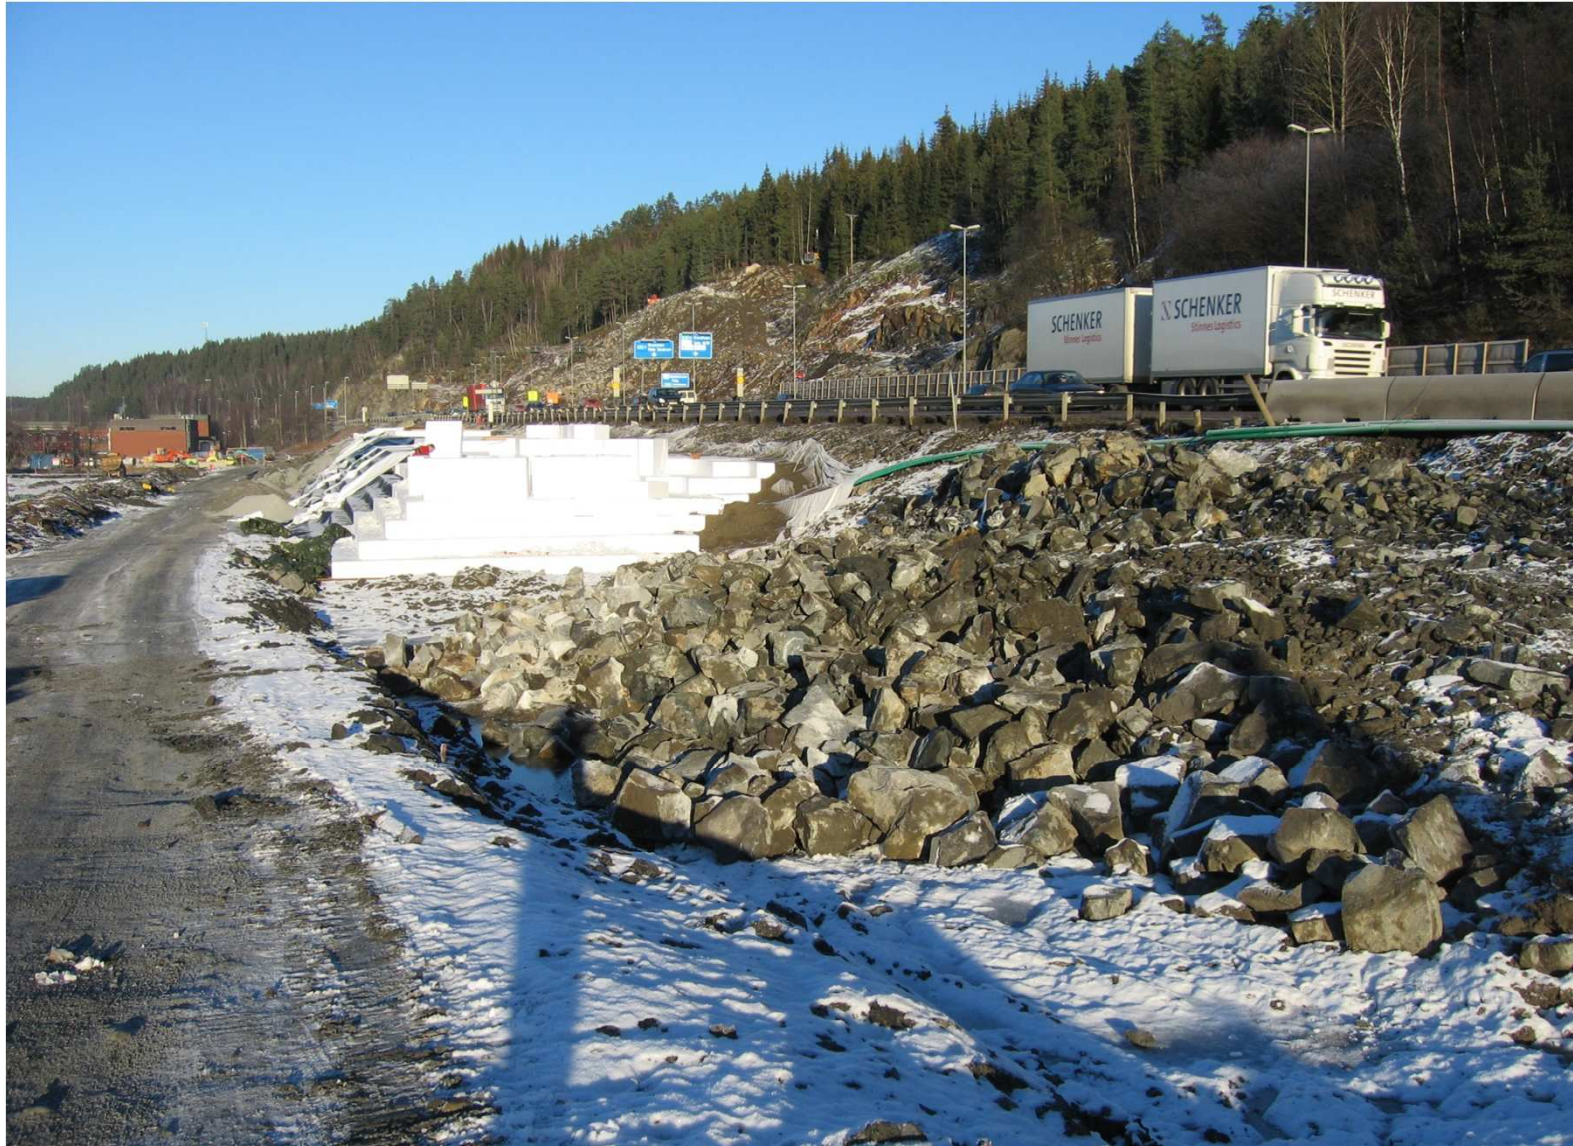
Construction- laying EPS geofoam blocks

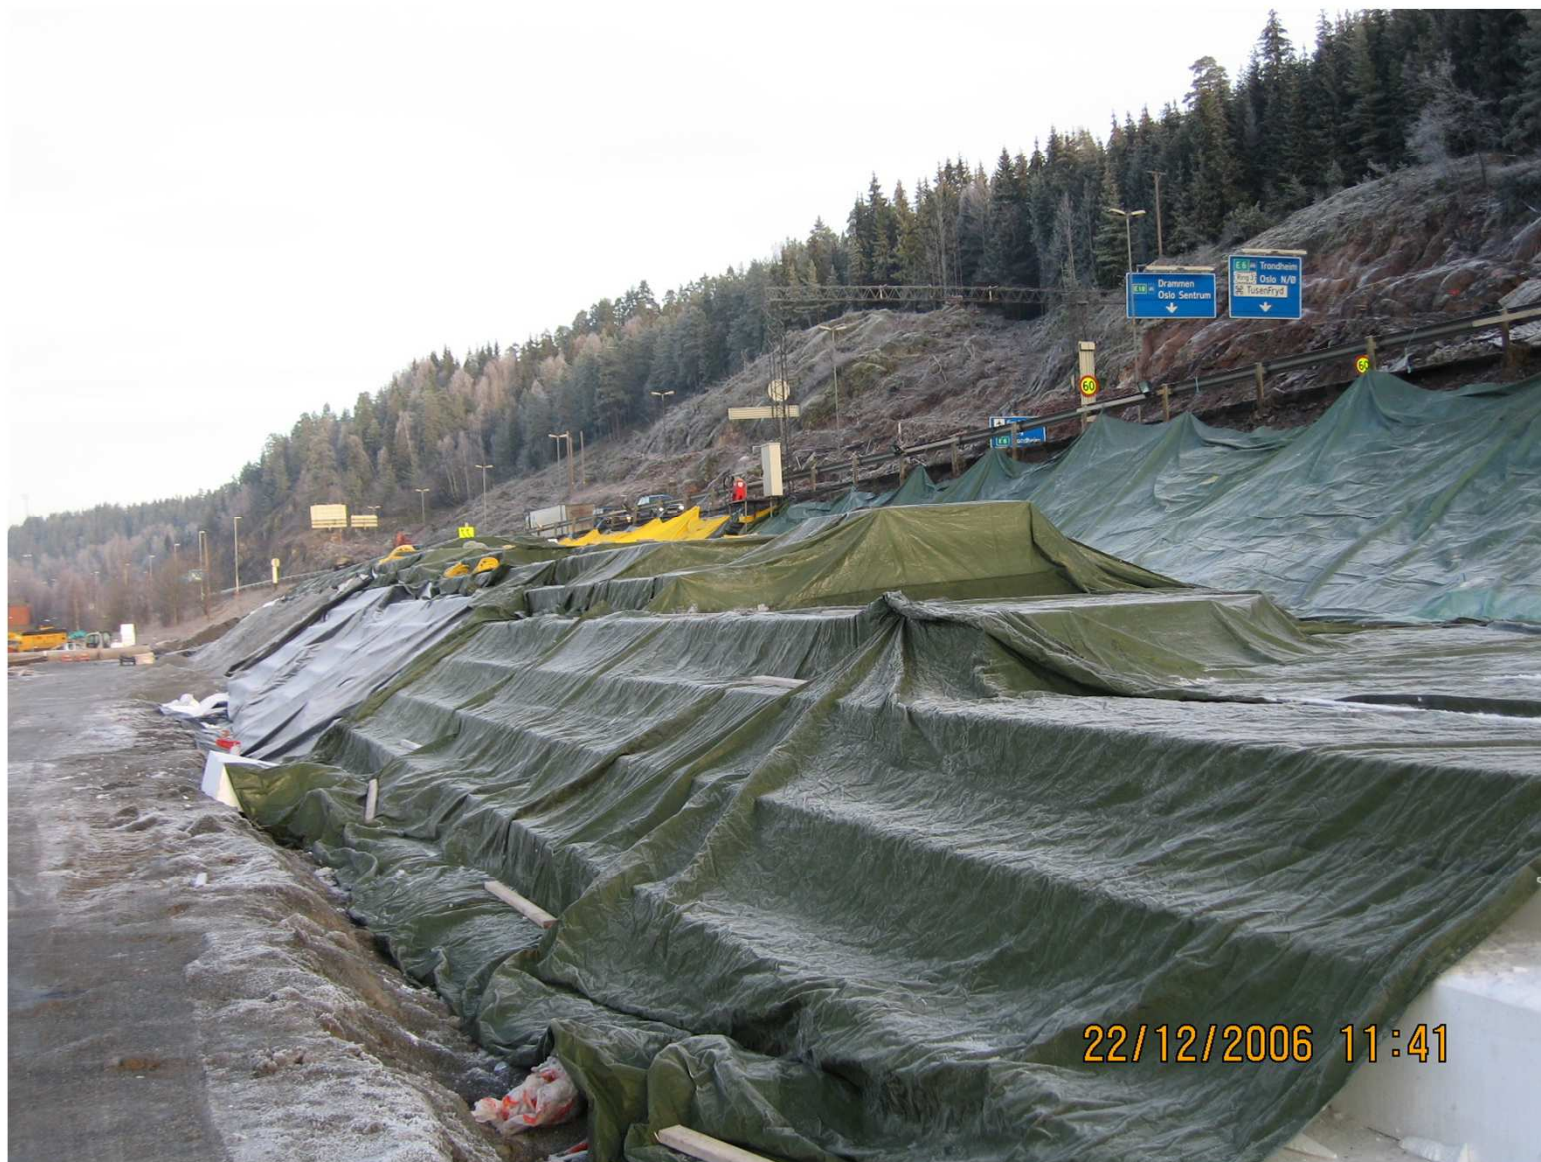
Construction- Protection from frost & snow

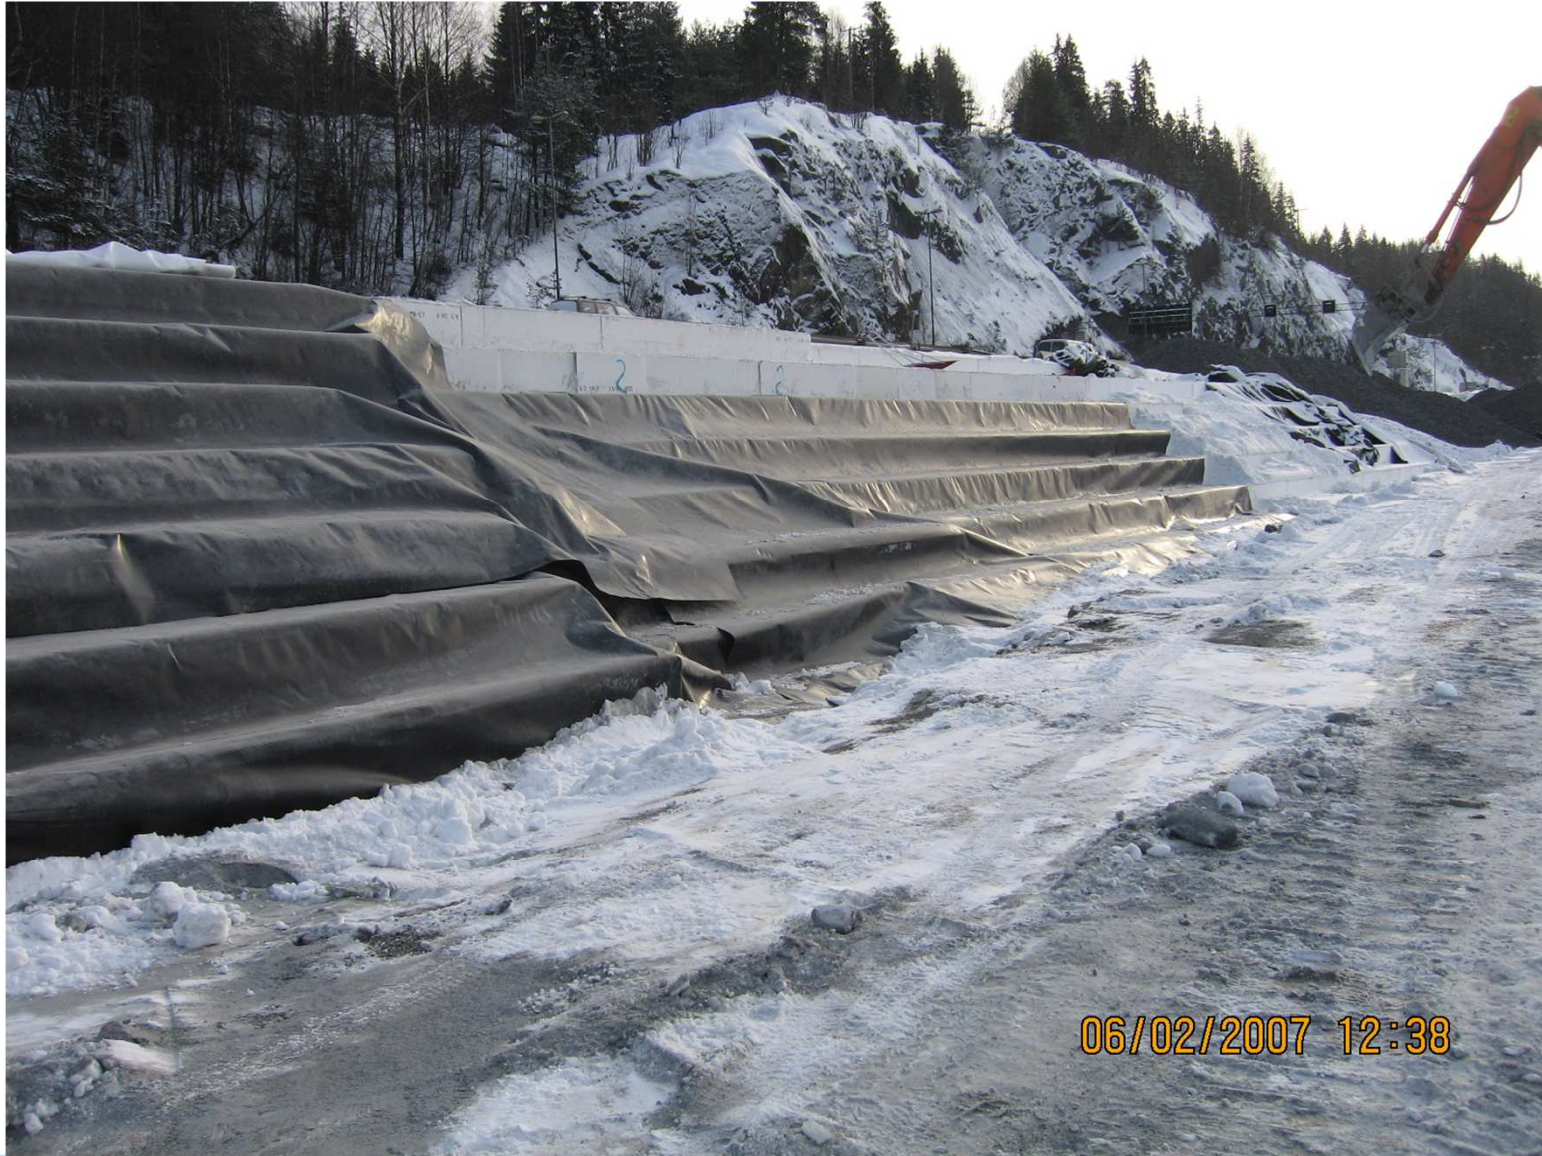
Construction- Plastic membrane over EPS embankment

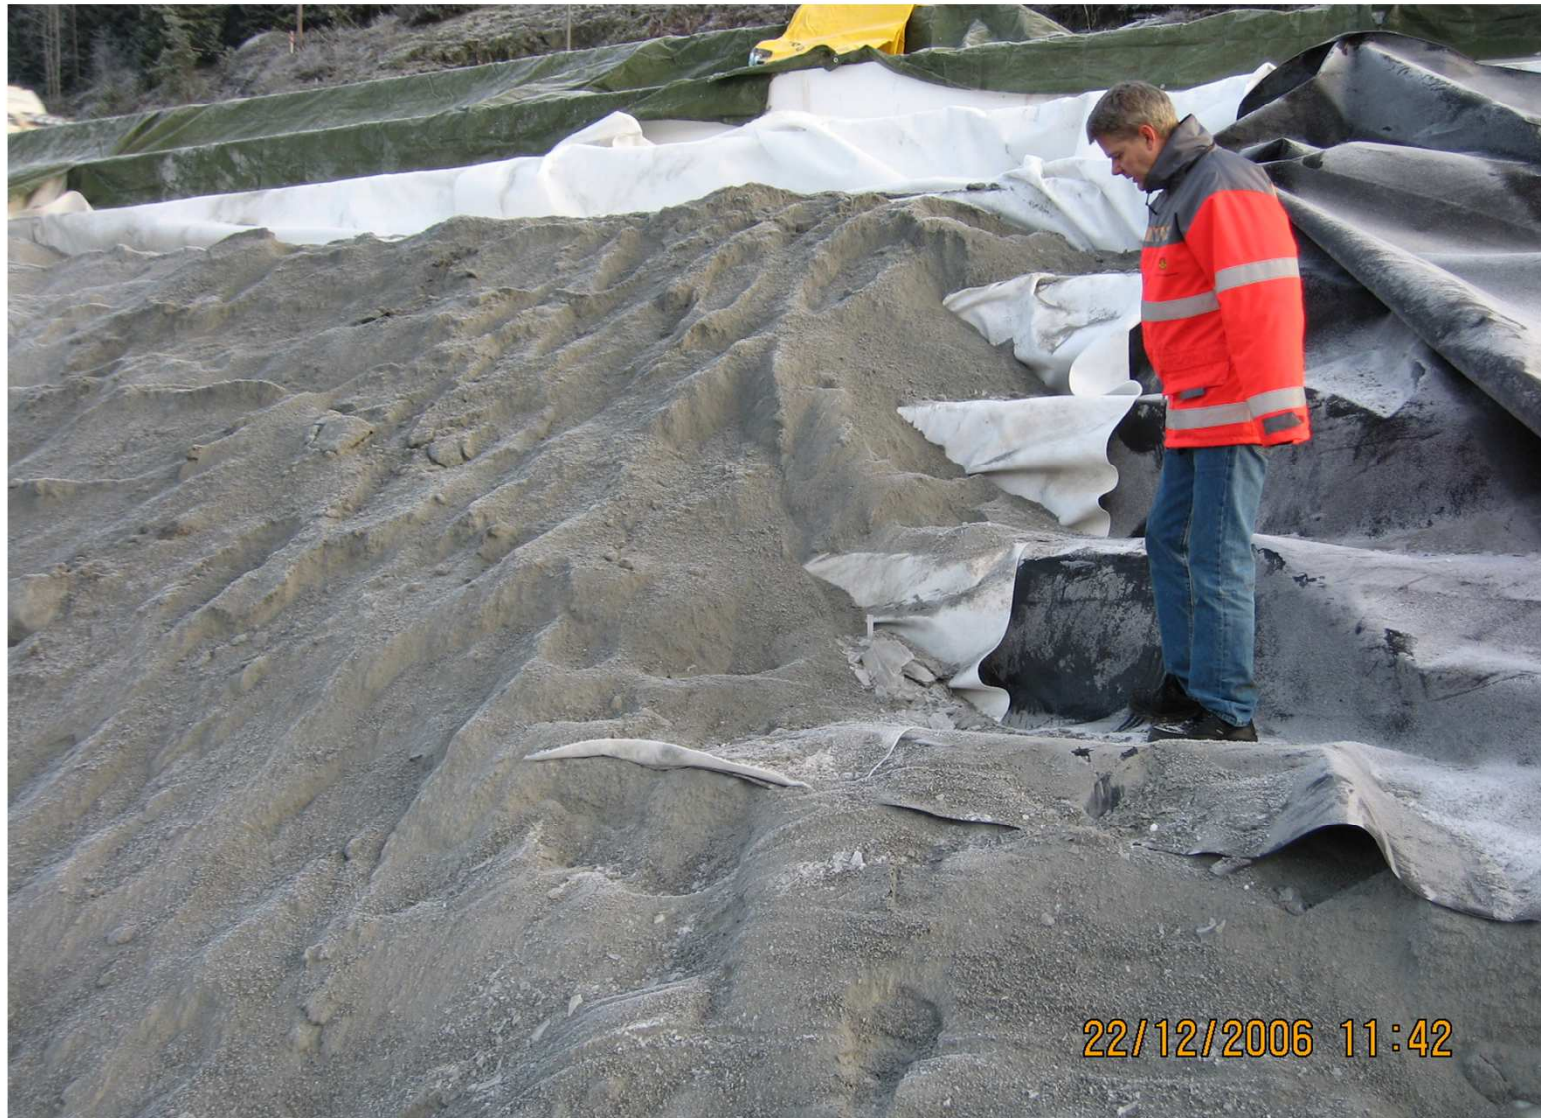
Construction- Plastic membrane, geotextile and residue from crushed rock over the EPS embankment

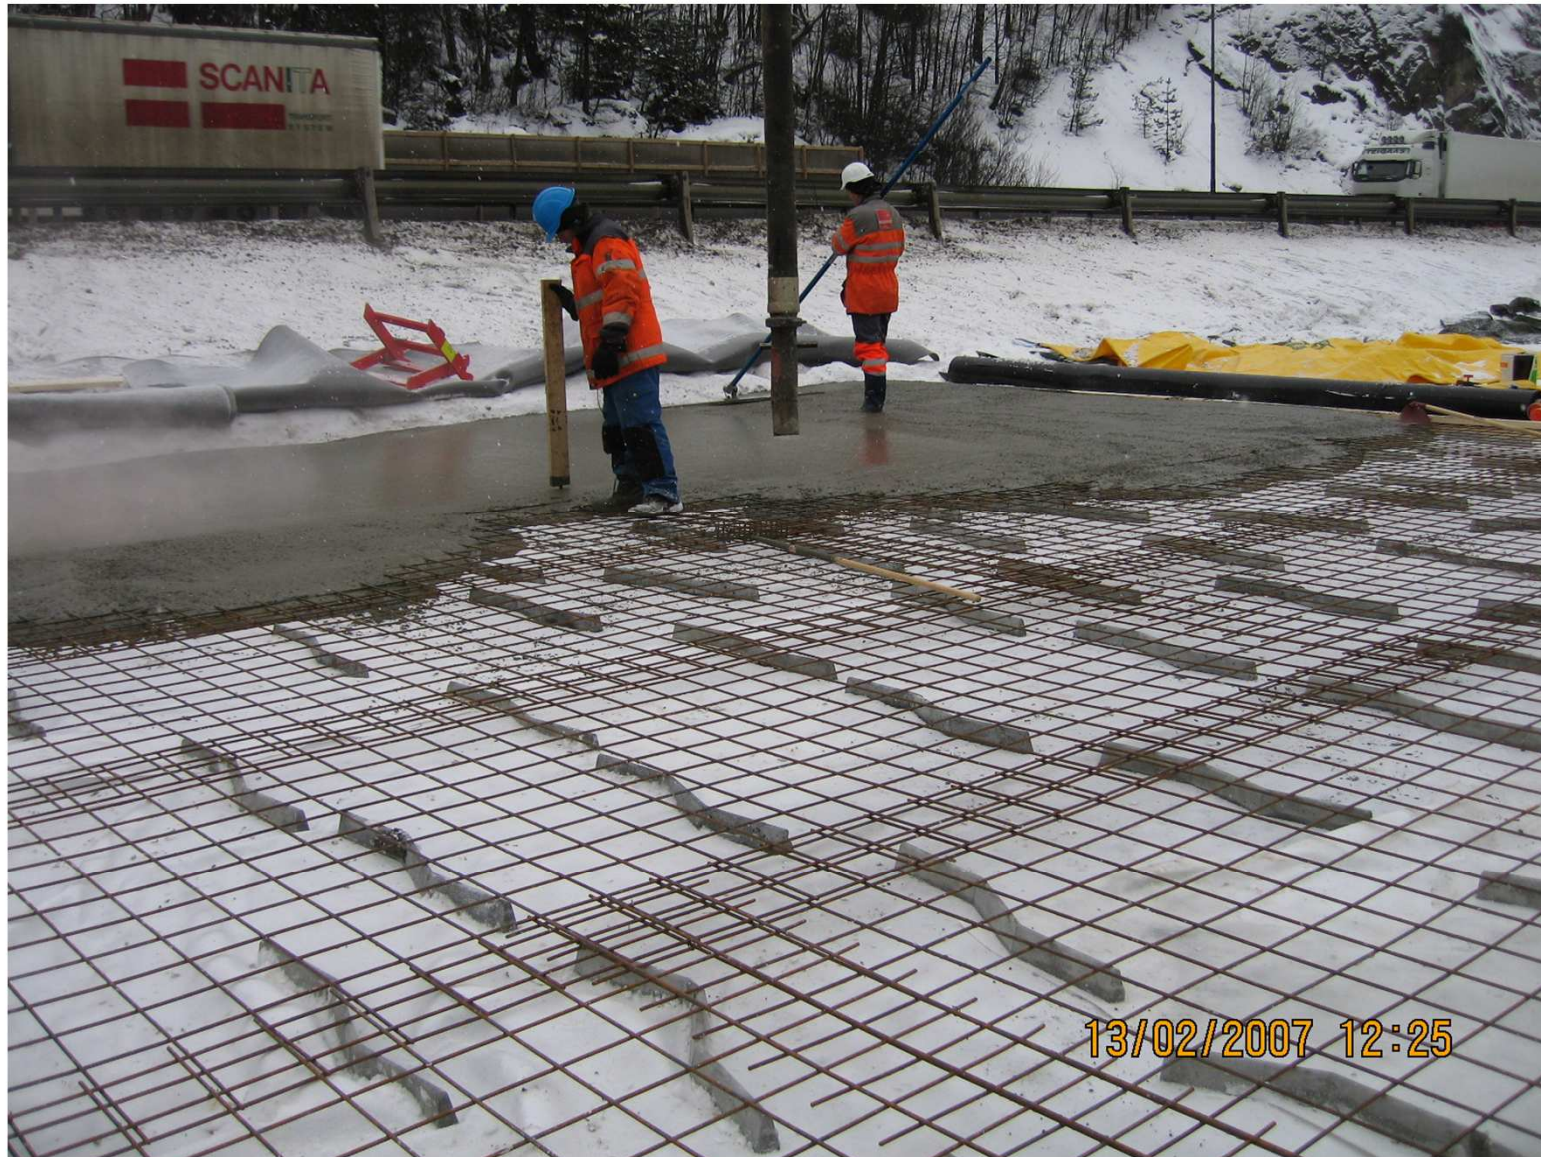
Construction- Casting concrete slab over EPS embankment

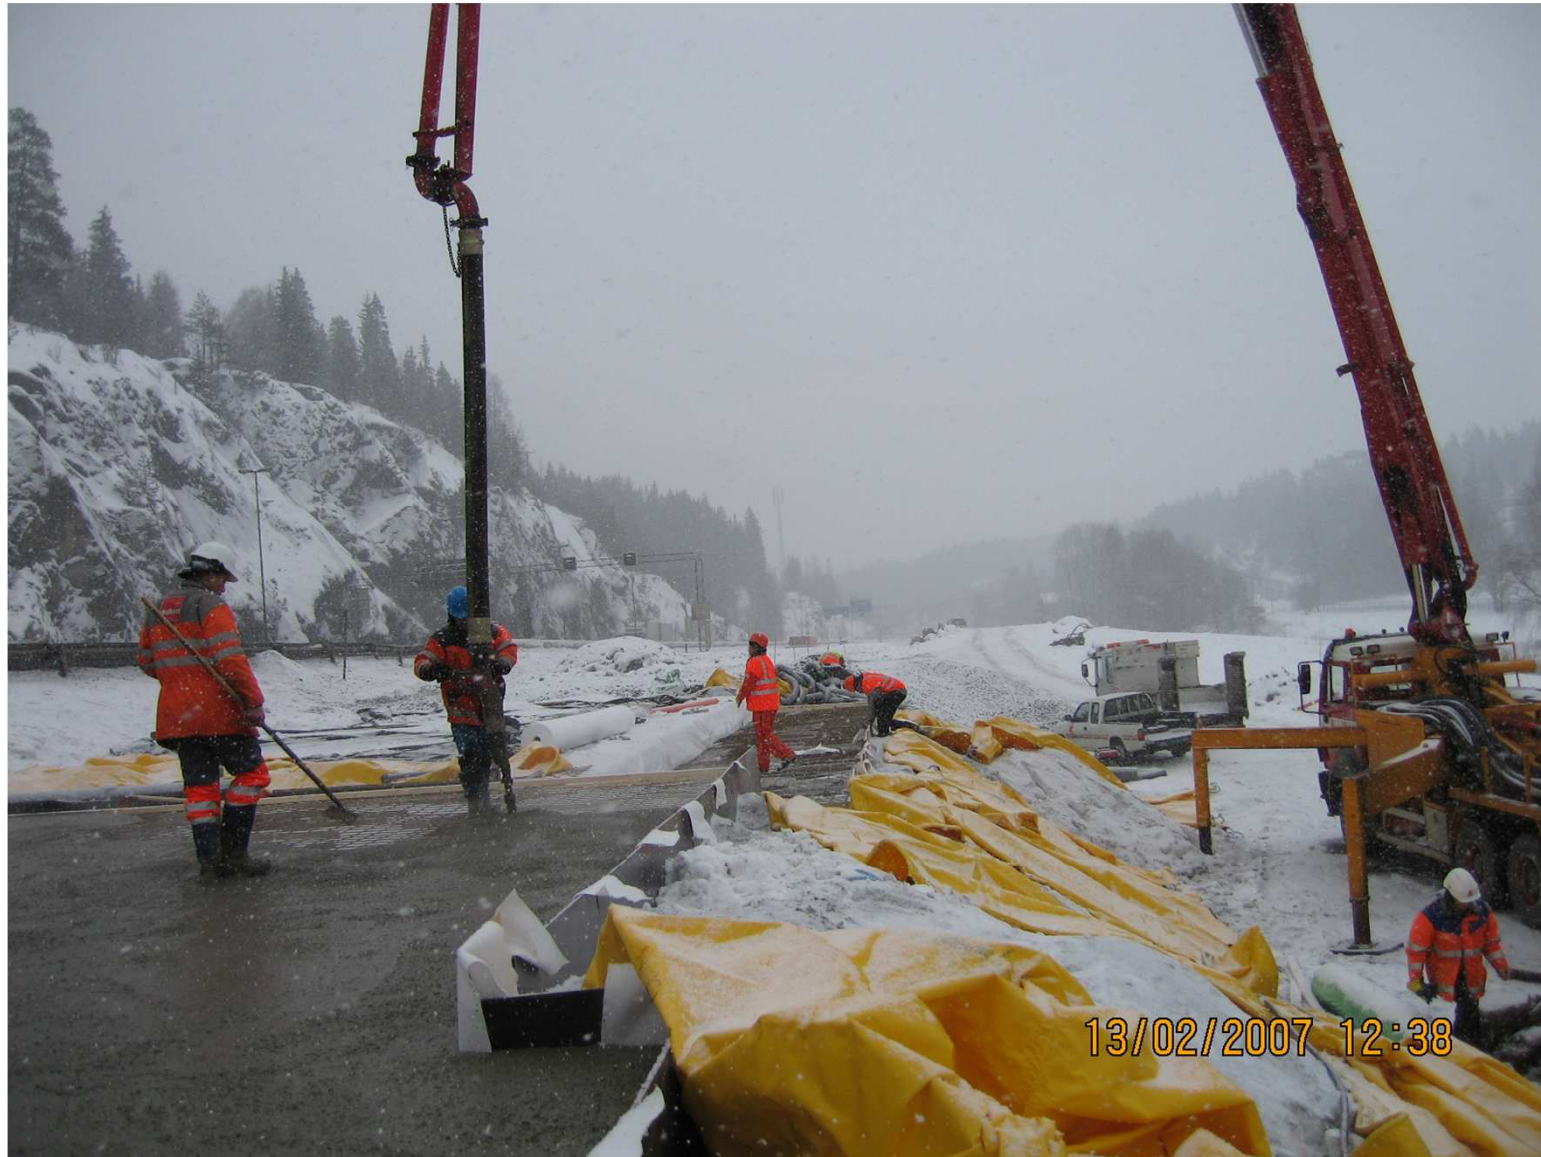
Construction- Casting concrete slab over EPS embankment

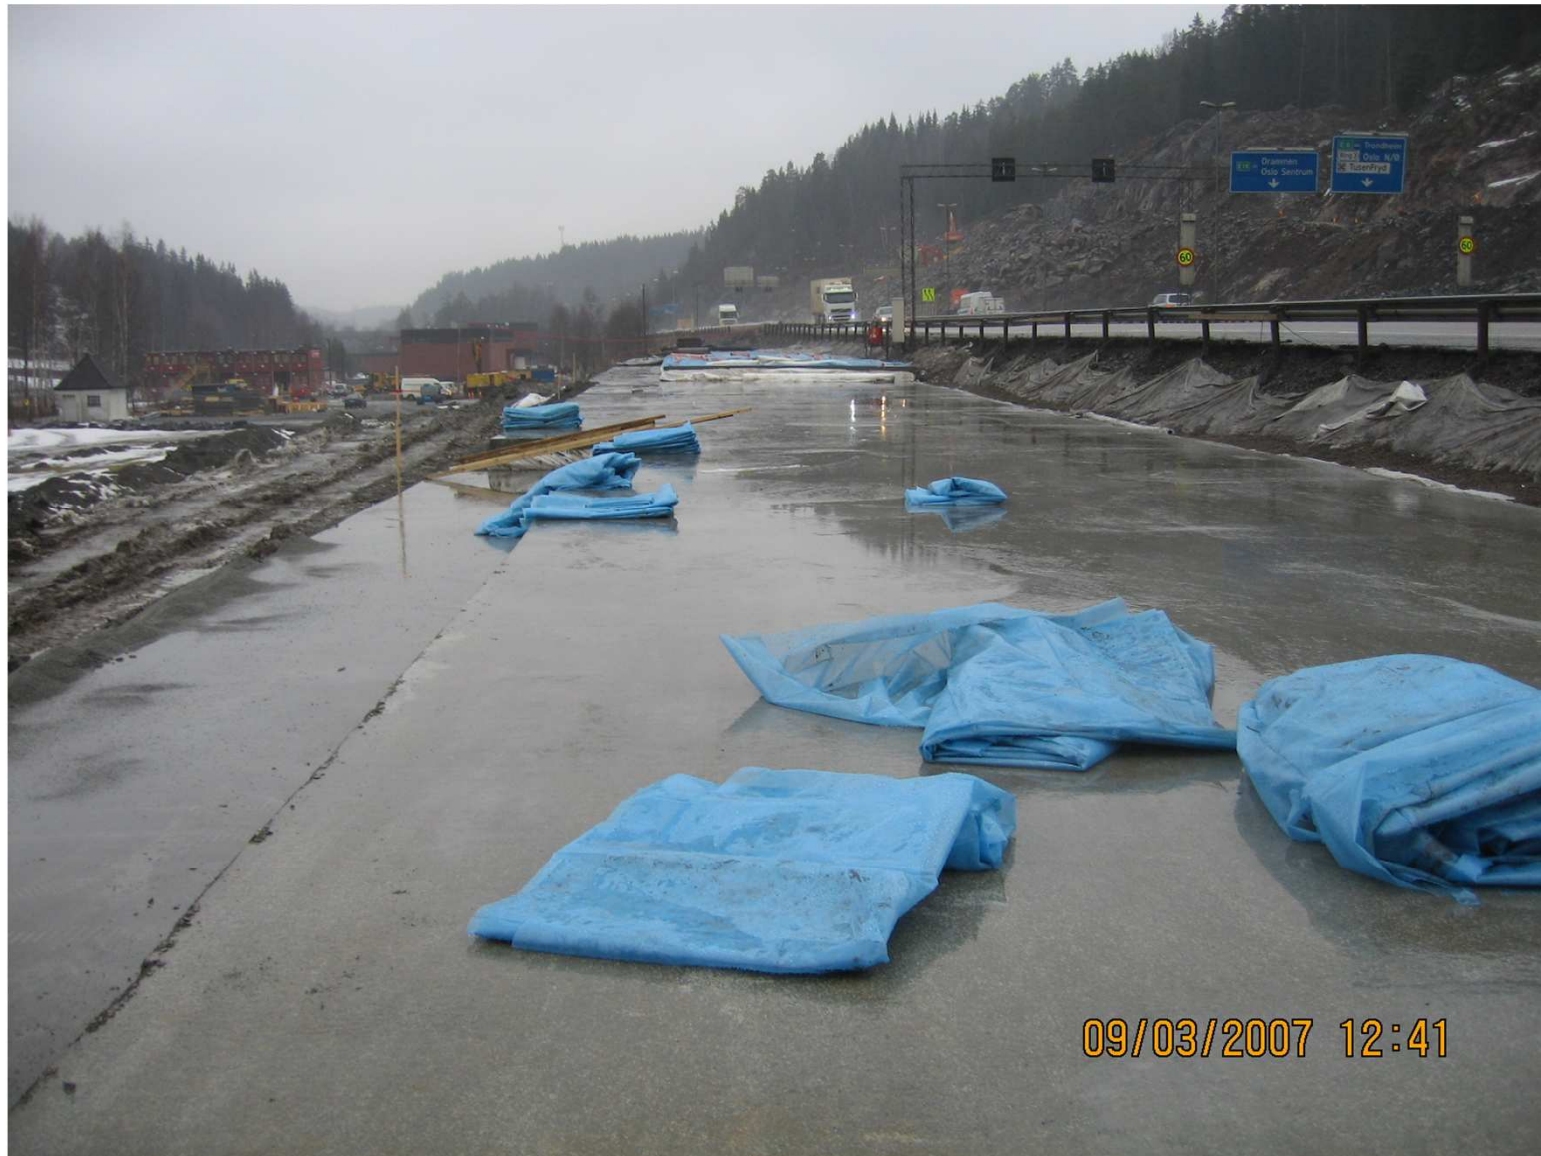
Construction- Concrete slab over EPS embankment

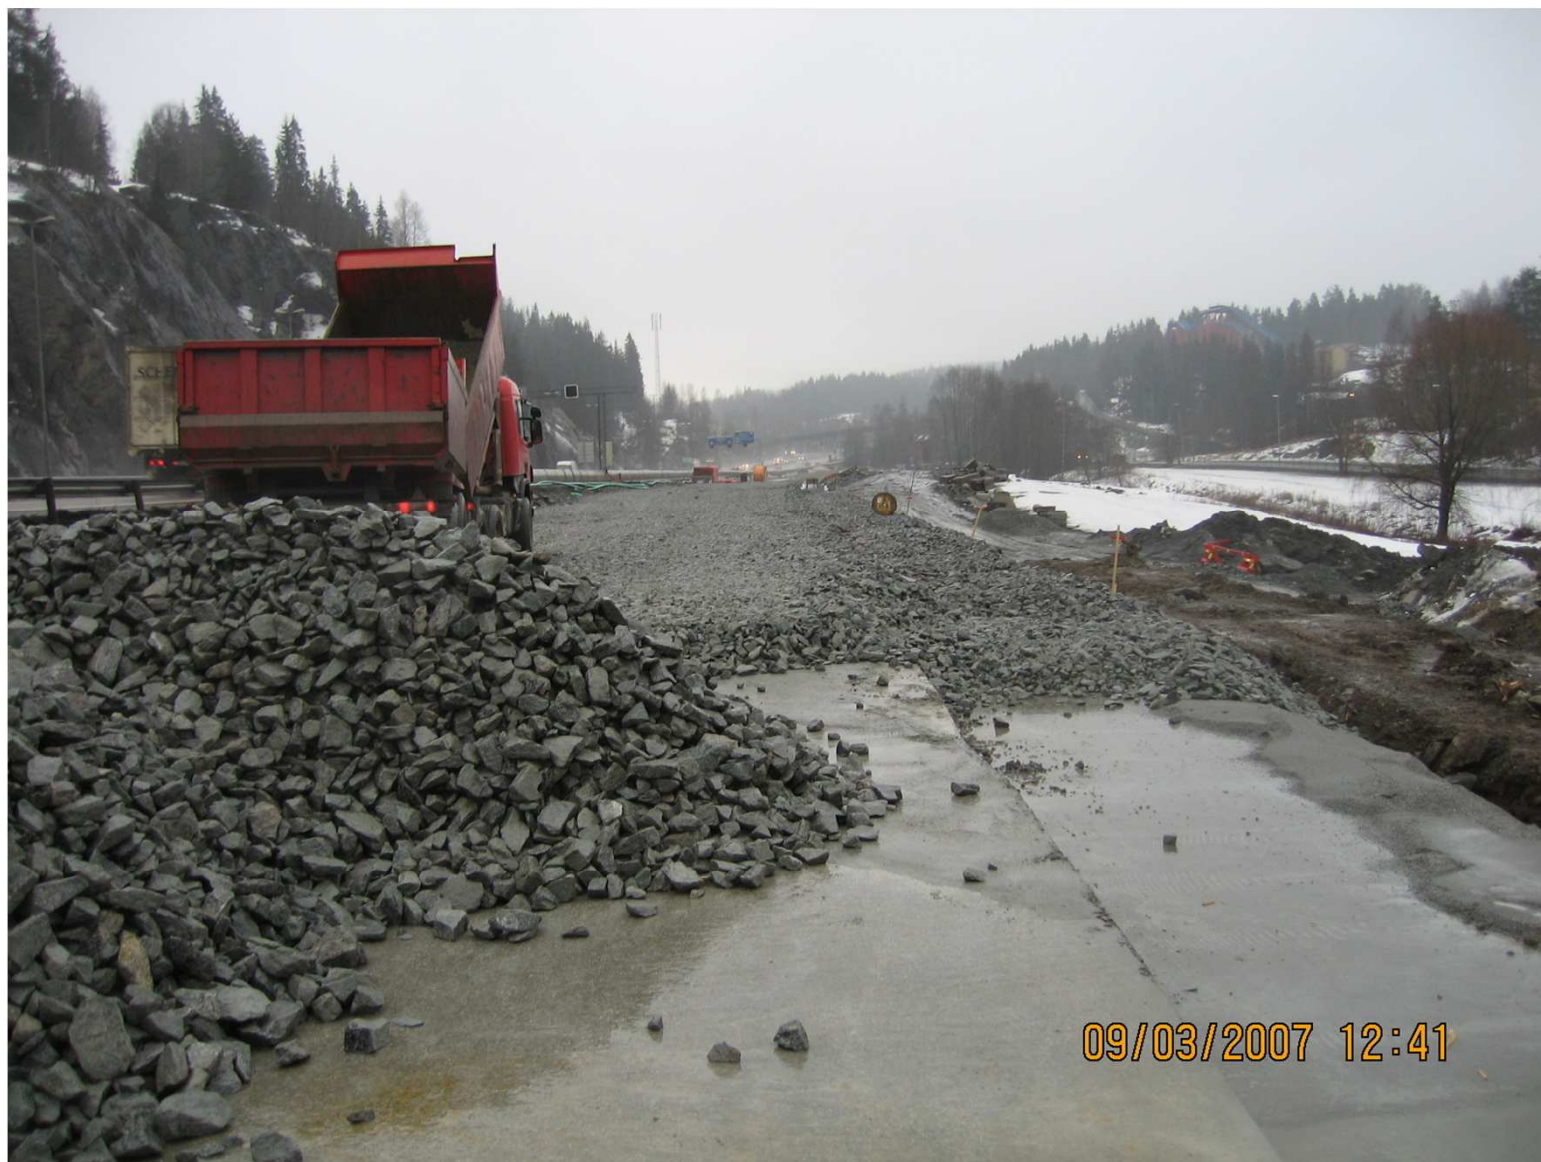
Construction- sub-base placed above the EPS

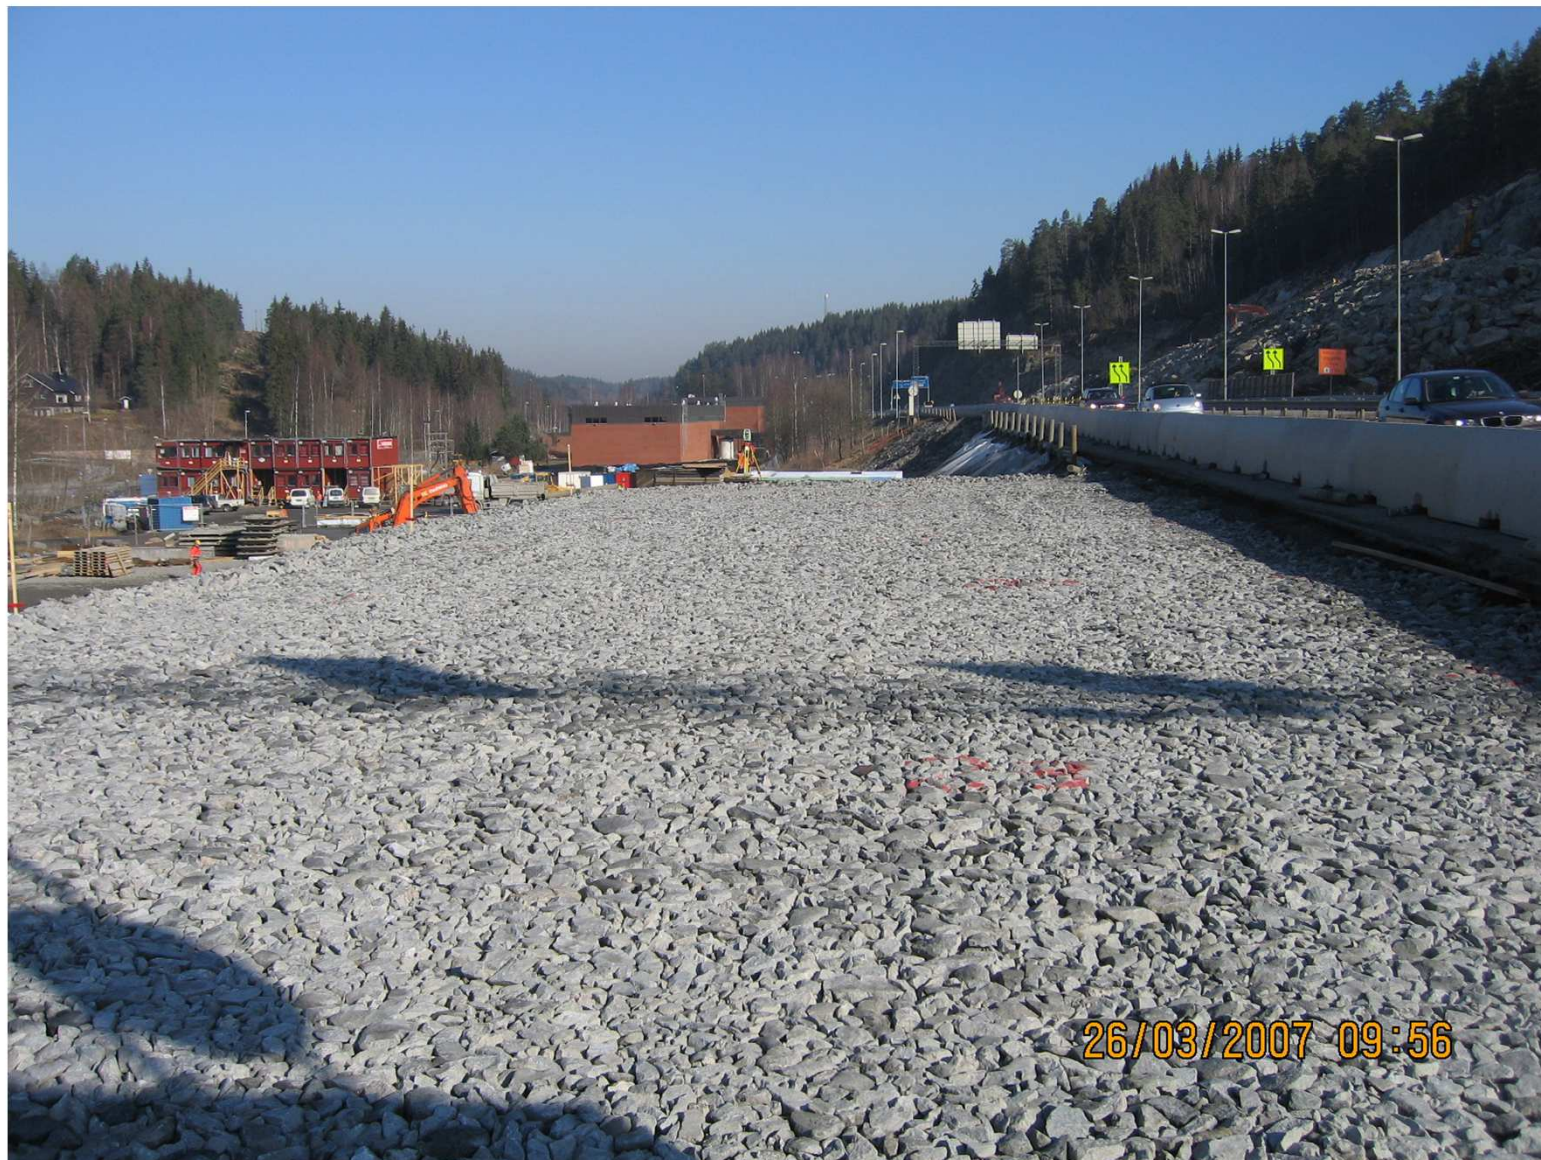
Construction- Finished sub-base above the EPS
