# Case Histories with EPS Geofoam Fills from Eastern Norway

Tseday Damtew, Norwegian Public Roads Administration  
Jan Vaslestad, Norwegian Public Roads Administration  
Geir Refsdal, Norwegian Public Roads Administration

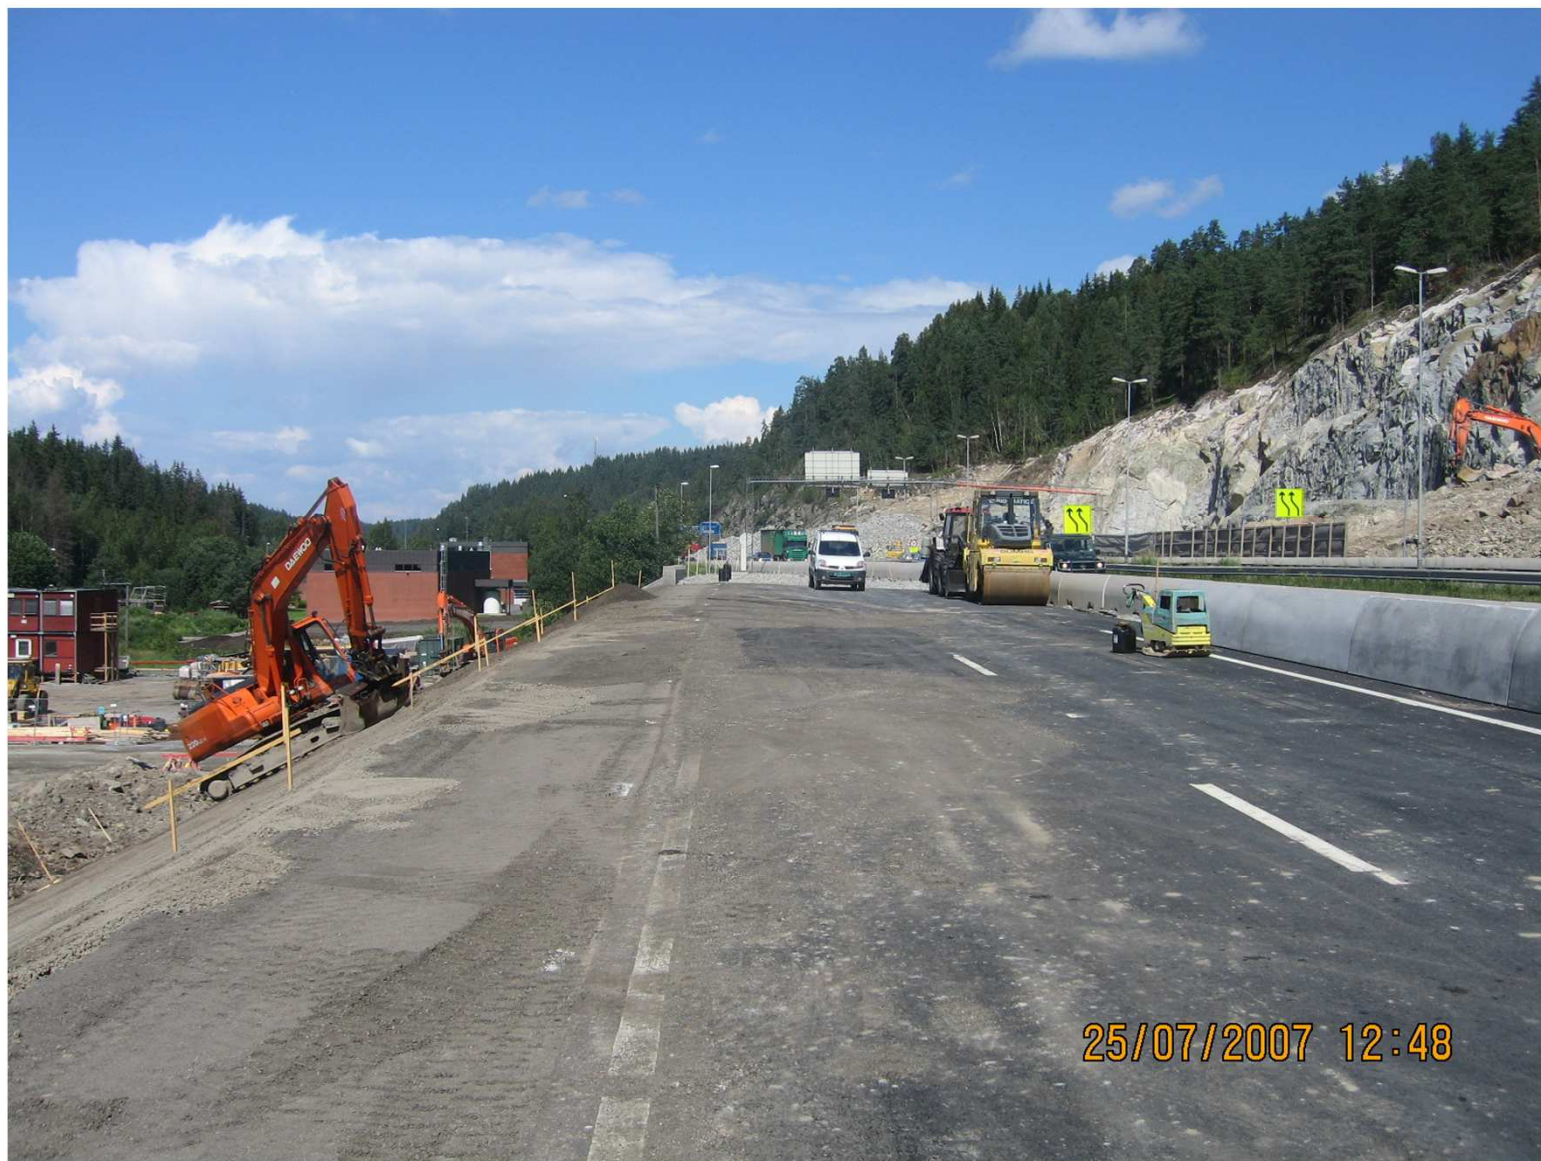
Construction- Finished road with asphalt surfacing

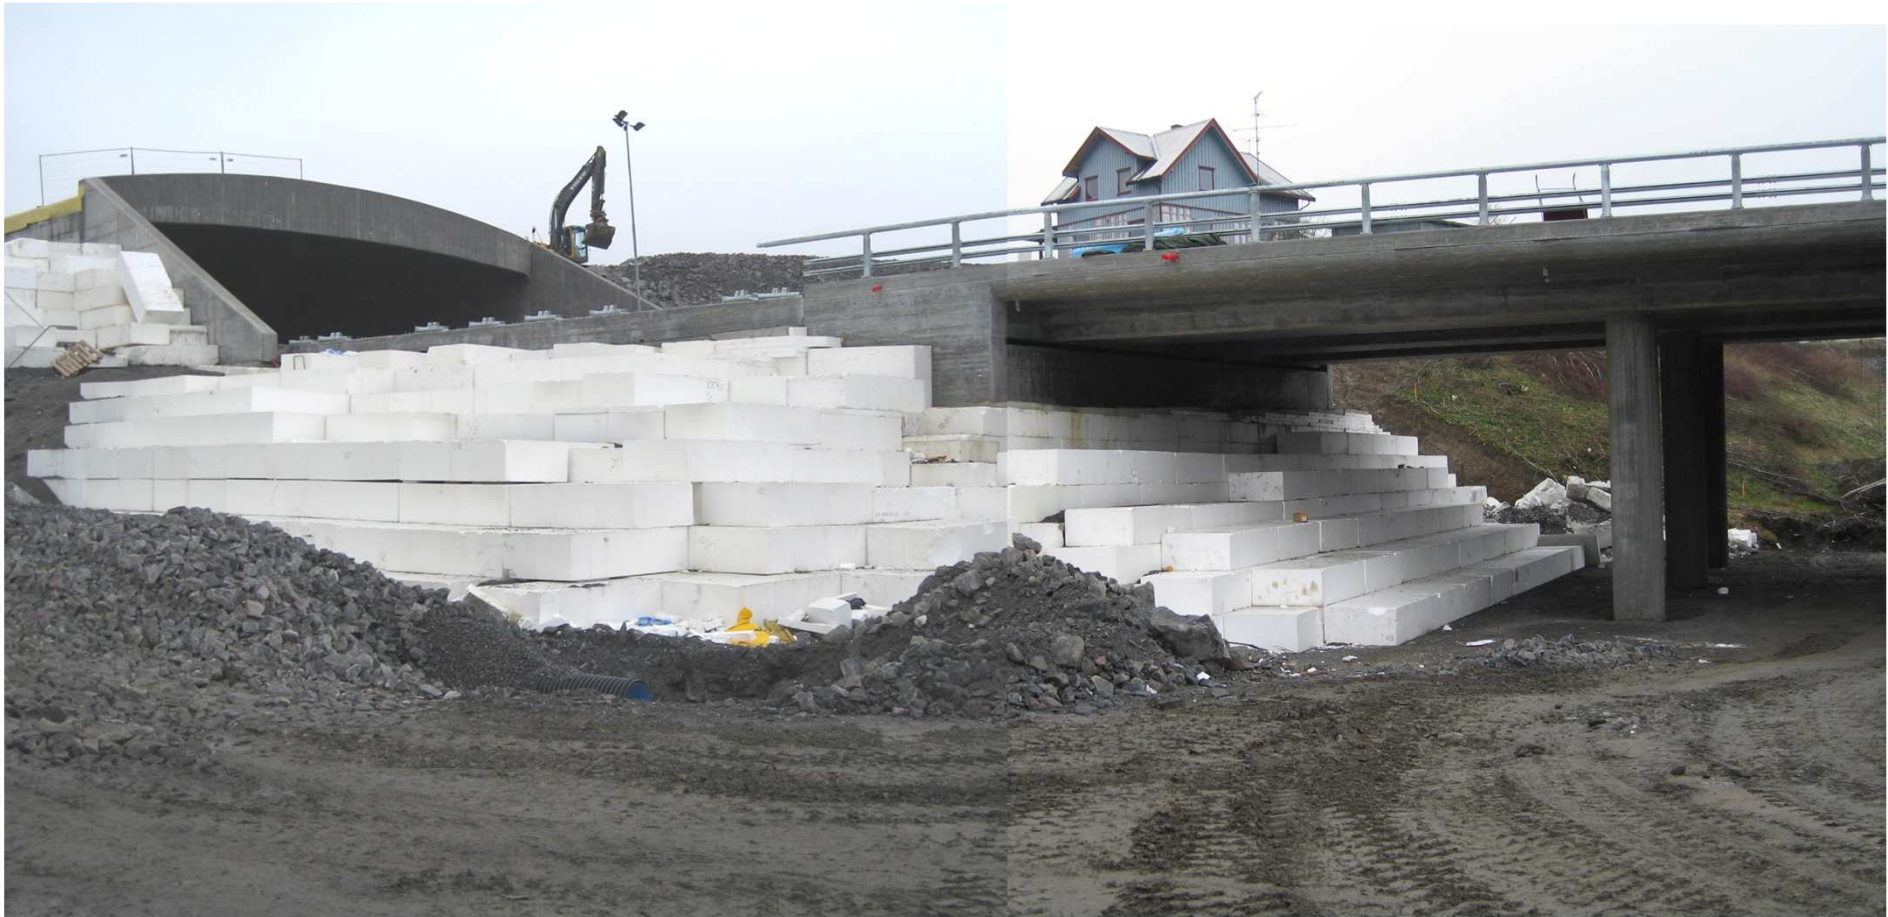
EPS geofoam blocks placed - fill against abutment and culvert side

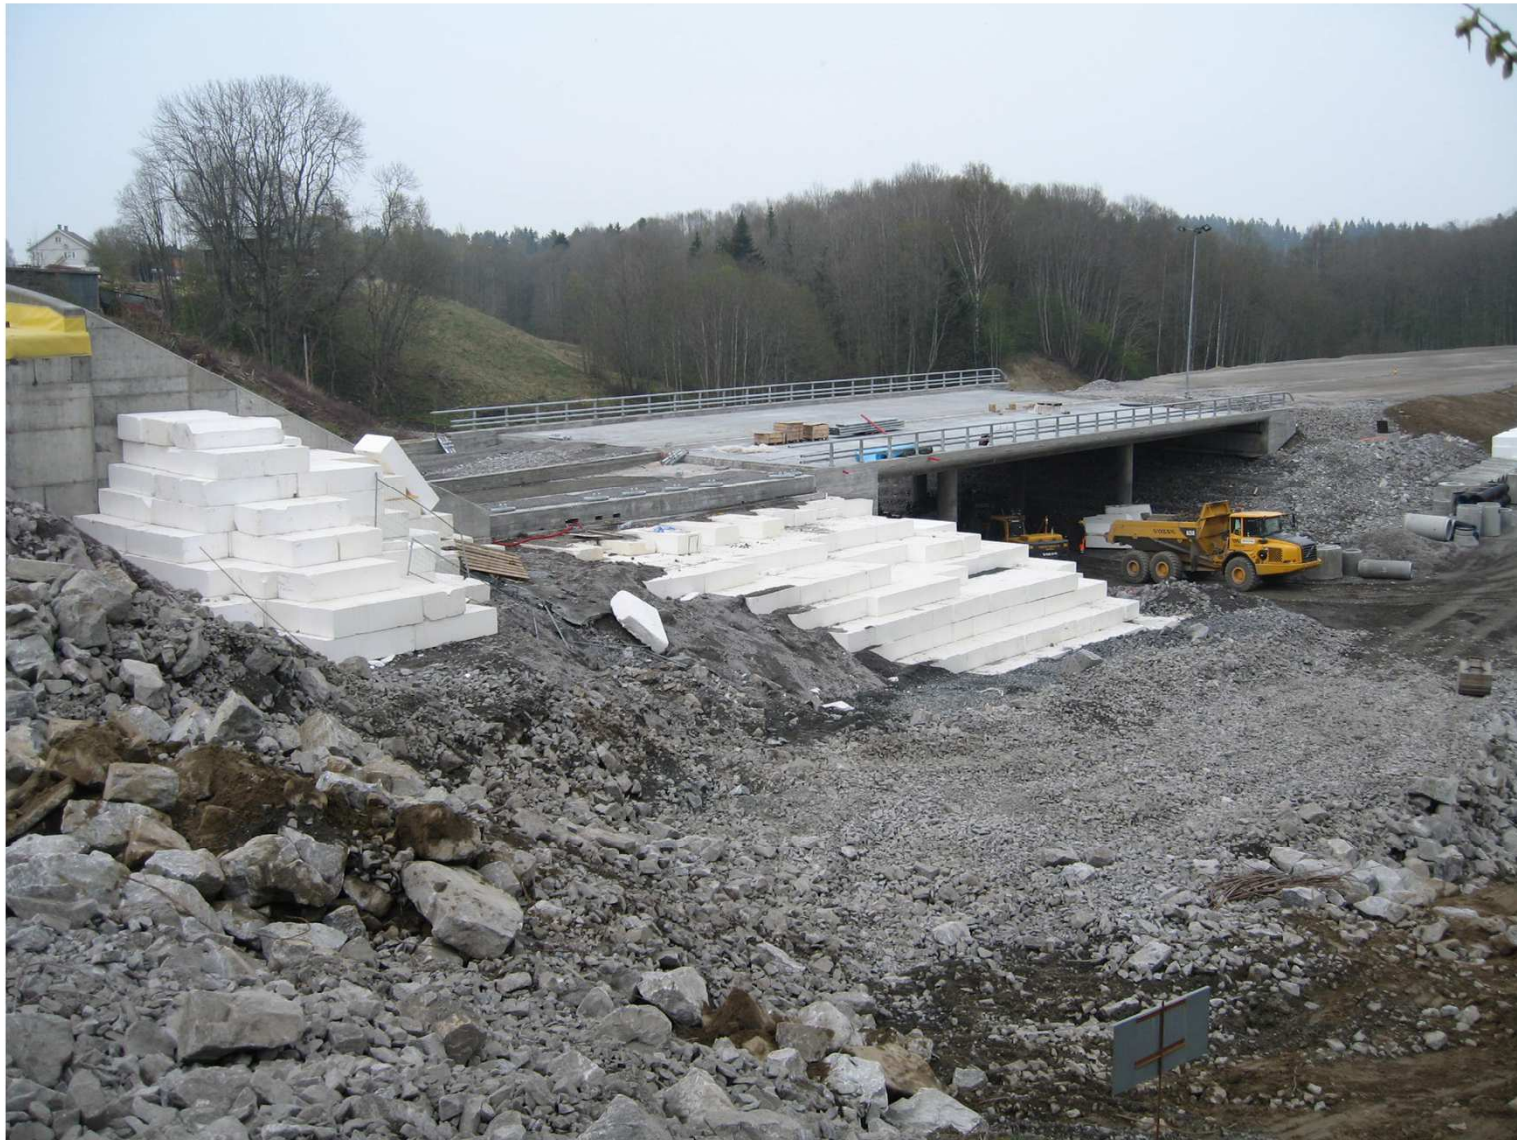
EPS geofoam blocks placed - fill against abutment and culvert side

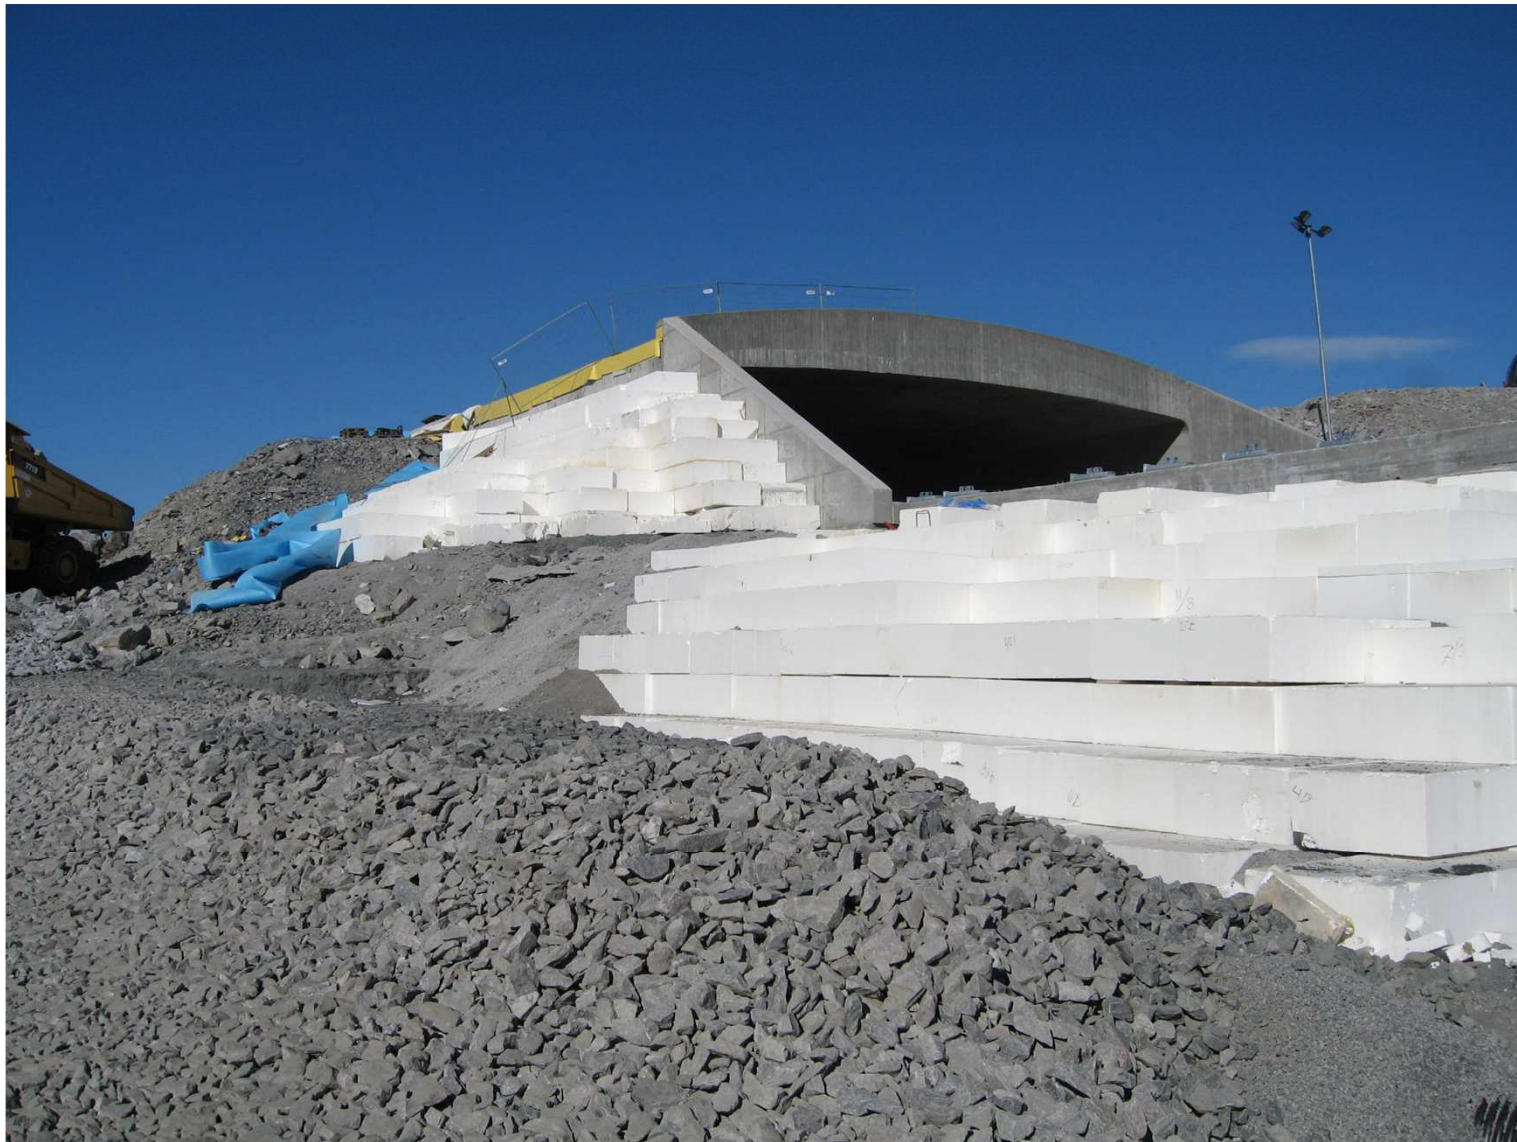
EPS geofoam embankment as a side fill to Tenor culvert

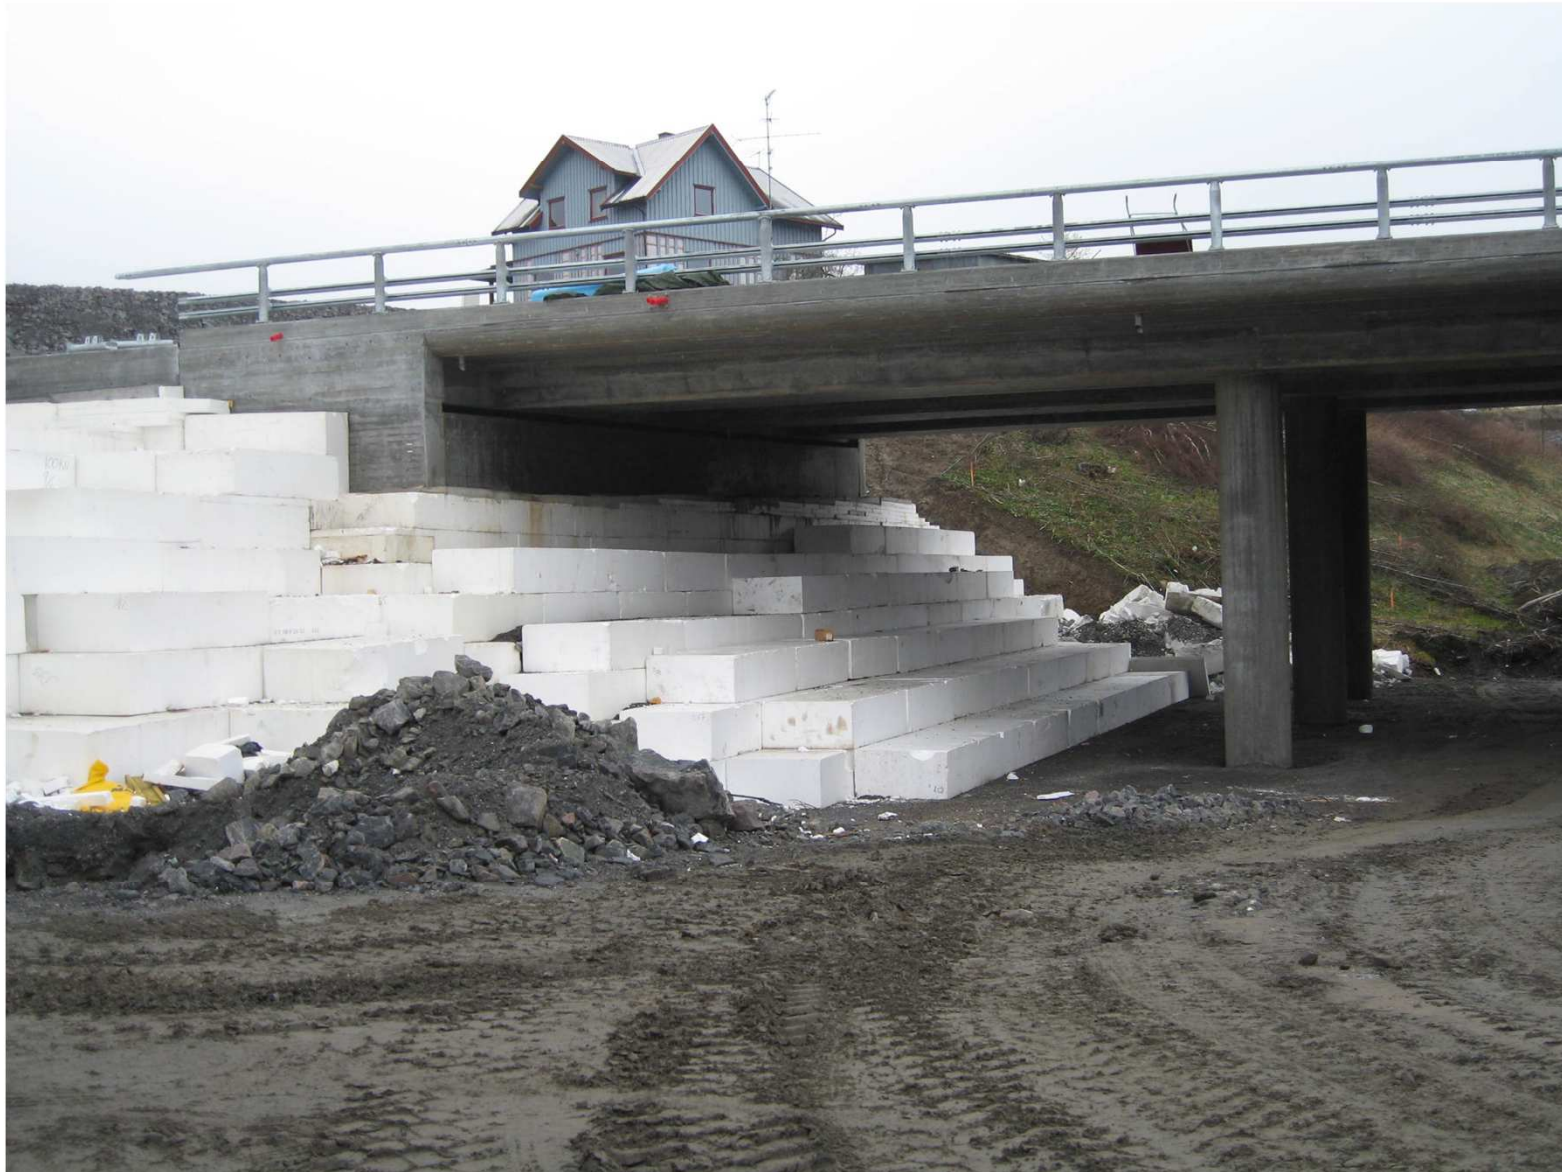
EPS geofoam embankment at the abutment of the Almark Bridge

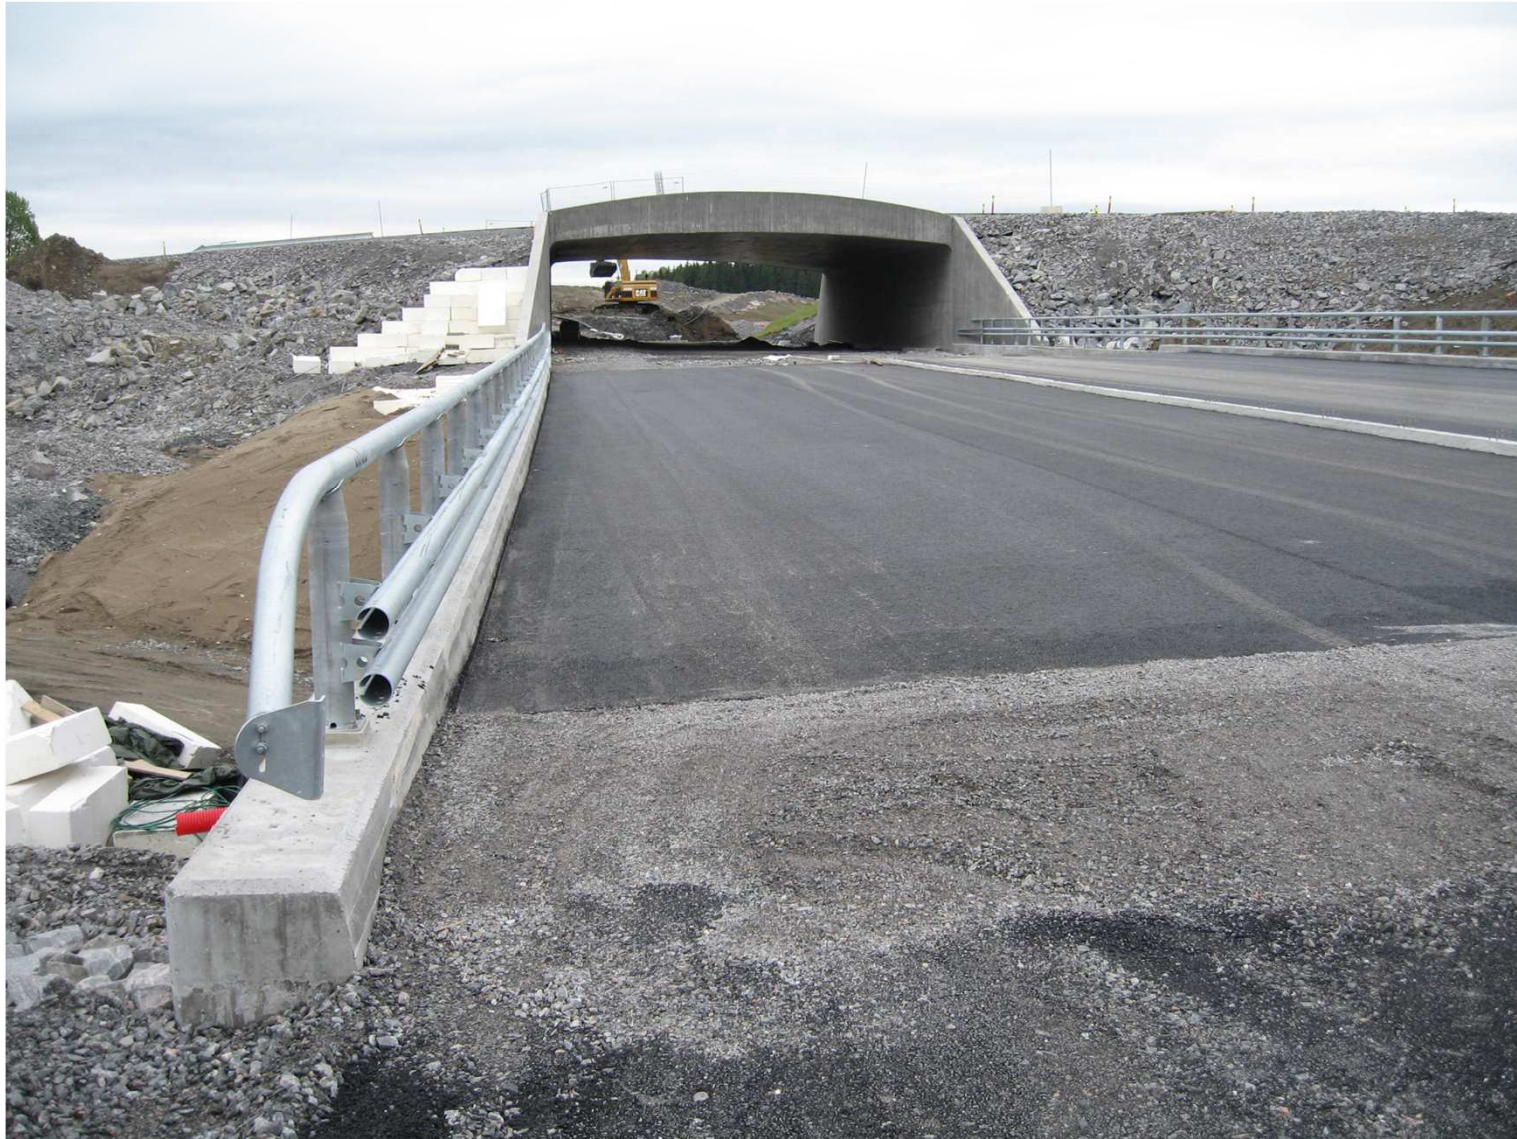
The EPS embankment at the Almark Bridge covered by sand

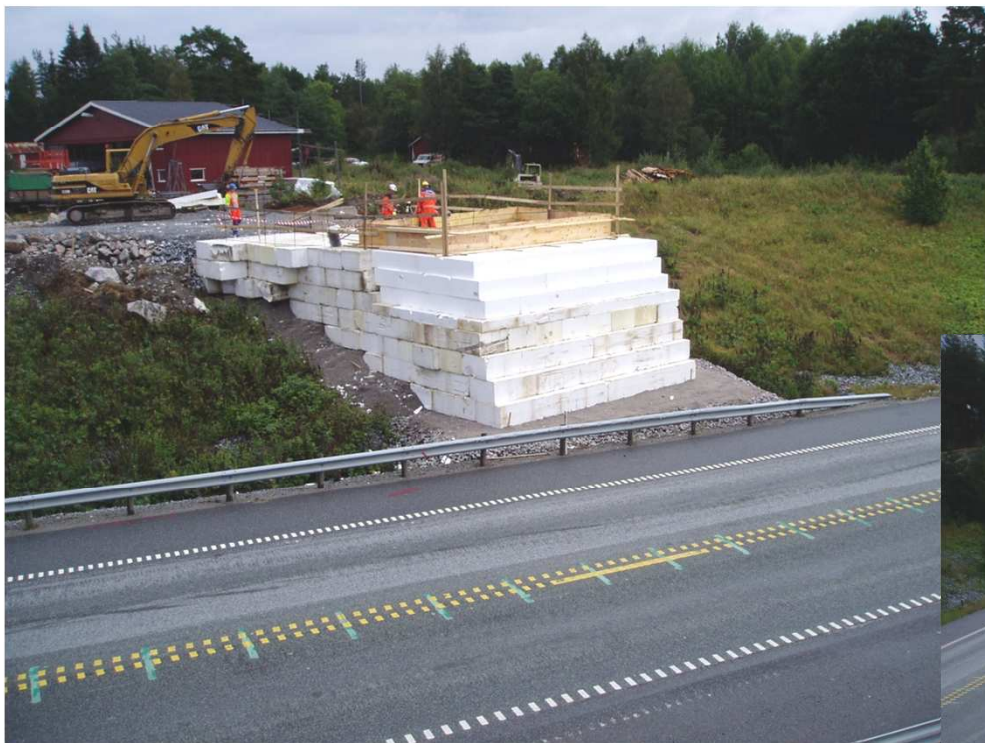
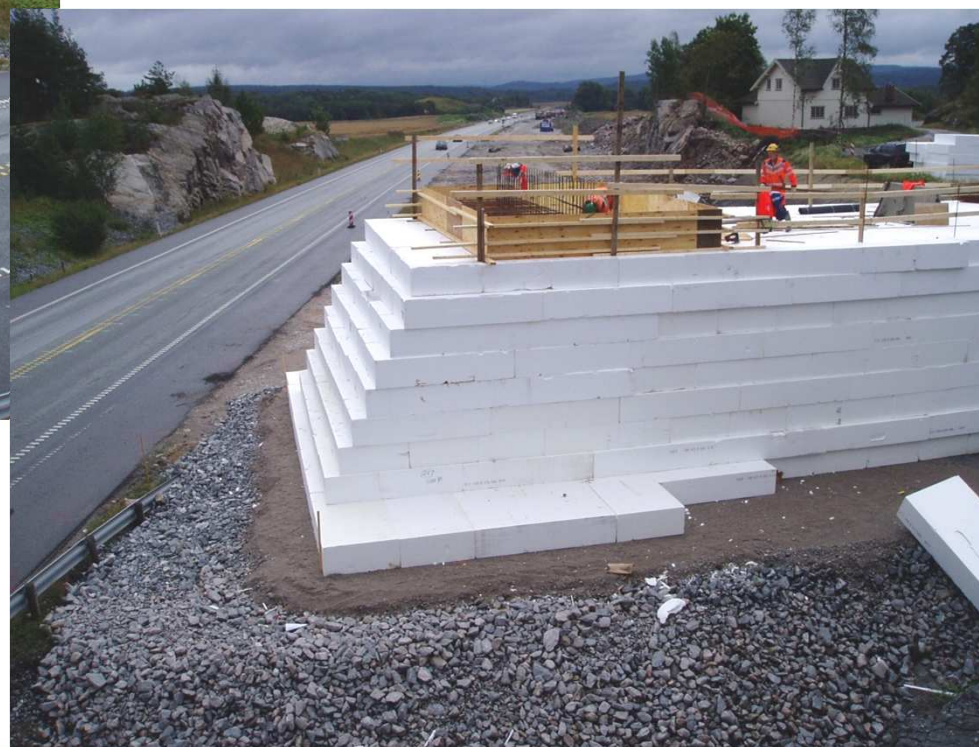
Embankment with EPS geof foam – left and right side abutments

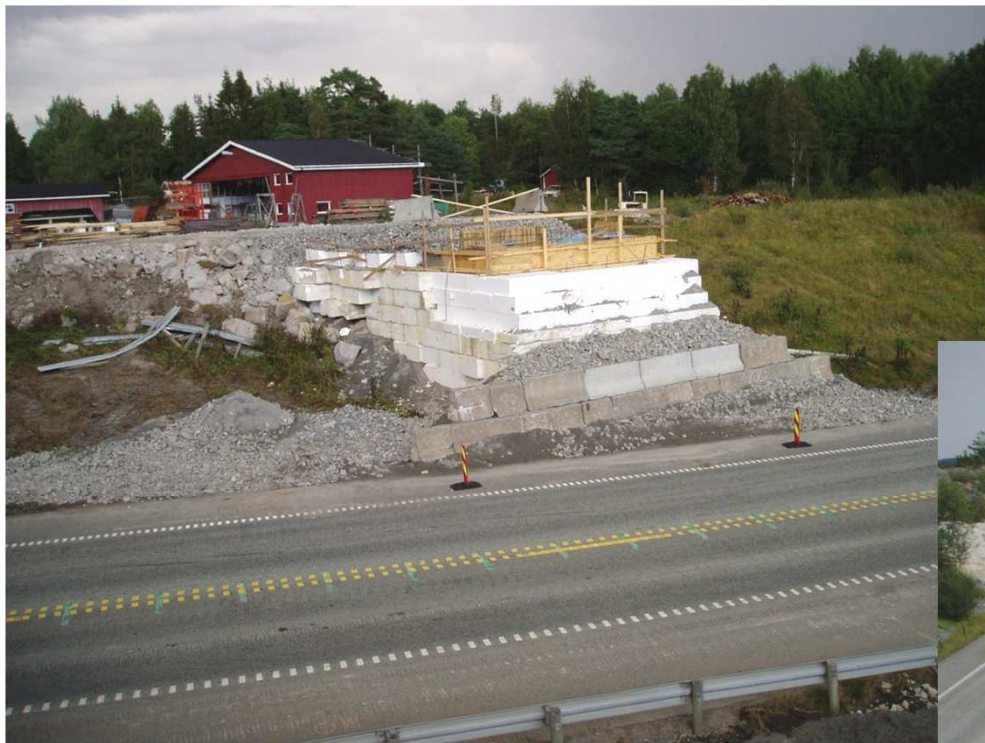
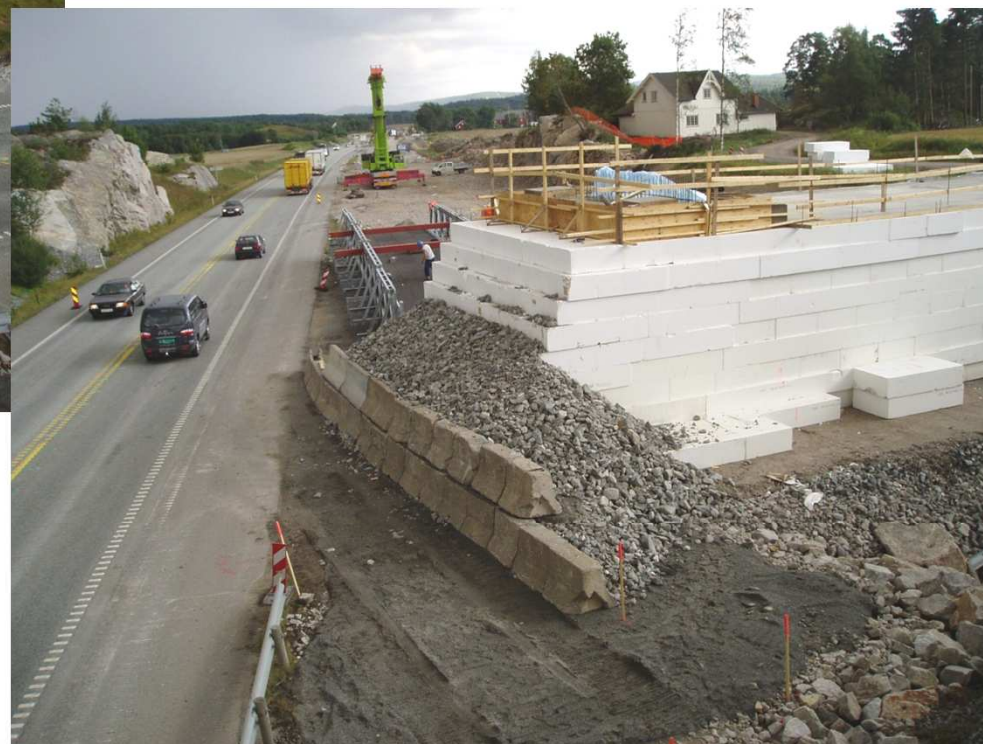
Embankment with EPS geofom – left and right side abutments

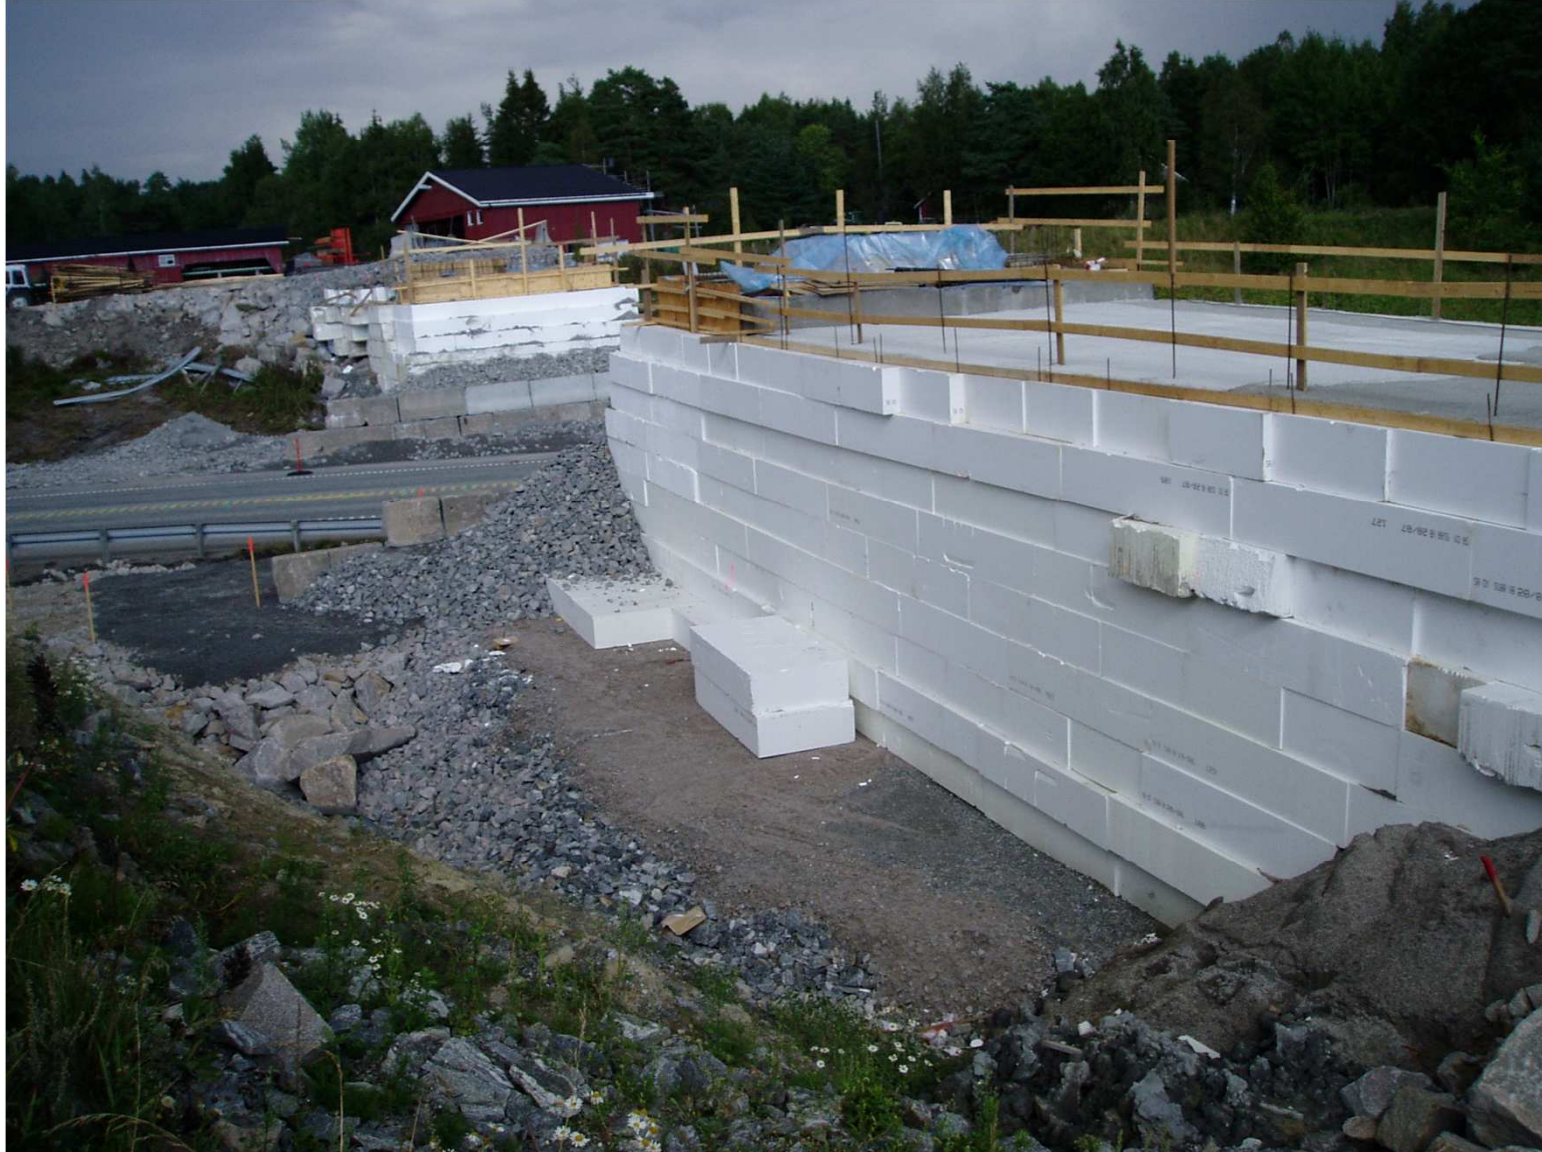
Embankments with EPS geofoam – before installation of bridge

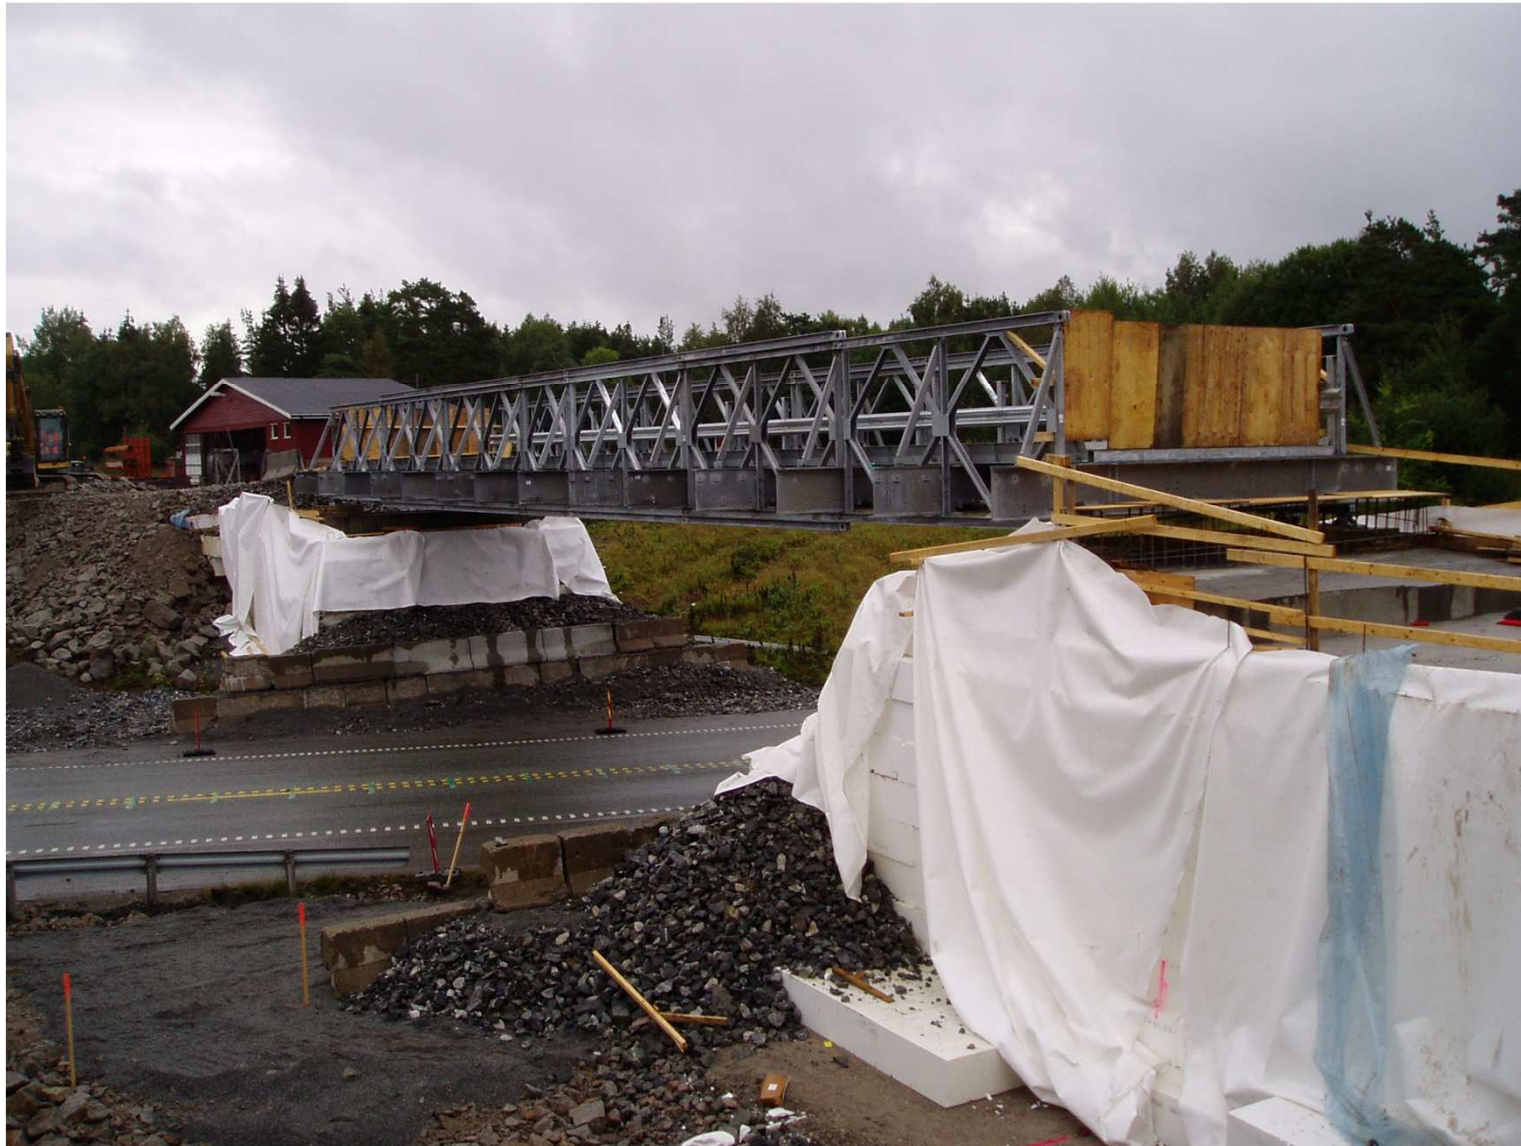
Embankment with EPS geofoam – after installation of Bridge

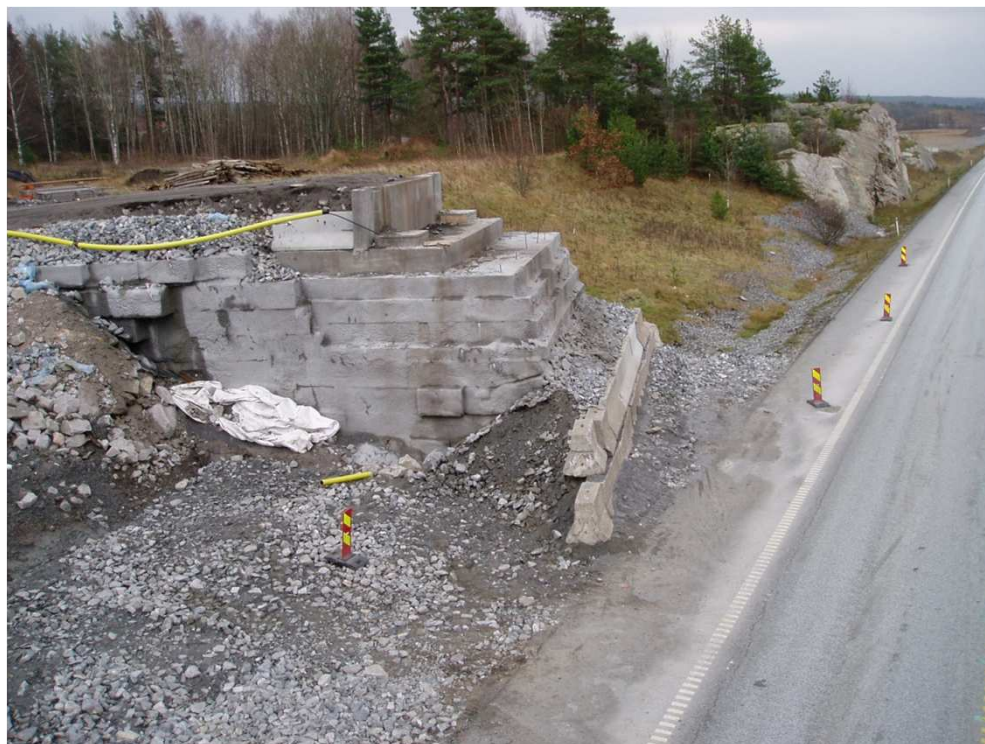
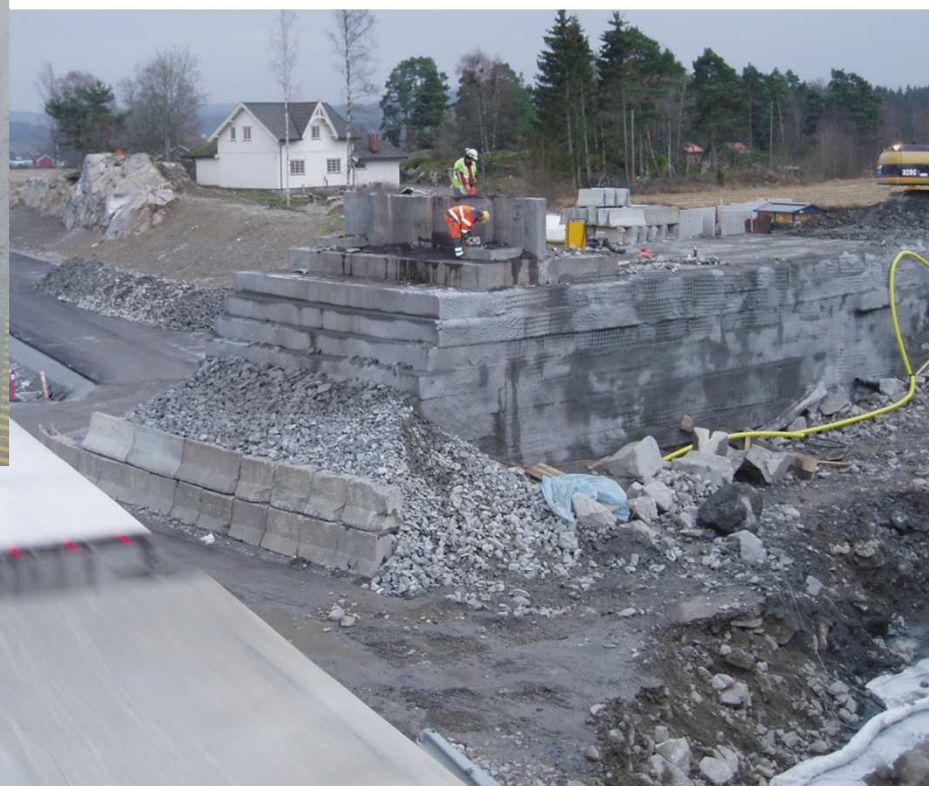
EPS geofoam – covered with reinforcement mesh & shotcrete
