***CO US 36 Wall Foundation Failure and
Use of Geofoam to Reopen the
Roadway in 6 weeks***

**44th Annual Southwest Geotechnical
Engineering Conference
June 23, 2021**

U.S. 36 Emergency Project—Geofoam Fill to Support Urban Roadway Traffic

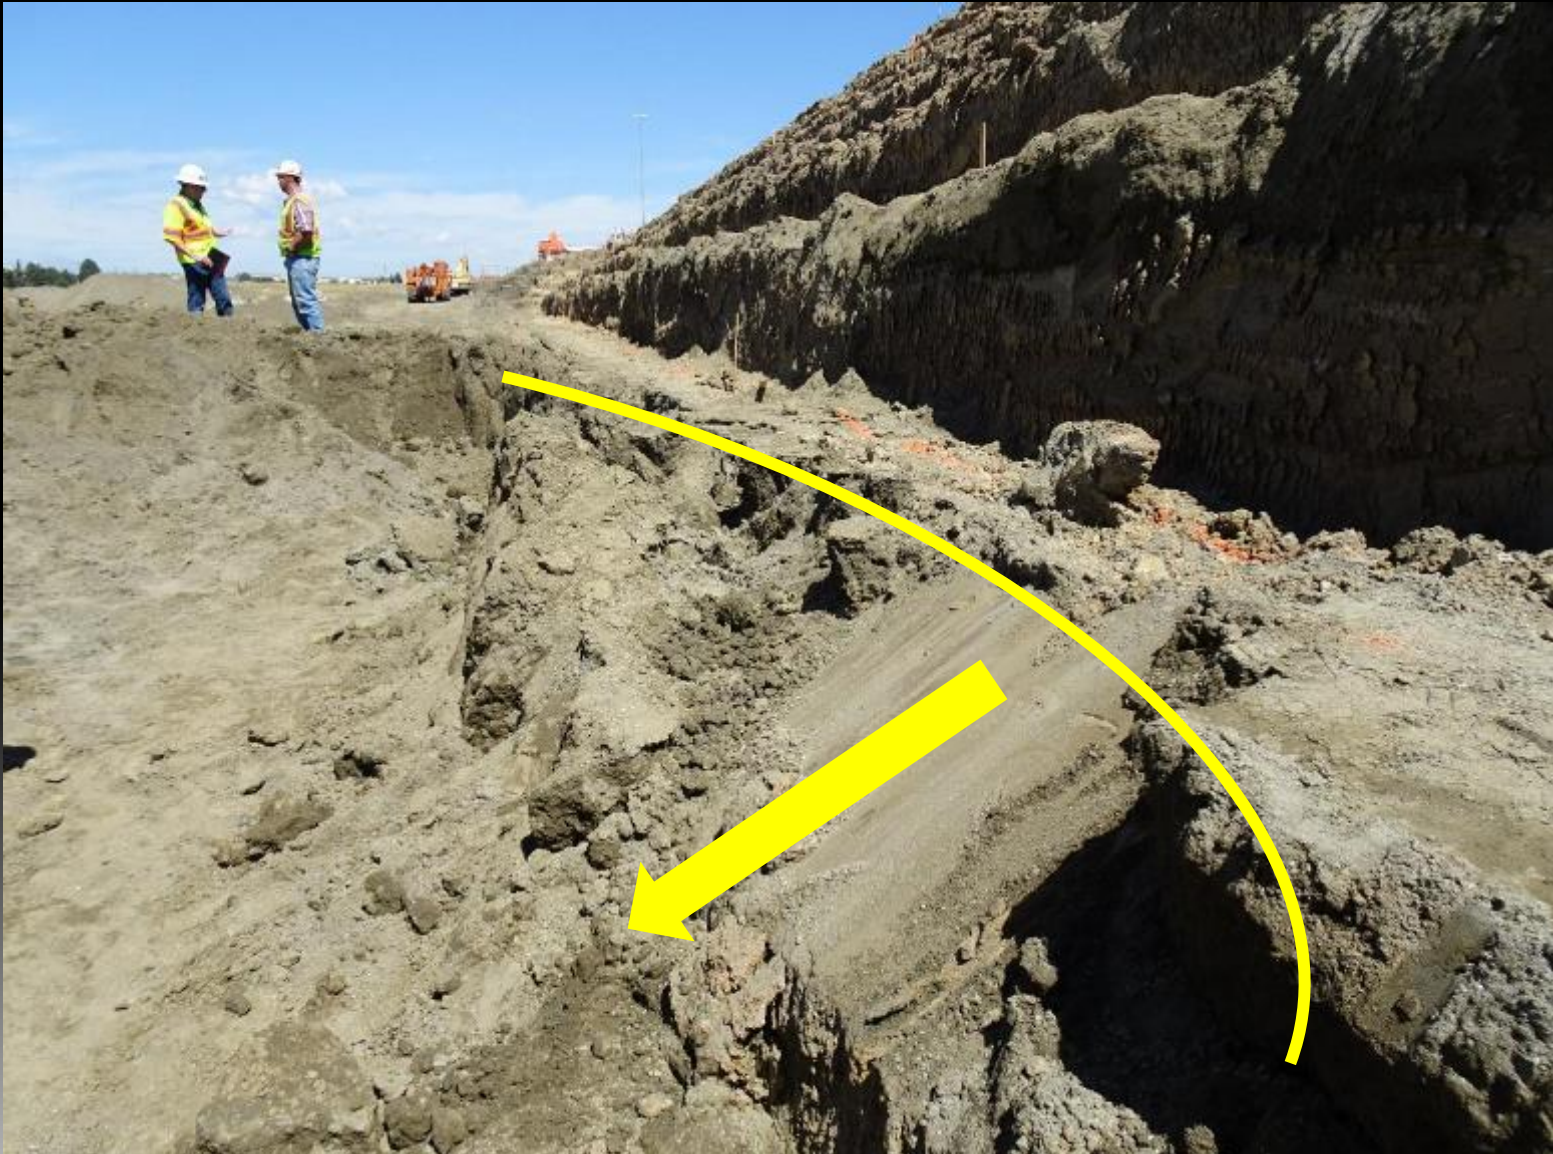
August 9, 2019

Failure Surface Exposed

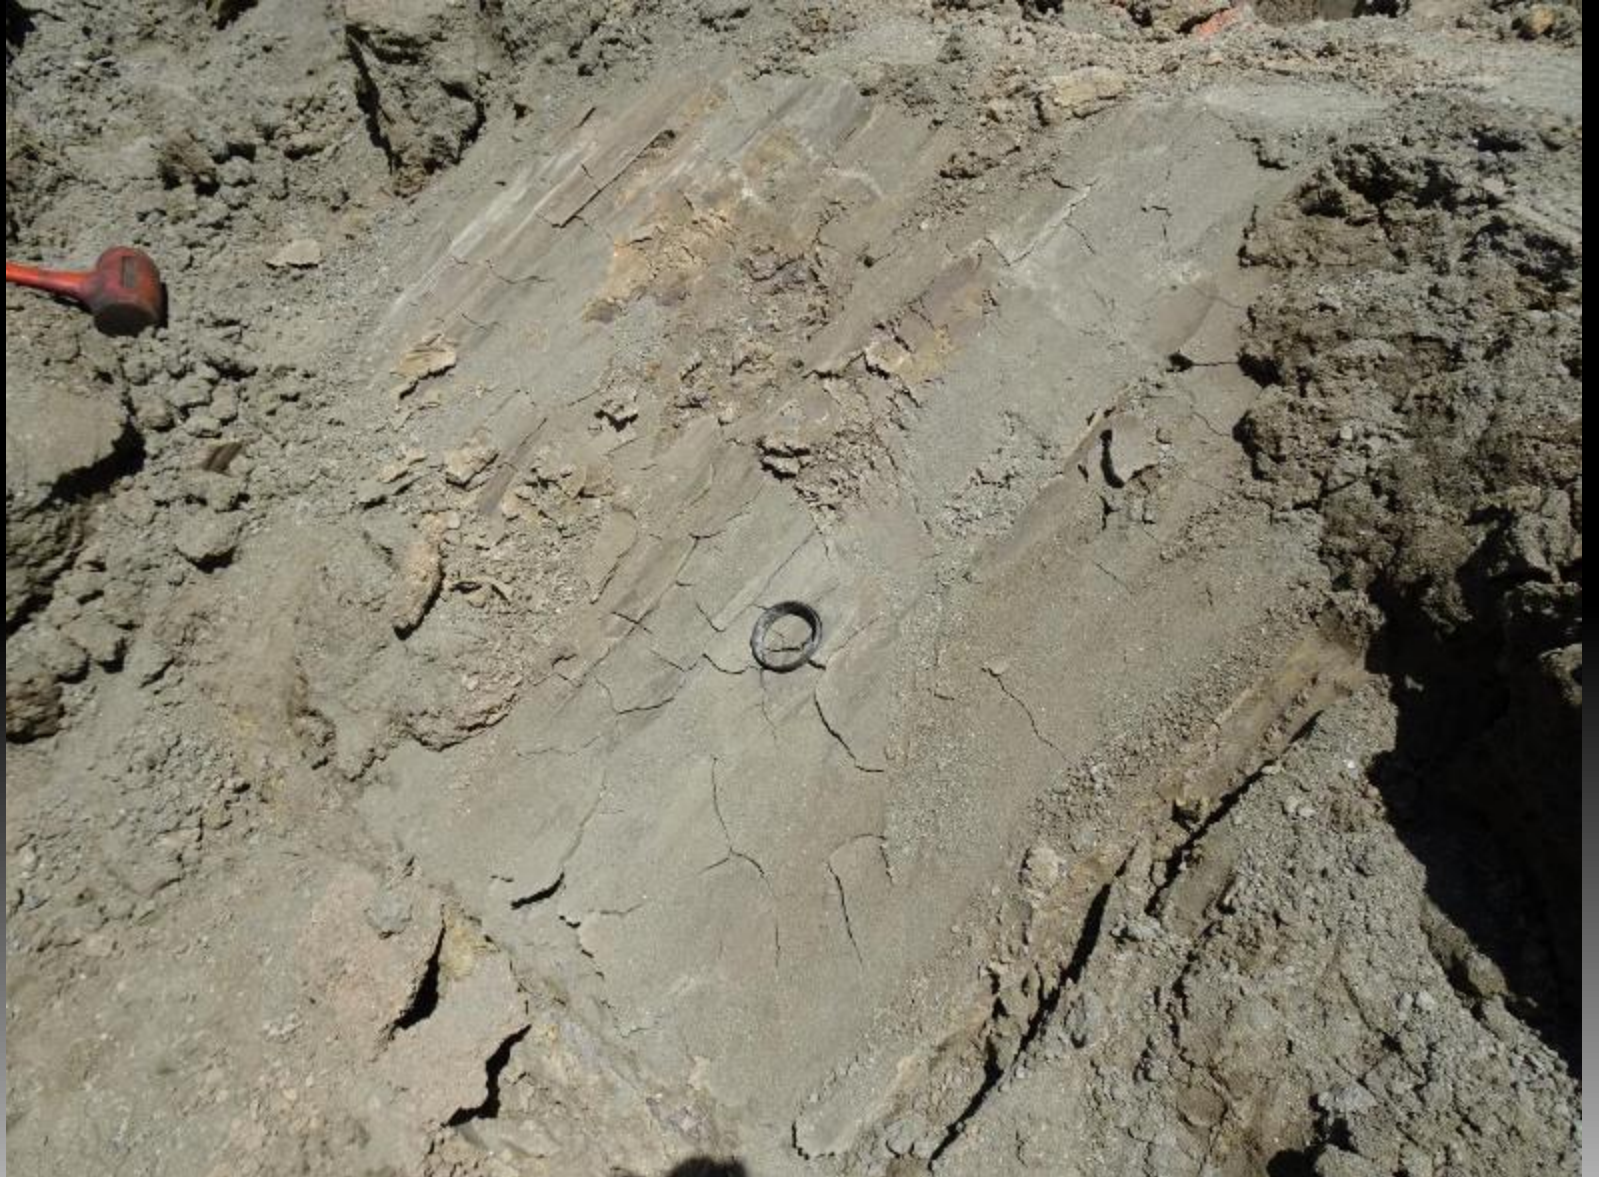
California Sampler

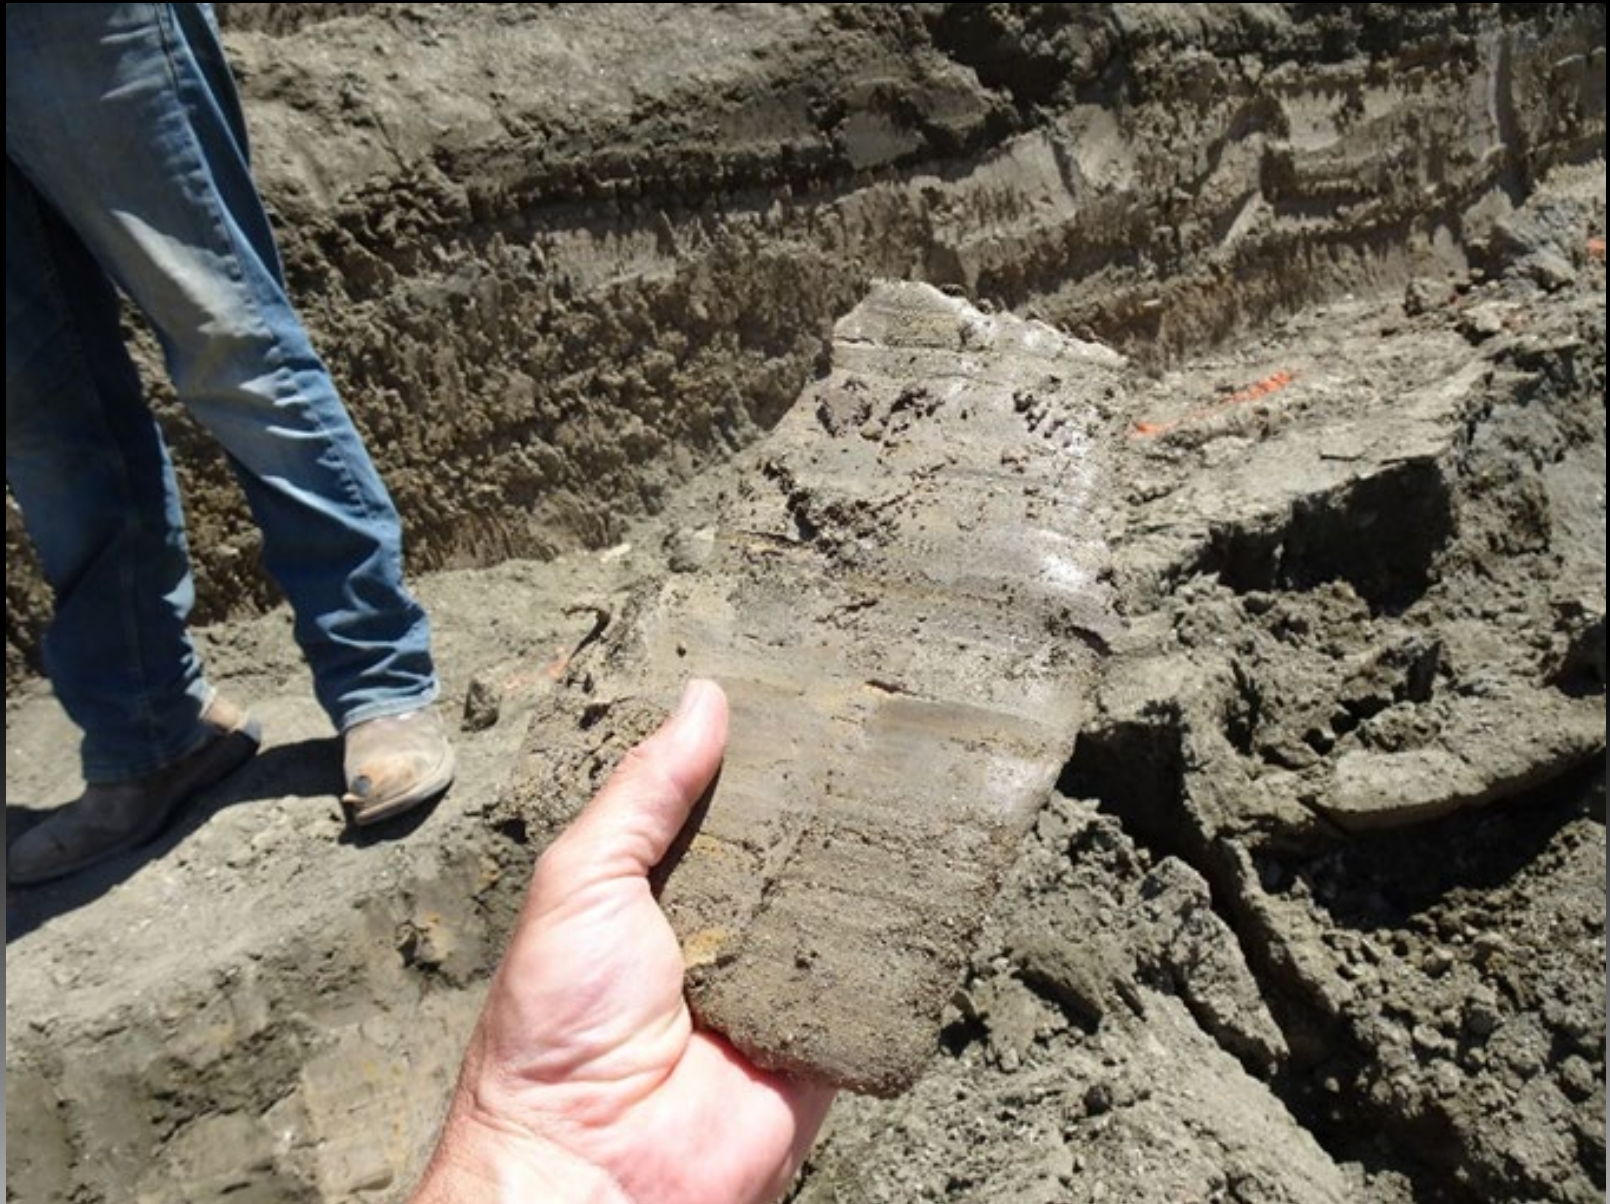
Slickensided Surface

1. Cohesion is very important in Modeling Effort. We should consider not simply use “zero” for cohesion.
2. Actual Cohesion is a very small number (i.e., 5 psi) but has significant impacts on the analysis.
3. Where do we sample? Incredibly difficult to get a sample in the actual failure plane.
4. Quick Geofam Characteristic – Deformation is vertical and horizontal.

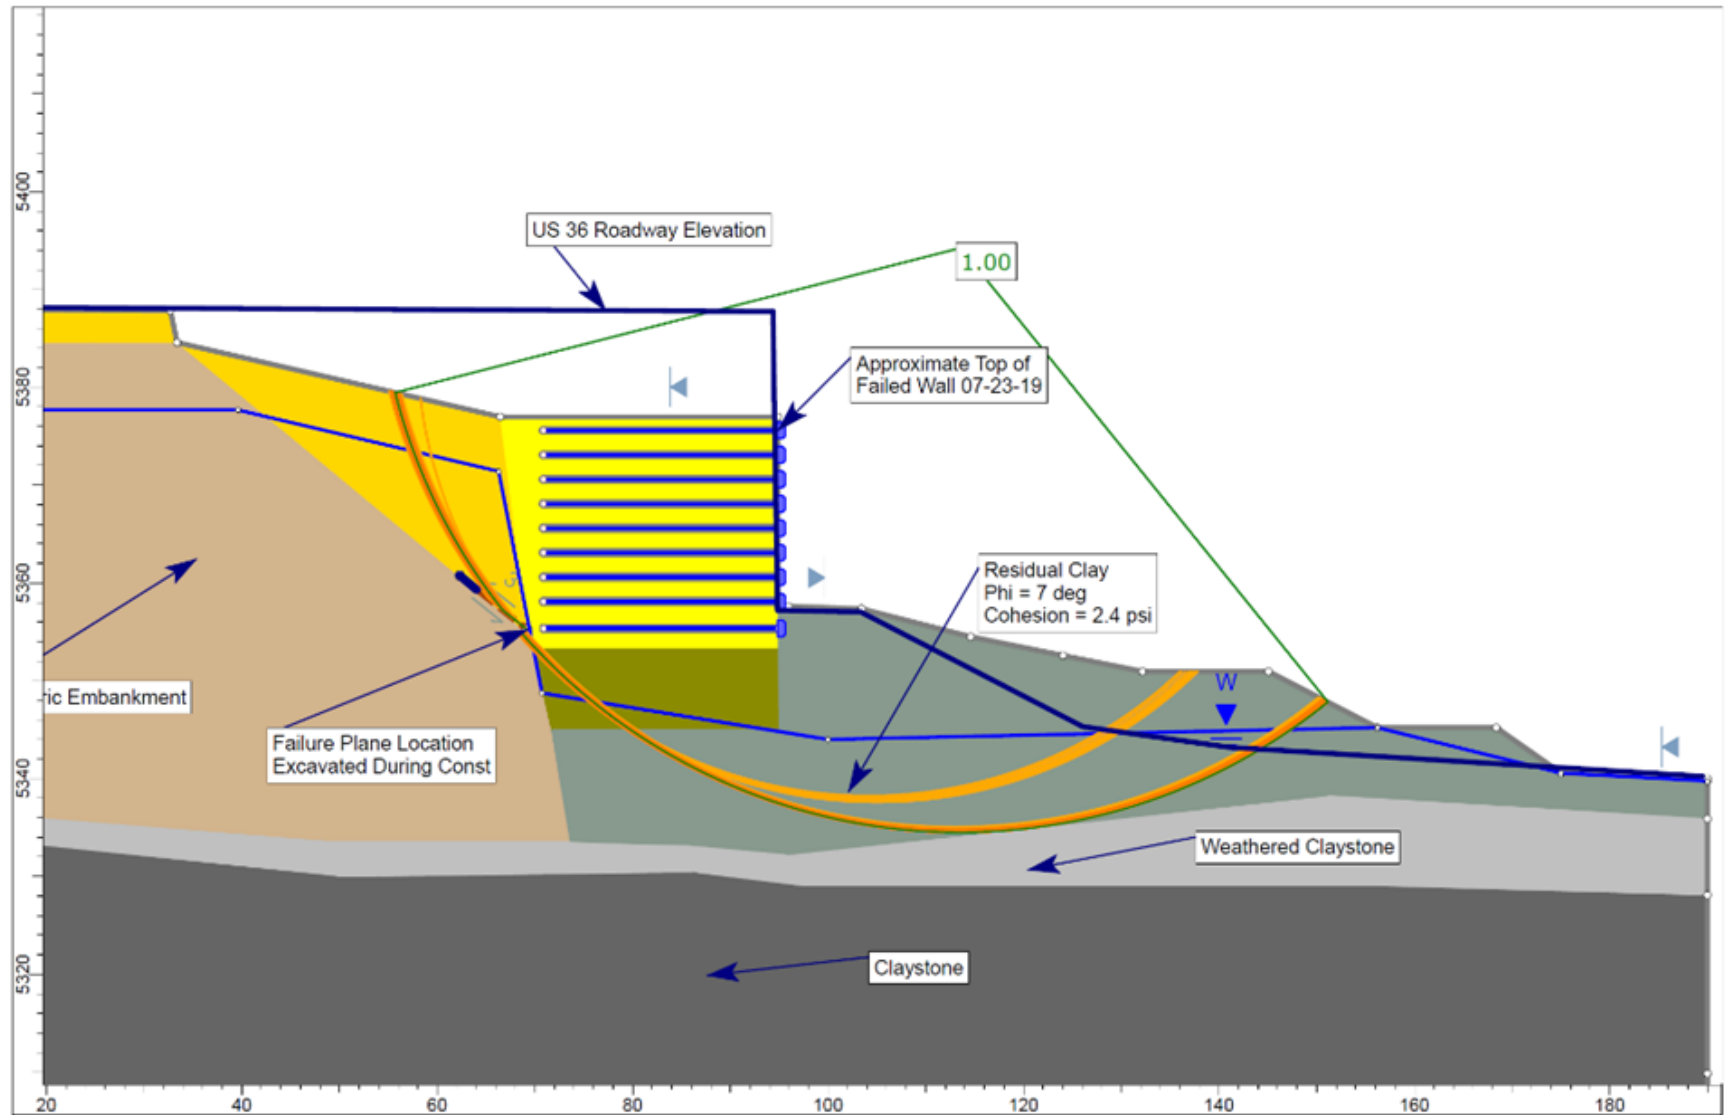
Residual Strength LE Model with Cohesion

US 36 Emergency Rebuild - Ongoing Failure 07-23-19

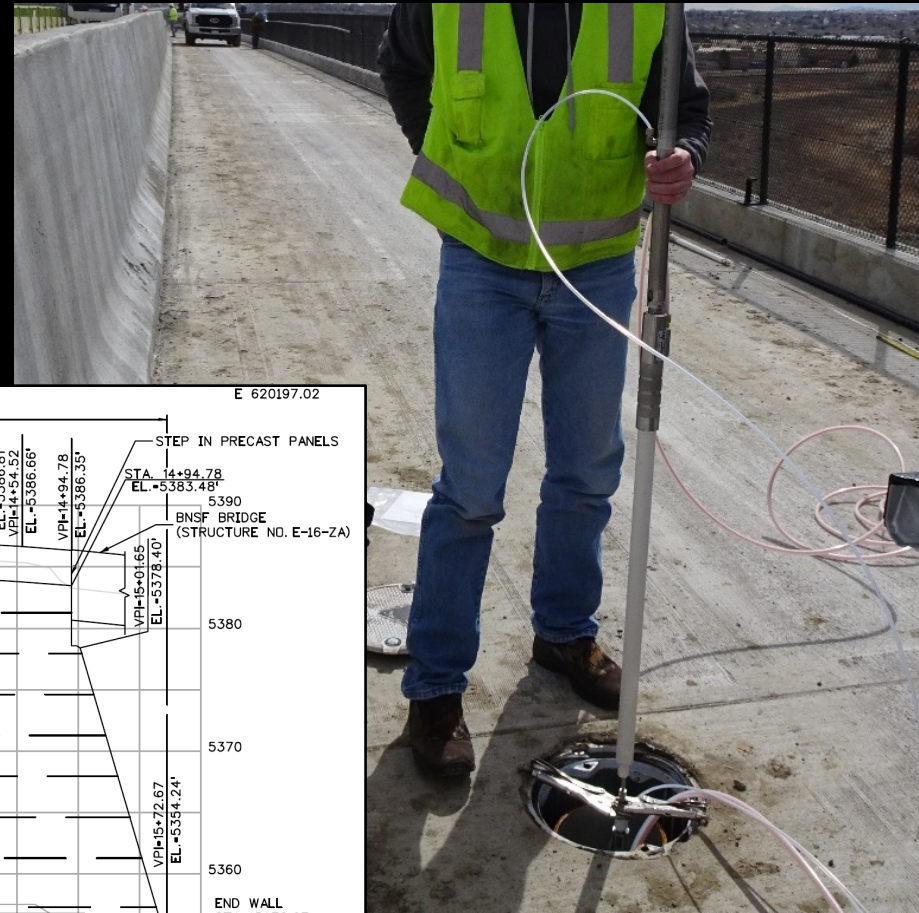
Installation of Extensometer Instrumentation
