Lightweight filling materials for road construction

Road Technology Department

Oslo, December 2002

Long term performance and durability of EPS as a lightweight filling material

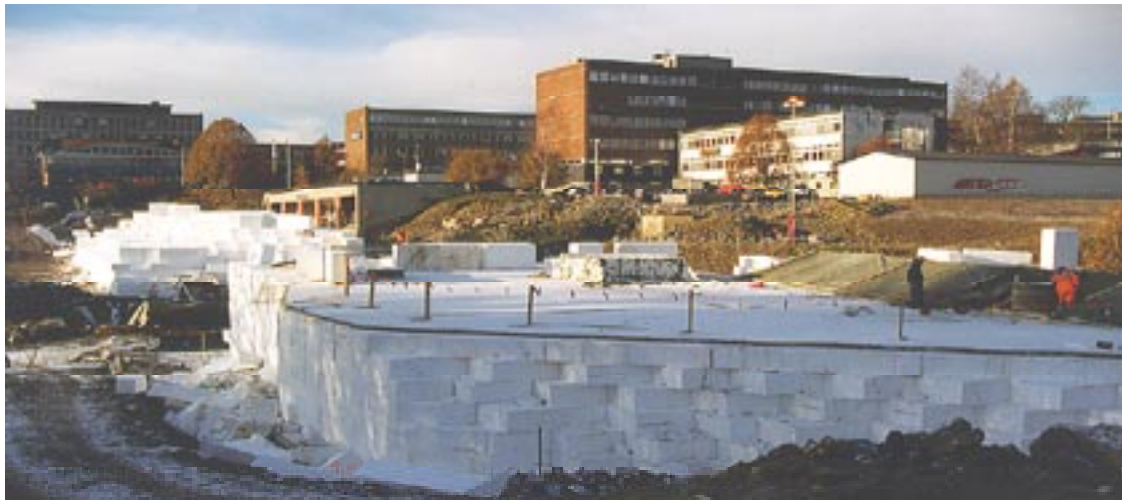
Figure 1: An EPS embankment with vertical walls for a city tramline in Oslo as an alternative to a bridge.

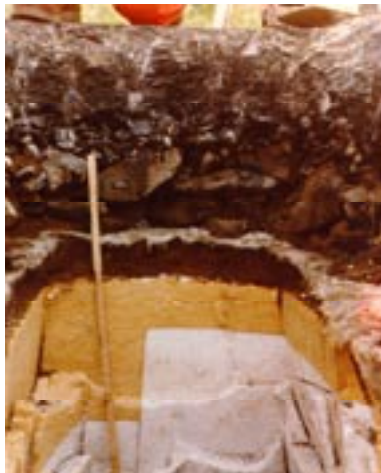
Figure 2: Excavation of the first EPS embankment at Flom bridge.

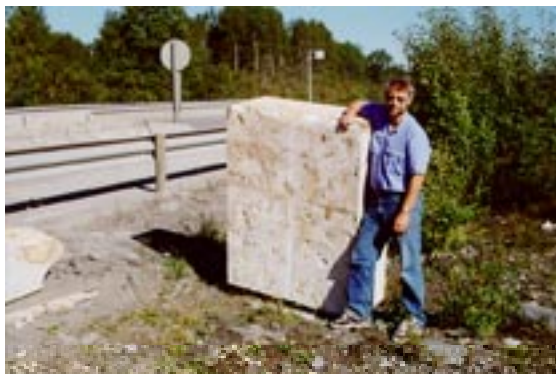
Figure 3: Excavation of a 24 years old EPS block from the first EPS embankment at Flom bridge.

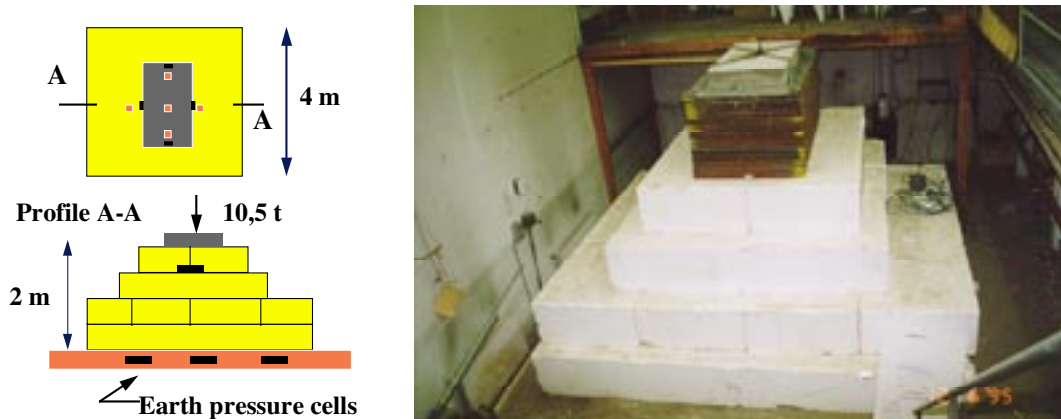
Figure 8: EPS test fill at the Norwegian Road Research Laboratory (now the Road Technology Department)

In a laboratory test at the Norwegian Road Research Laboratory (now the Road Technology Department) a test fill of height 2 m with normal size blocks and a compressive strength $\sigma = 100$ kPa has been loaded to a value of $q_{dw} = 52.5$ kPa and the resulting deformations observed over a period of 3 years (Figure 8). The results are shown in Figure 9 together with calculated deformations to be expected according to the theories introduced by Magnan & Serratrice.

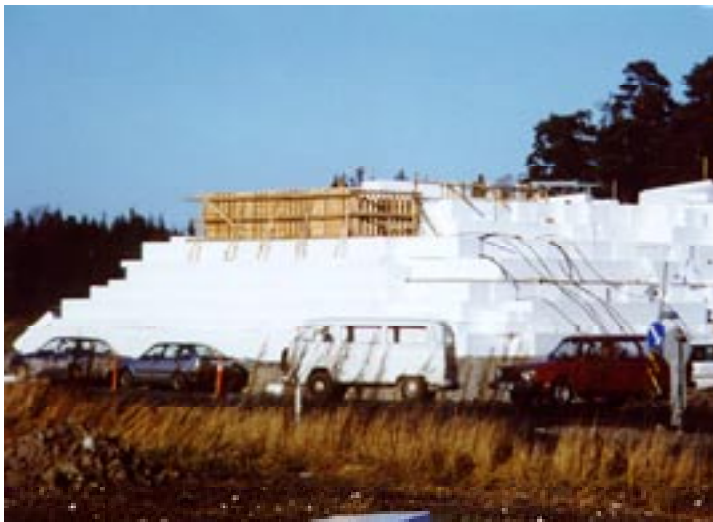
Figure 10: Construction of one abutment on the EPS embankments at Løkkeberg bridge.

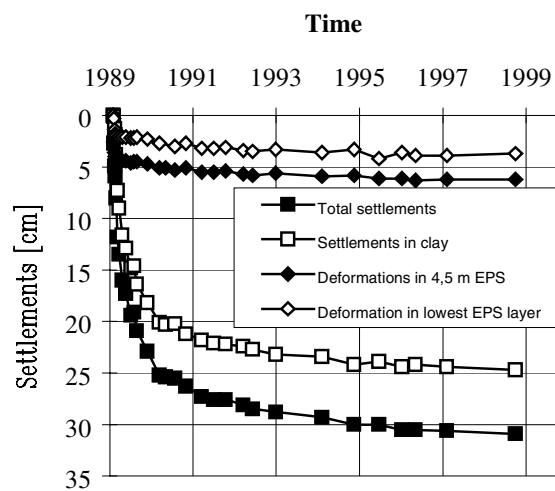
Figure 13: Creep deformation at Løkkeberg.

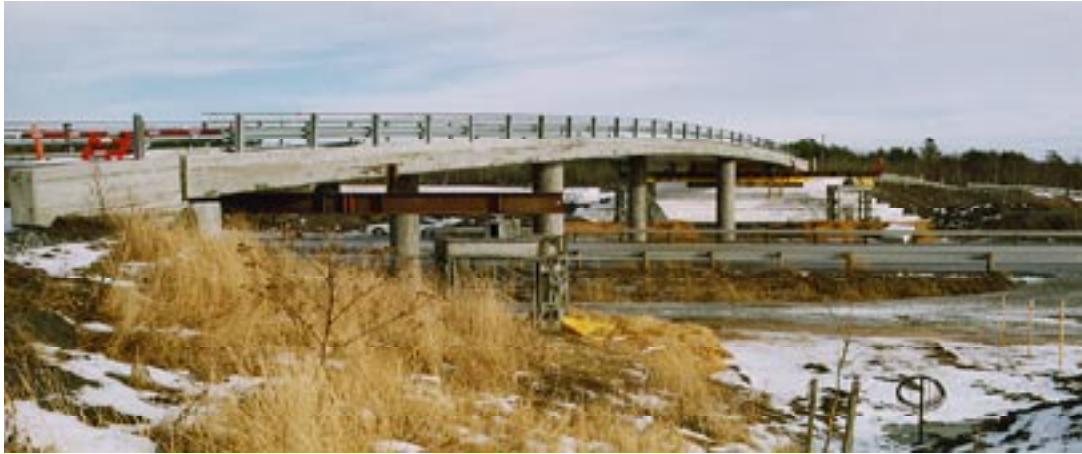
Figure 20: Temporary support of abutments at Hjelmungen.

Repair works were initiated in December 1995 and completed in the spring of 1996. One abutment was treated at a time while the bridge deck was provided with a temporary support as shown in Figure 20. Thickness and densities of the original filling materials were recorded as they were removed in order to have accurate data for control of load and settlement calculations. After removing the old abutments, the concrete piles were inspected regarding possible damage before being cut at ground level. No pile damage was observed. Construction of the EPS fills could then start. In this case three different qualities of EPS were utilized. In the zone directly beneath the bridge abutment, as indicated by the trapezoidal shaped lines in Figure 19, a material quality of $\sigma = 235$ kPa was specified for the first three block layers beneath the bottom slab of the abutment. Further down a material quality of $\sigma = 180$ kPa was specified within the indicated zone. For the rest of the EPS fill a material quality of $\sigma = 100$ kPa was used. These quality requirements have been decided based on evaluation of stress distribution in the material in order to keep the stress level for dead loads within 30 % of the material strength. Stricter geometric requirements than normal were also enforced related to block dimensions in order to obtain an even fill and reduce initial deformations when the load from the bridge deck was transferred to the new abutment.

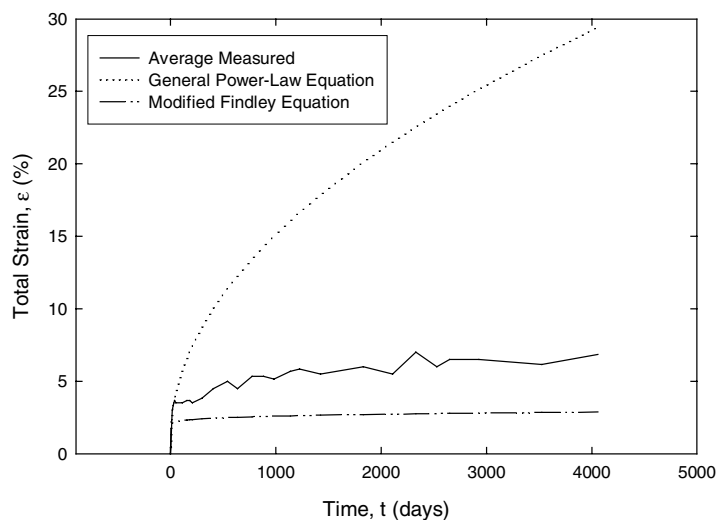
Figure 5: Comparison of total vertical strain measured in the lowest EPS block layer of the field test fill and the general power-law and modified Findley equations.

Figure 5 shows the total vertical strain measured in the lowest block layer. The density of the bottom row of EPS blocks is 20 kg/m^3 and the original thickness of the EPS blocks is 0.6 m. Three pressure cells were installed below the first row of blocks. An average pressure of 67 kPa was recorded in the three pressure cells during the period that the vertical strain was being obtained from the settlement rods. As shown in Figure 5, the power-law and modified Findley equations significantly overestimate and underestimate the measured total strains, respectively. However, the total strains predicted by the modified Findley equation are again in better agreement with the measured values than the power-law equation.

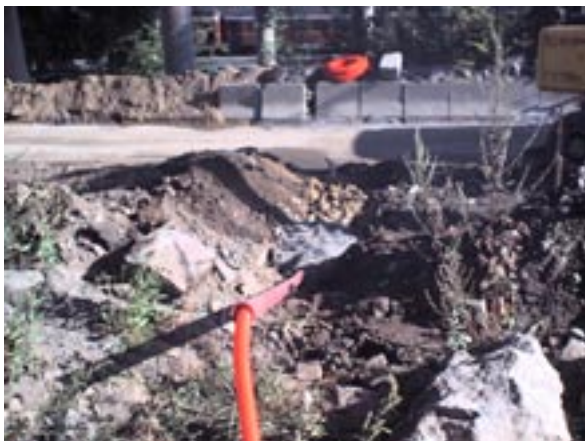
Figure 7: Monitoring long term deformations with tube settlement gauges.

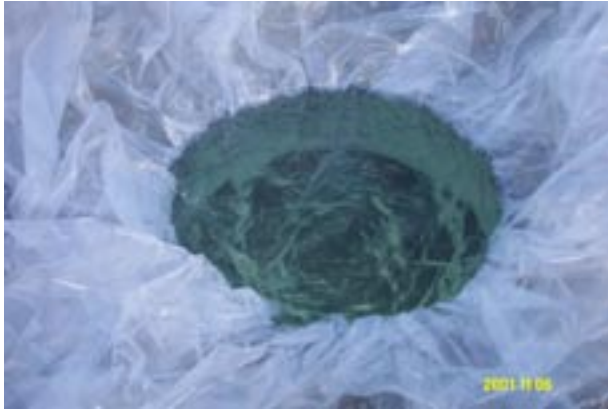
Figure 10: Water used to measure excavated volume.

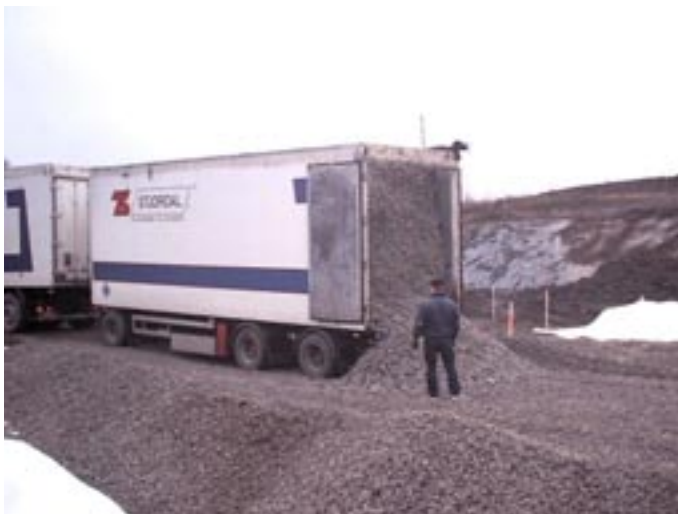
Figure 11: Transport to site in large trucks.

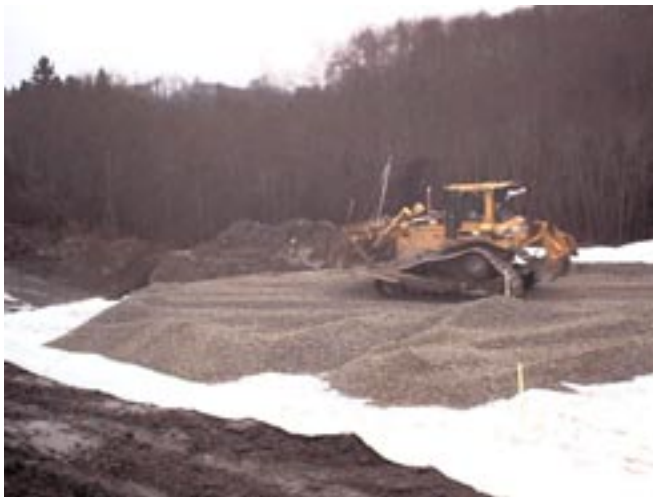
Figure 12: Distribution and compaction with dozer.
