# **PERFORMANCE OF A GEOFOAM EMBANKMENT AT 100 SOUTH, I-15 RECONSTRUCTION PROJECT, SALT LAKE CITY, UTAH**

**D. Negussey and A. Stuedlein, Geofam Research Center, Syracuse University, Syracuse, NY 13244**  
**S. Bartlett, University of Utah, Salt Lake City, Utah**  
**C. Farnsworth, Utah Department of Transportation, Salt Lake City, Utah**

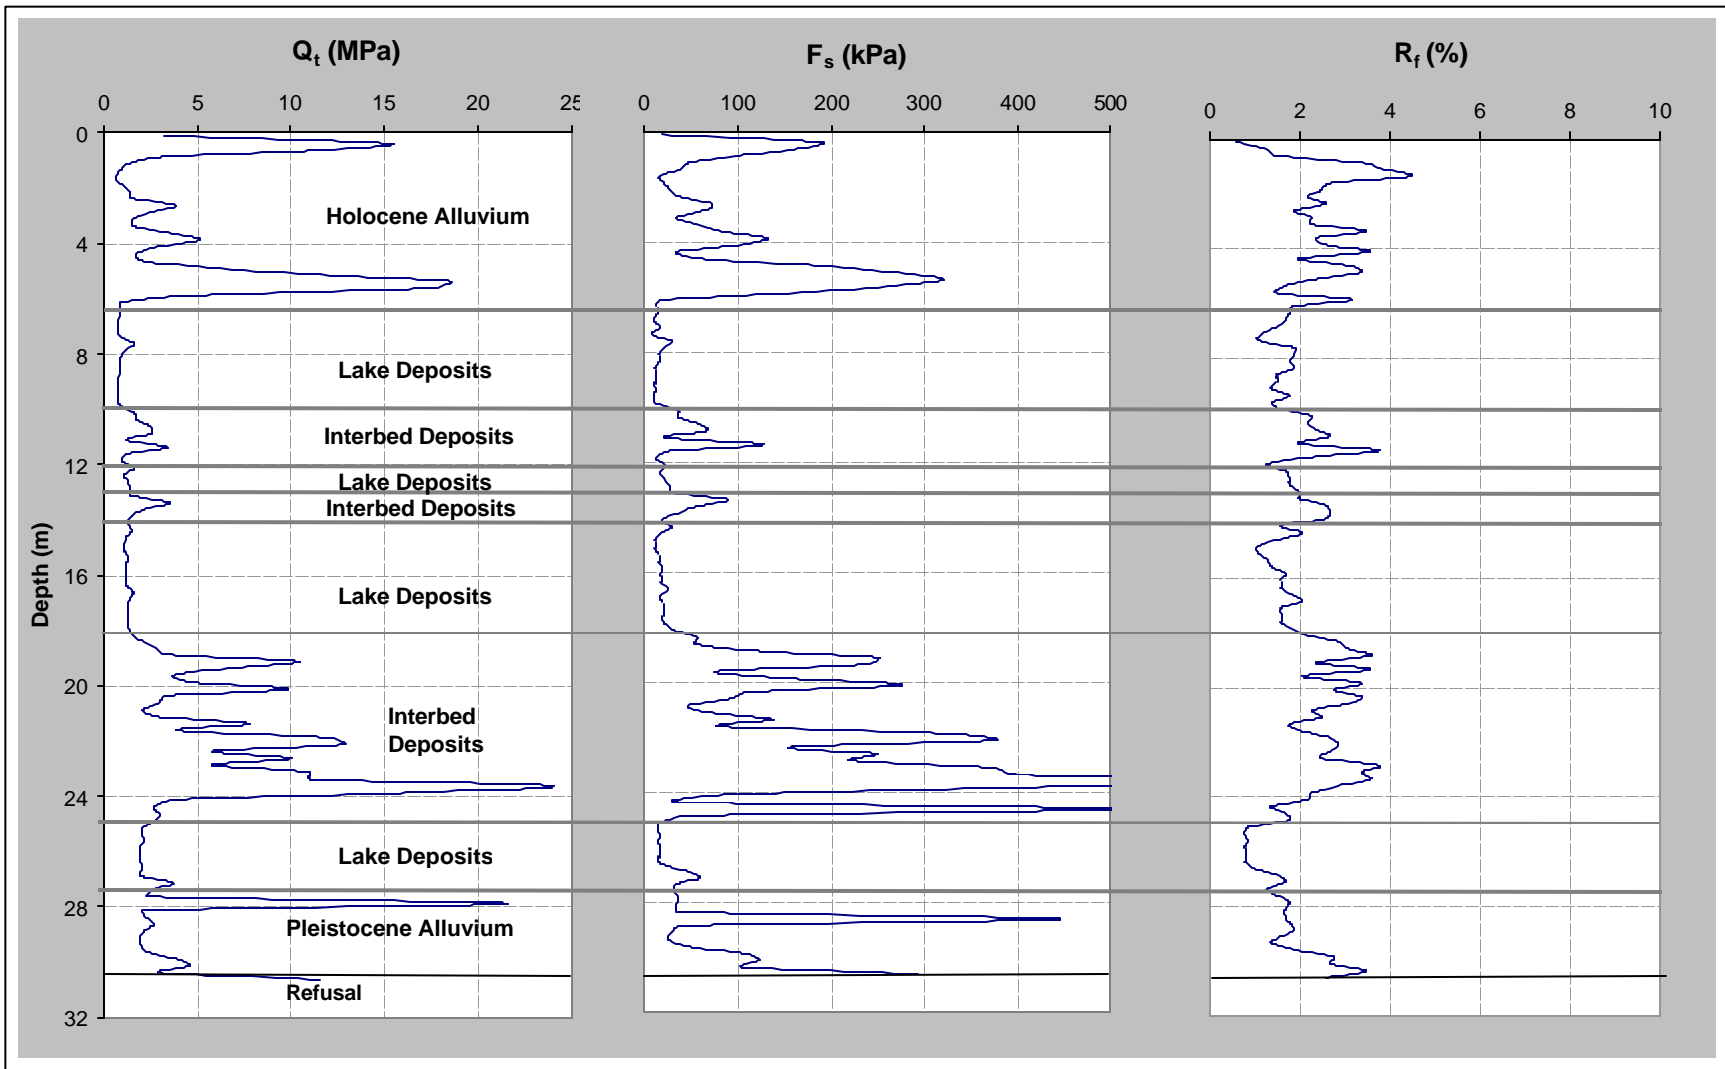
Figure 1 – Soil profile from CPT sounding 06-SC-10 near 100 South geofoam array site (UDOT Geotechnical Report, 1996).

Figure 1 shows a CPT soil profile in close proximity to 100 South at I-15. The stratigraphy consists of about 4.5 meters of desiccated clayey silt over 1.5 meters of poorly graded sand. Soft to firm lean varved clay of up to 13.5 meters thickness underlie the poorly graded sand layer. The pertinent soil indices corresponding to the thick clay layer include natural water contents in the range of 20 to 50%, plastic limits in the range of 17 to 30, and liquid limits in the range of 30 to 60 (UDOT Geotechnical Report, 1996). Table 1 summarizes some of the engineering index properties of the Bonneville Lake deposit.

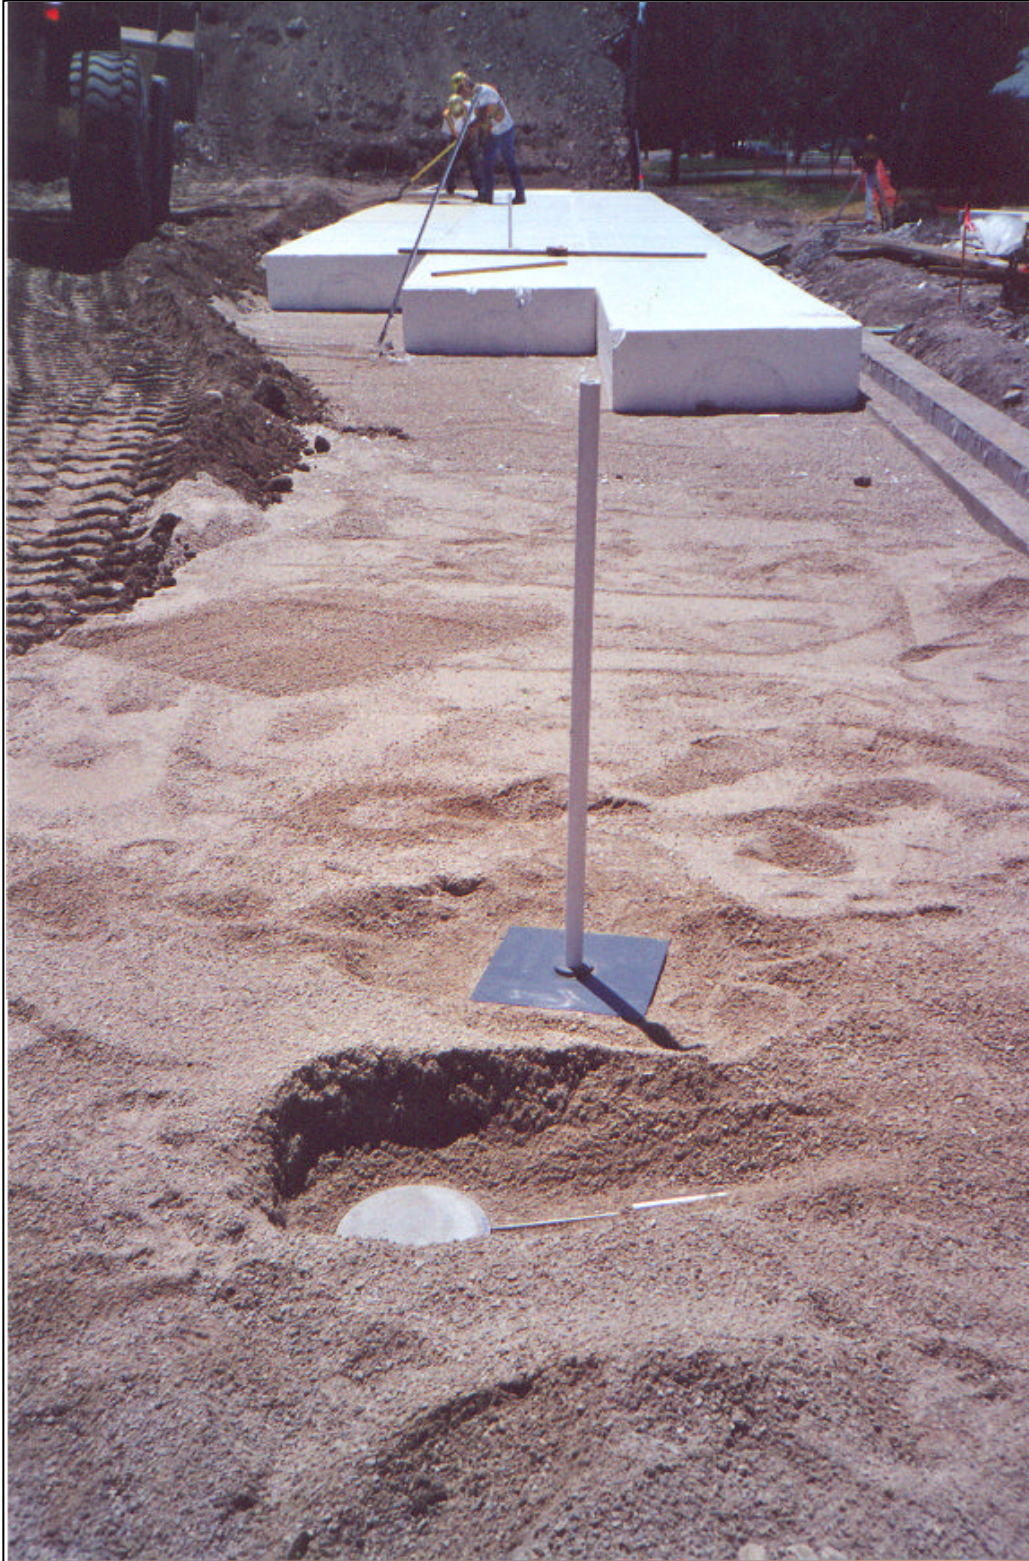
**Figure 4 – Stress cell and extensometer plate in the leveling course below the geofilm fill. Note geofilm and grade beam for fascia wall support in background.**

Total earth pressure cells of 345 kPa capacity were installed 150 mm into the bedding sand underlying the geof foam (Figure 4). Pressure readings were detected by vibrating wire transducers. The accuracy and resolution of the cell readings were  $\pm 0.9$  and  $\pm 0.4$  kPa, respectively. Zero readings showed one of the cells in the South Array to be non-responsive. The remaining two cells showed significant pressures with just one half-height block of foam in place. Subsequent increases in stress readings were consistent with the applied incremental load. The zero shift suggests the stress cells were overloaded during construction.

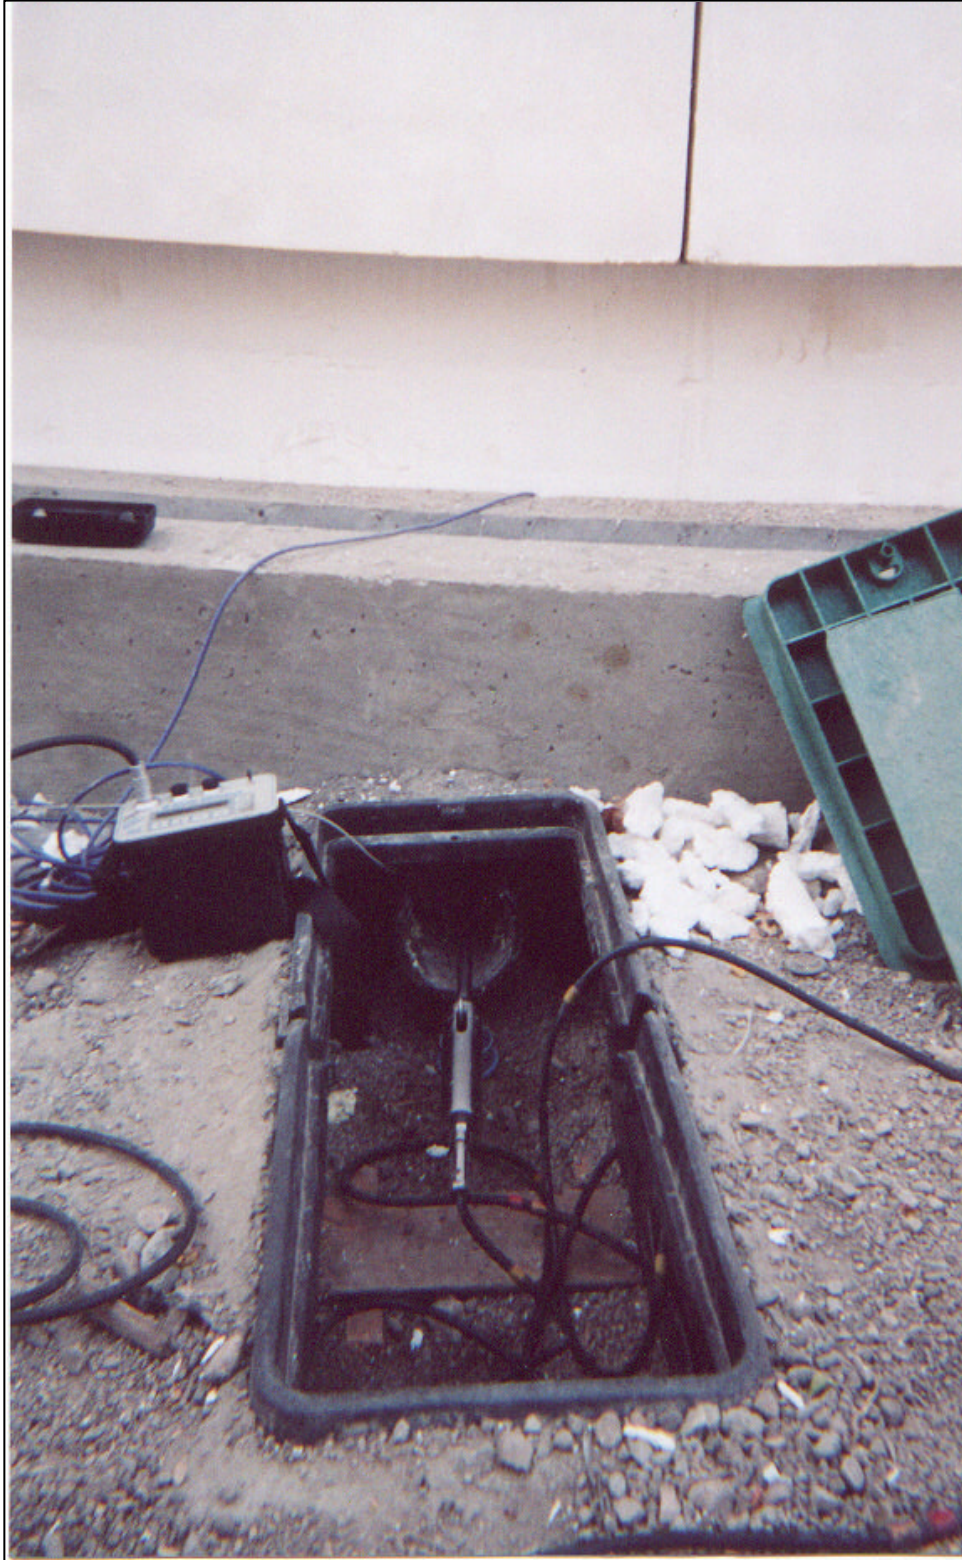
**Figure 6 – Access port for the north array basal inclinometer beneath the fascia wall grade beam (See Figure 3).**

The two basal inclinometers were set in the foundation soils prior to placement and leveling of the bedding sand and pouring of the grade beam for the fascia wall. The lengths of the 85 mm inside diameter inclinometer casings for the North and South Array are 4.3 m and 4.9 m, respectively. Both extensometers tie into the toe of the existing embankment and terminate in access boxes outside the wall (Figure 6). The top horizontal inclinometer of the South Array is 30 m long and straddles across the geof foam and scoria fill over the existing embankment. U-shaped plywood templates of 150 mm depth were used to trace a cradle trench with a hot wire cutter. The U-trench was lined with a geotextile fabric across geof foam blocks and a thin layer of bedding sand was placed for seating. The casing was then connected and installed in the foam U-trench, followed by backfill and leveling of hand compacted sand. The final geof foam course of half-height blocks was then placed over the U-trench. The horizontal inclinometer was extended in 3.05 m lengths into the scoria fill to monitor transitional settlements between the reconstructed and existing embankments. The horizontal inclinometer probe has an accuracy of  $\pm 0.24$  mm/m, and a resolution of  $\pm 0.04$  mm/m.

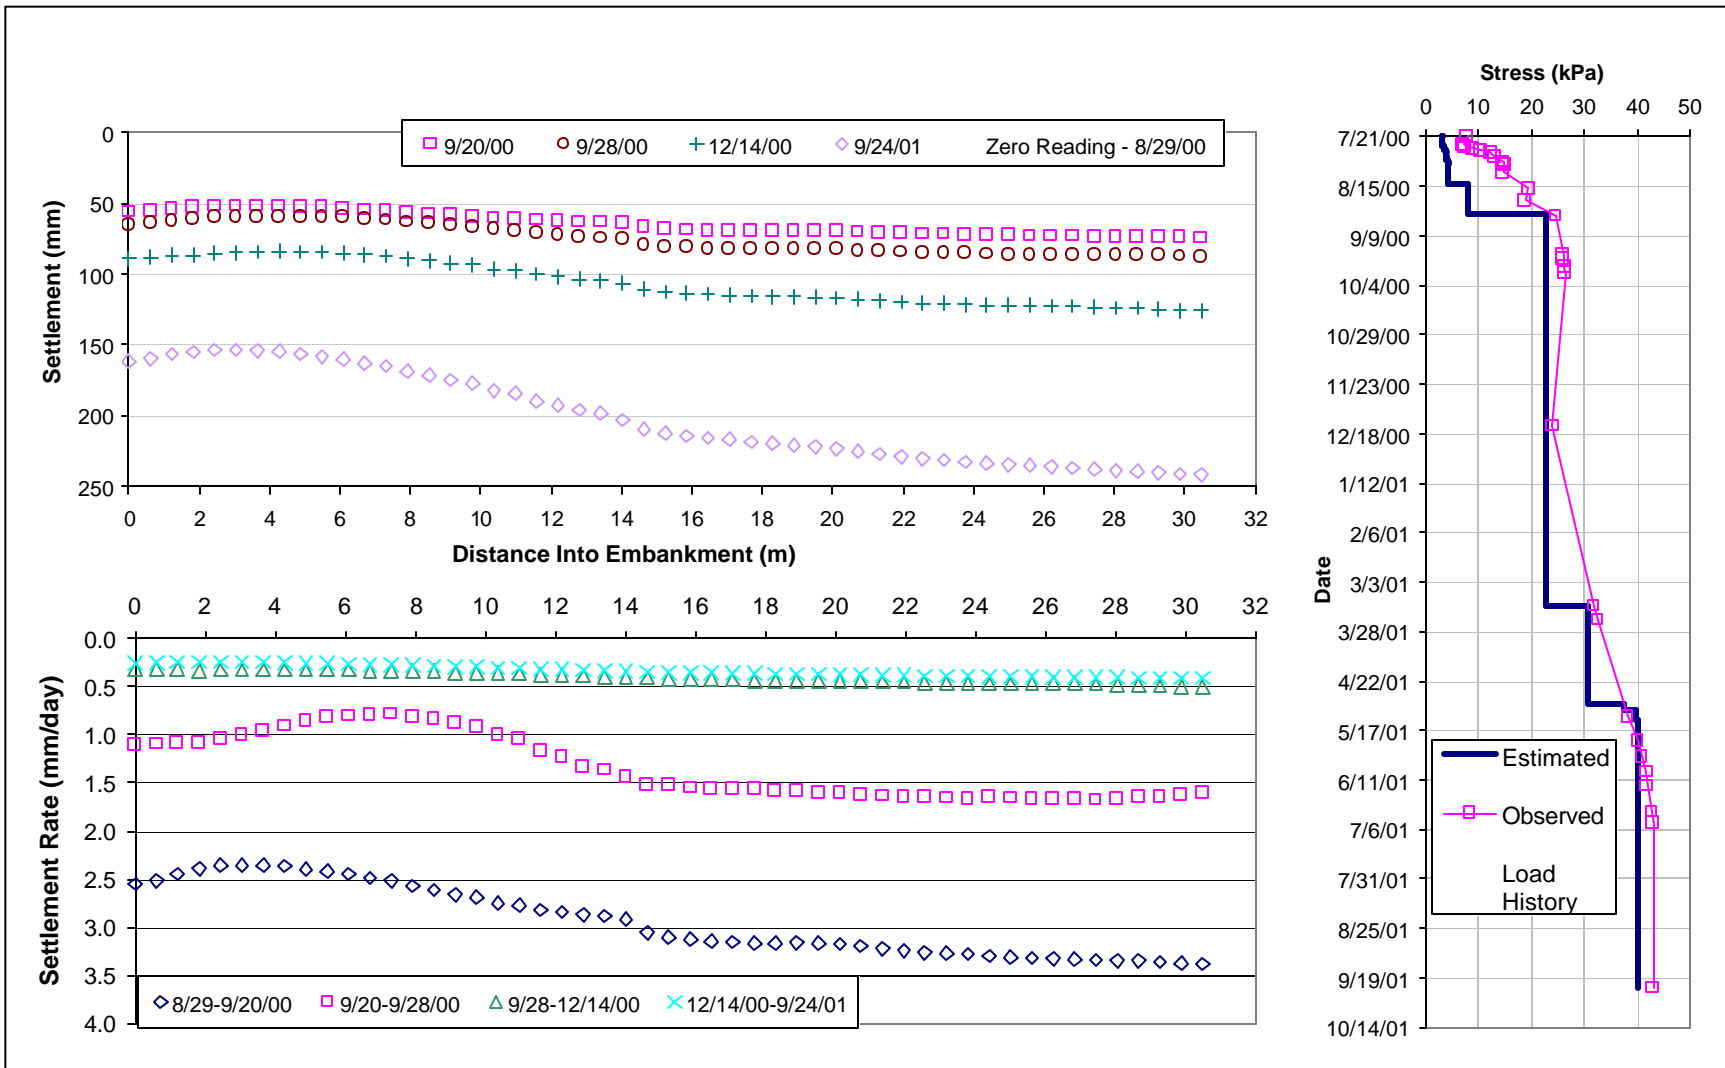
Figure 12 – Basal cross-section settlement at the north array, 100 South.

Figure 13 – Basal cross-section settlement at the south array, 100 South.

Figure 14 – Top cross-section settlement at the south array, 100 South.

The two basal and one top horizontal inclinometers at 100 South record the cross-sectional embankment settlement, as shown in Figures 12, 13, and 14. The basal inclinometer data show the settlement response of the foundation soils below the geofoam. More settlement occurred during construction beneath the grade beam supporting the wall than below the geofoam. With time, further settlement followed in parts of the foundation underlying the geofoam. The foundation settlement below the grade beam at both basal inclinometers is about 80 mm. Settlements beneath the back end of the inclinometers have reached 80 and 70 mm for the north and south array, respectively. Settlement rates were higher beneath the grade beam initially, but are now higher at the back. This suggests a higher rate of deformation beneath the old embankment and raised grade achieved with the scoria fill. The most recent readings indicate gradual differential settlement of up to 0.1 mm/day over the length of each inclinometer.

The subsurface reaction to the placement of the load slab on 14 August 2000 was more evident at the grade beam. The addition of the scoria, open graded base, PCC pavement, and detailing, led to more settlements, with sustained rates on the order of 0.2 – 0.3 mm/day. A subsequent reading on 18 September 2001 of the basal inclinometer at the south array, however, shows the post construction rate of settlement slowing to approximately 0.1 mm/day. Subsequent readings of the basal inclinometers should indicate slowing of settlements. Overall, the basal inclinometers show a total of about 80 mm of foundation soil settlement under the geofoam by the end of construction.

The data for the top inclinometer at the south array shows the performance of the geofoam and scoria fill. The fascia wall and full geofoam section have experienced a total settlement of about 150 mm. In the transition zone, total settlements vary between 150 and 200 mm. Almost 250 mm settlement has taken place beneath the roadway centerline and scoria fill segment. At present, the rate of settlement is about 0.3 mm/day at the wall face and approximately 0.4 mm/day at the road centerline in the scoria fill section. The settlement across the inclinometer profile is relatively uniform. Both incremental and differential settlements have been decreasing. The difference in total settlement between the basal and top inclinometers of about 80 mm match the total settlements shown in the magnet extensometer data.

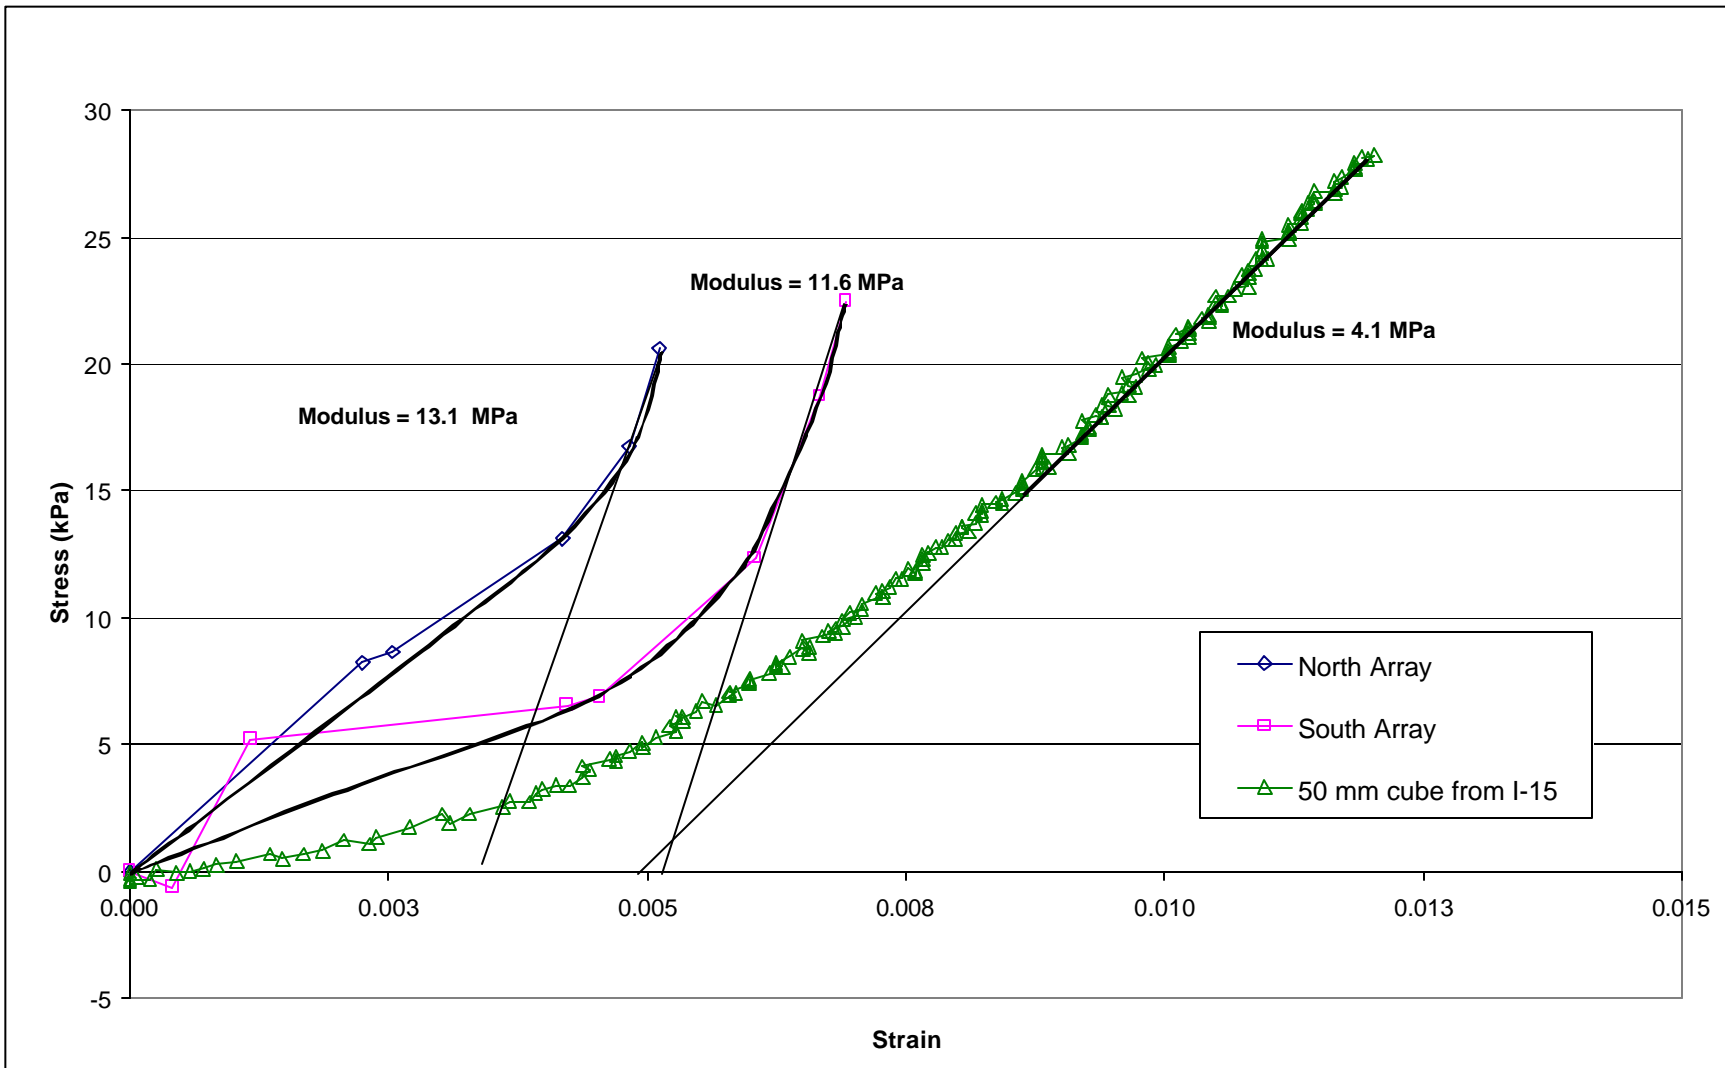
Figure 15 – Average stress-strain curves derived from stress cells and extensometer increments.

Figure 15 presents average stress-strain curves derived from stress cell and extensometer deformation increments, neglecting stress due to the self-weight of the geofoam fill and the initial zero shift of the stress cells. The initial segments of the curves manifest a similar deformation to seating error in small test sample data as represented by the uncorrected stress-strain curve for a standard compression test on a 50 mm cube sample. The global stress-strain curves of the geofoam are for layer 1.5 to layer 9.5 and 9 for the north and south arrays, respectively. The trends of the three curves are similar. As the loading is increased, seating and gap closure occurred. The modulus gradually increased. Corrected modulus (ASTM D-1621) values for Type VIII geofoam, used for the I-15 project, determined from 50 mm samples were on the order of 2.9 to 5.1 MPa. The provisional GRC geofoam specifications provide a modulus to 1% strain of 4.3 MPa for the Type VIII geofoam. BASF Corp. (1998) indicates the modulus of EPS 20 falls in the range of 3.4 to 7.0 MPa. The trend of field moduli beyond the installation of the load distribution slab are of the order of 10 MPa and higher than values from standard small sample lab tests. Deformations of the geofoam fill due to seating and gap closure take place during construction and before final paving. The response of the pavement under service loads and the performance of the geofoam fill would be assessed to be inferior if the evaluation is based on small sample laboratory tests. This conclusion is
