# Geofoam as a Subbase Material

Issue: Premature pavement distress/failure has occurred atop geofoam. What is the cause of this poor performance?

Steven F. Bartlett, Ph.D., P.E. Univ. of Utah

# TH 47 in Isanti County, Minnesota

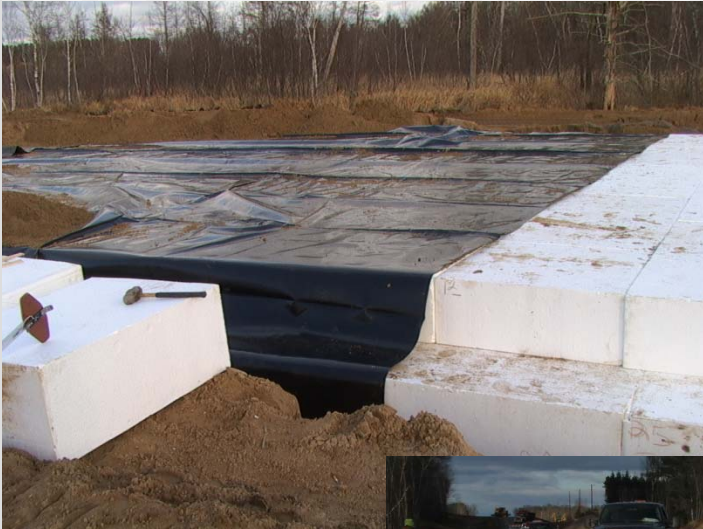
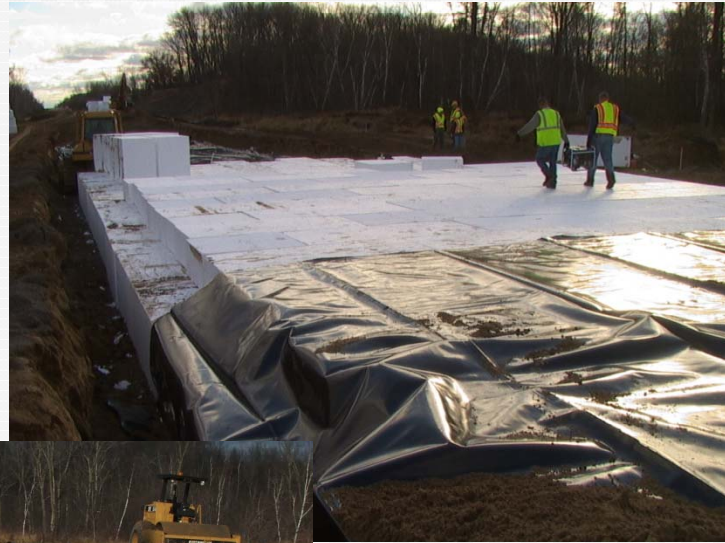
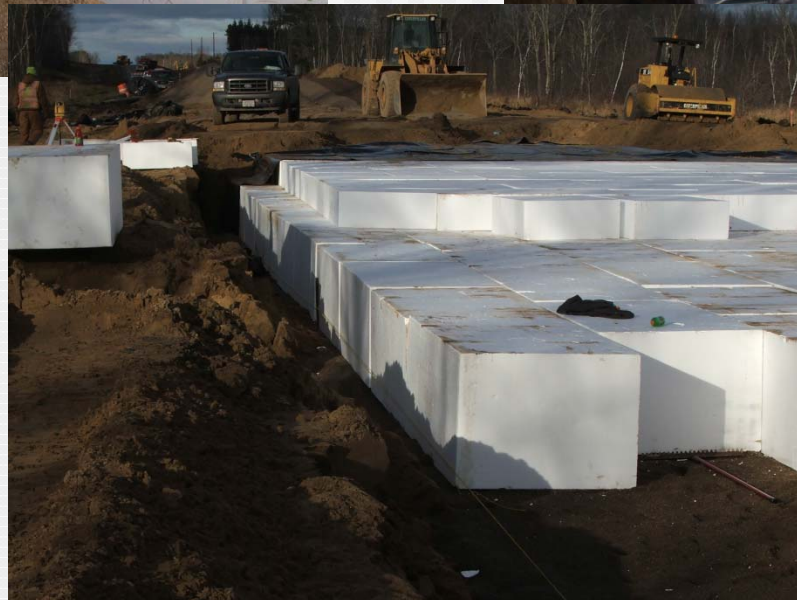
# TH 47 in Isanti County, Minnesota

- geof foam fill placed in Nov. 2005
- roadway completed in Dec. 2005
- small cracks in Spring 2006
- severe rutting Spring 2007

- Geofabric out of specification
- Geofabric damage during construction (placement of overlying materials and compaction)
- Pavement section under-designed
  - no load distribution slab
  - flexible pavement with insufficient structural support
