I-15 Reconstruction Project: Innovative Foundation and Embankment Construction

Steven F. Bartlett, Ph.D., P.E.
Assistant Professor
University of Utah

I-15 Reconstruction – Project Extents

I-15 Reconstruction - Quick Facts

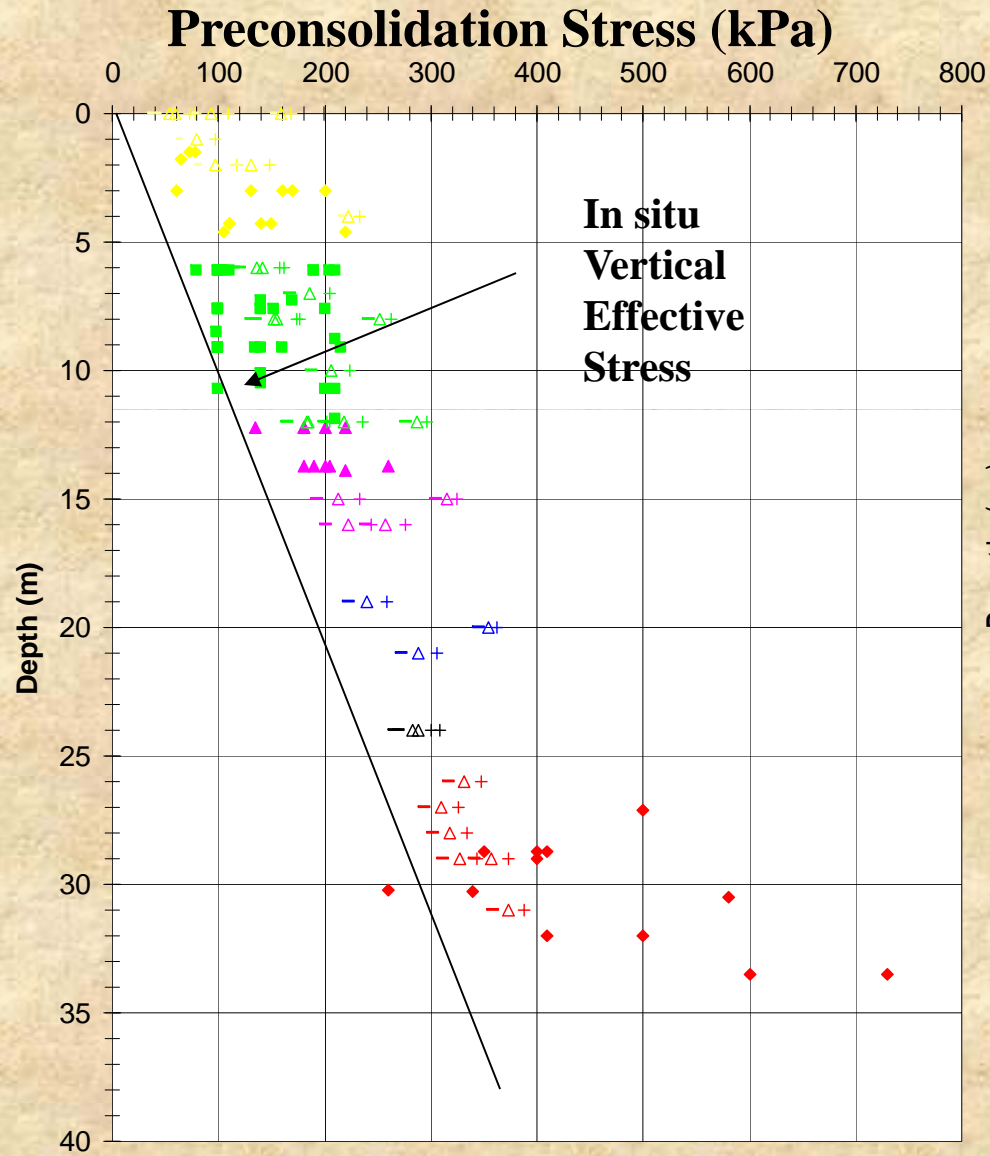
Consolidation Properties

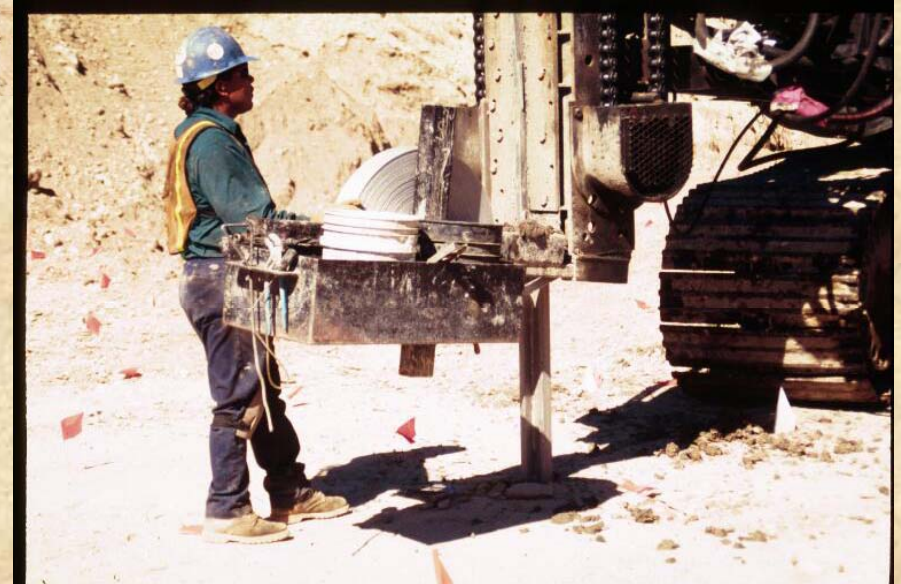
PV drain pushed into ground

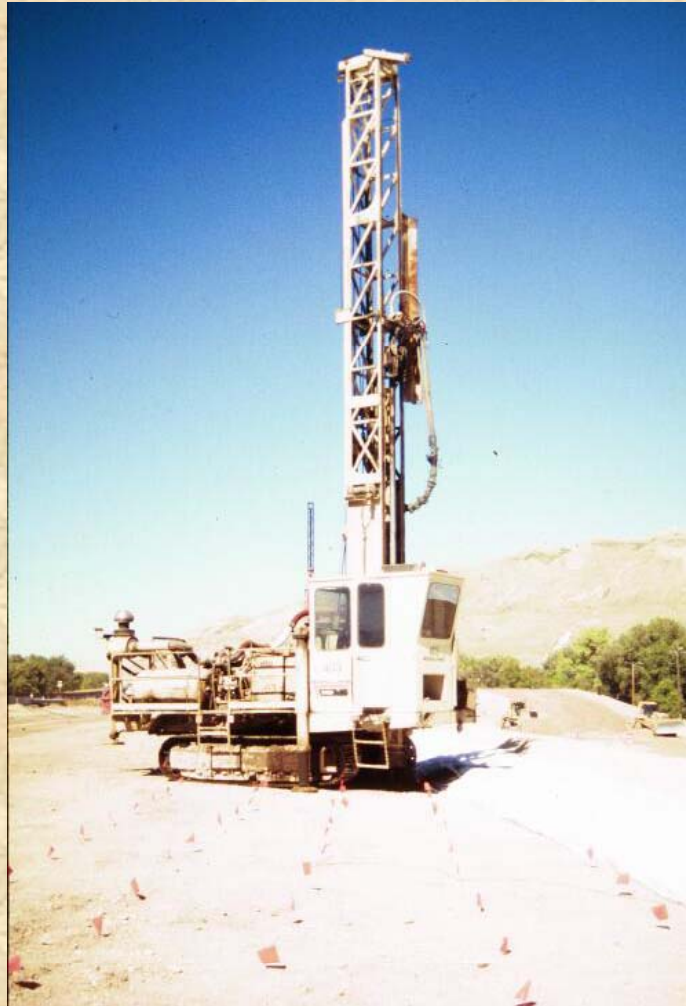
Pre-drilling of PV Drains Required through Existing Embankment

Approximate 3 drill rigs req'd for one PV drain rig

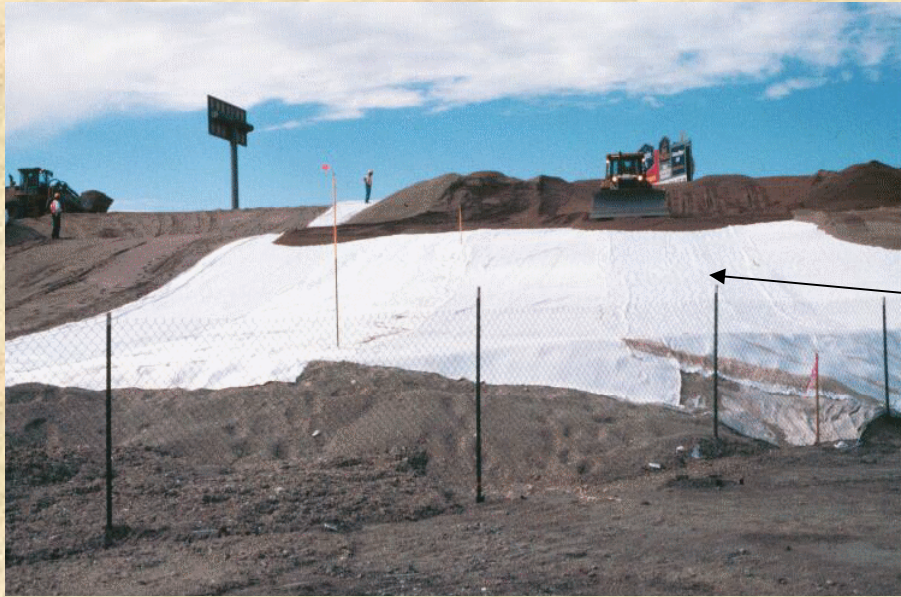
Geotextile placement on sloped, pre-existing embankment

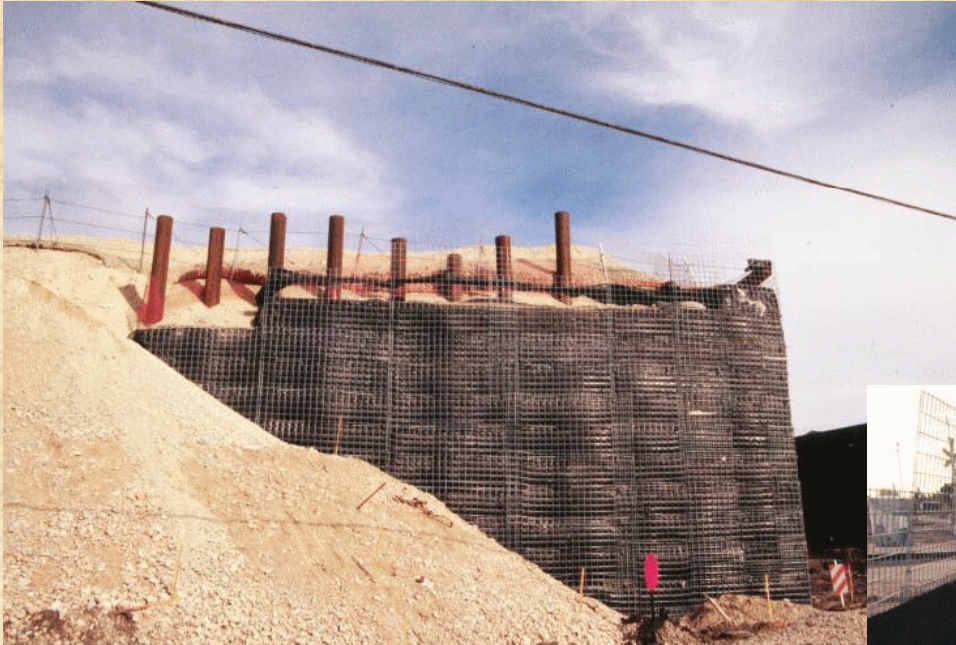
Right-of-way constraints required many slopes to be built vertically.

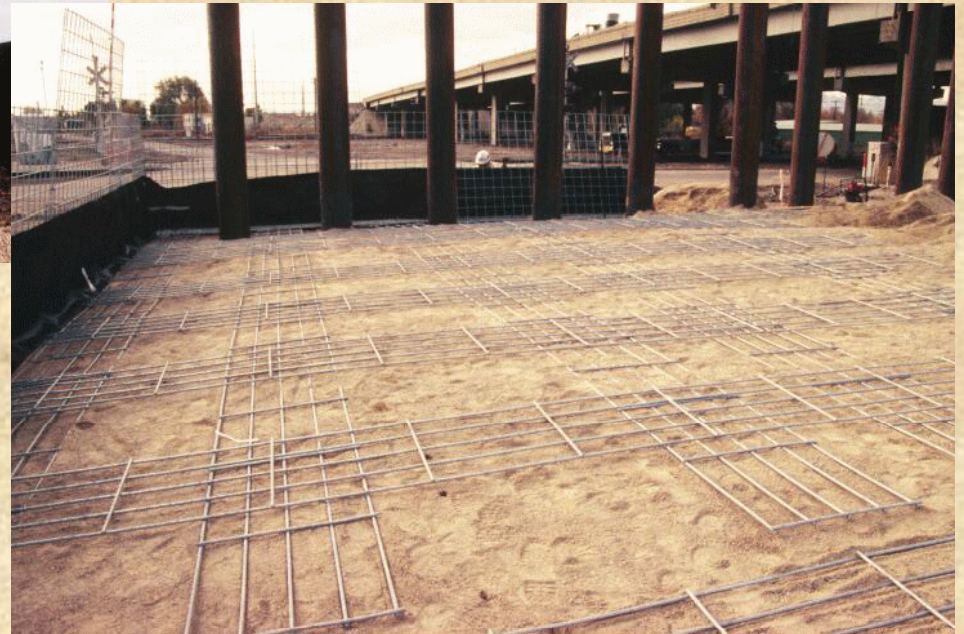
Beginning of 2-stage MSE Wall

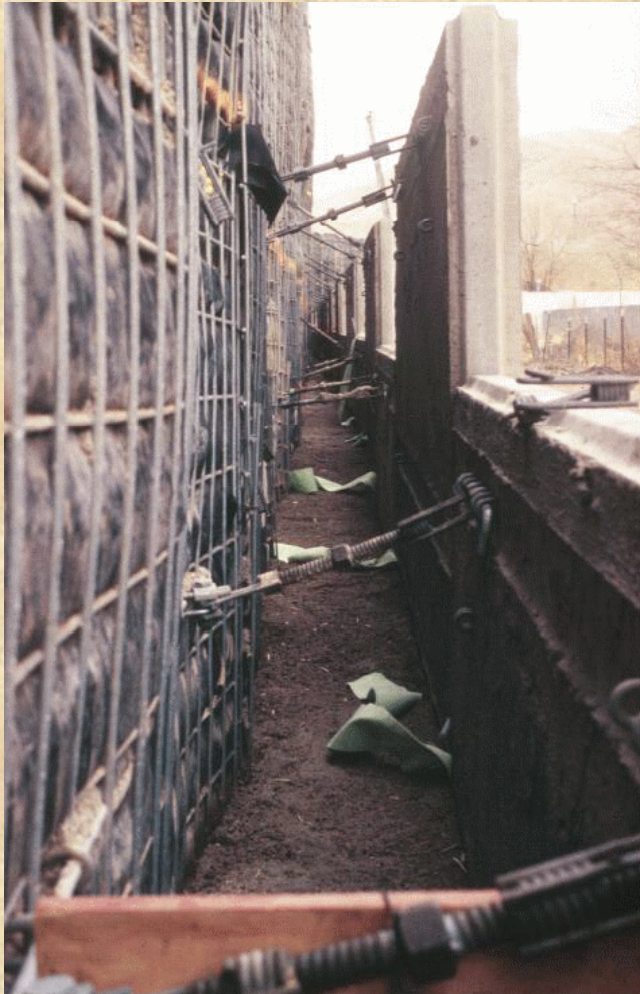
Attachment of Panels with threaded rod

Female threaded rod coupler

**Concrete
Fascia Panel**

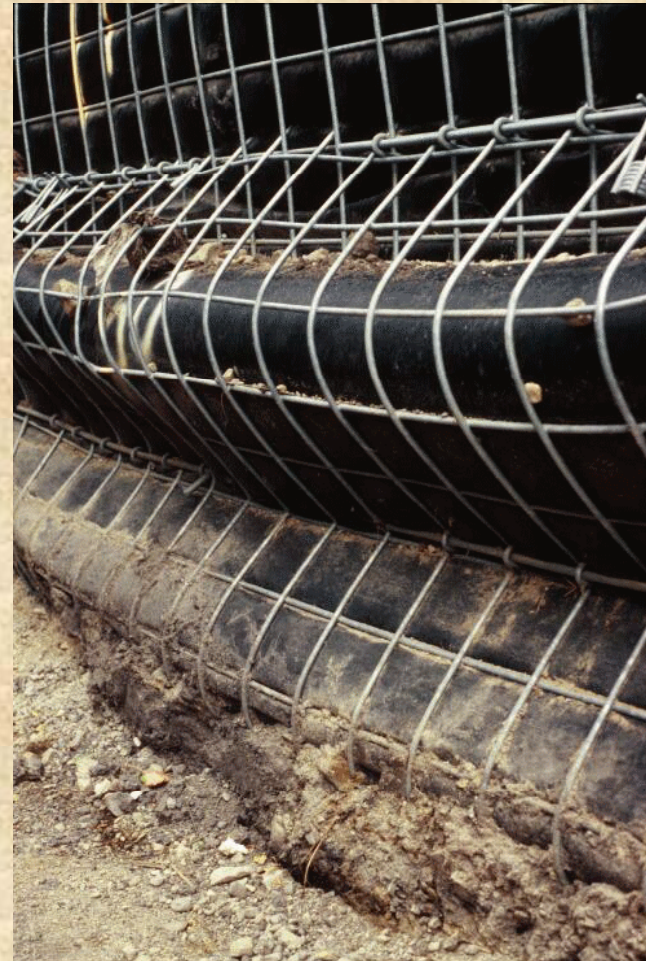
Deformation of Welded Wire Face at Toe of Wall

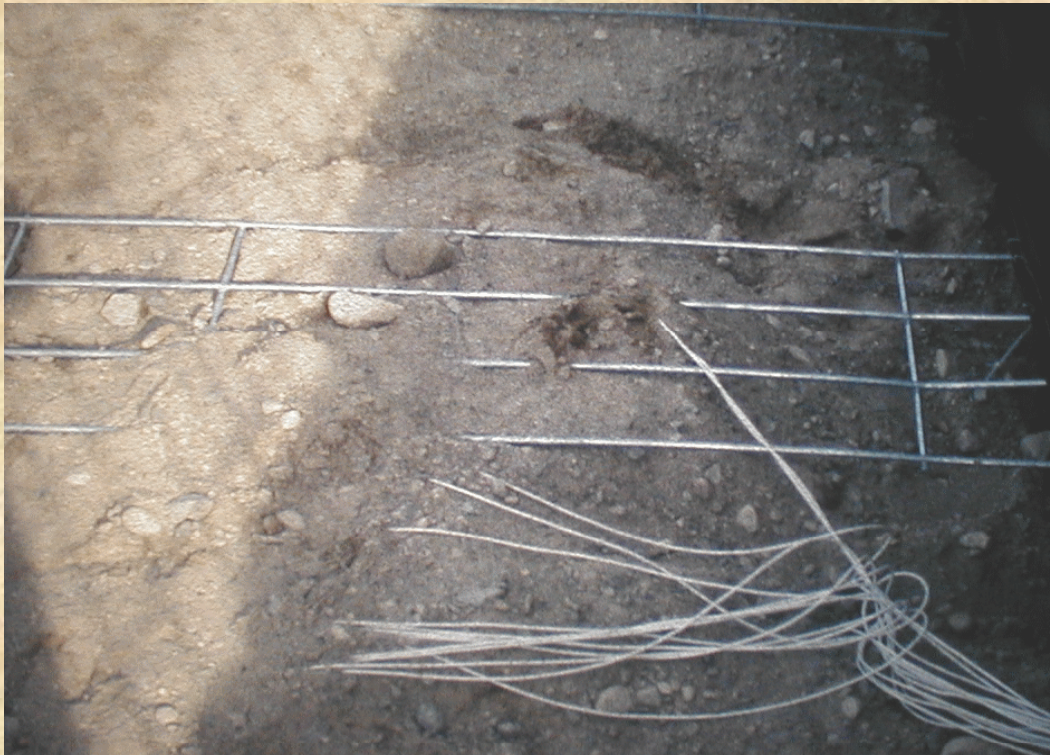
Horizontal reinforcing (bar mat) with strain gages.

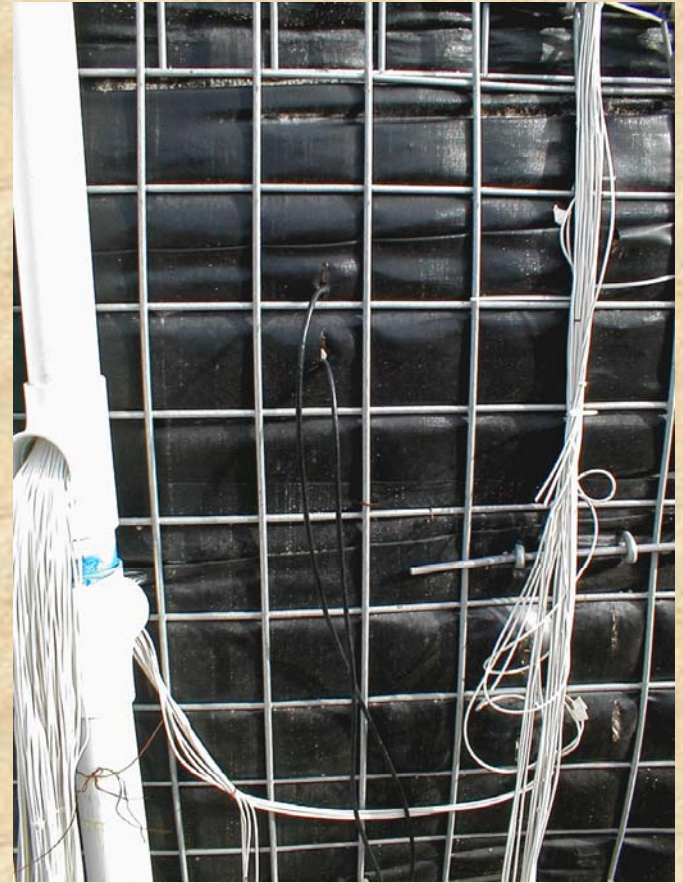
Strain gage wiring at face of MSE wall

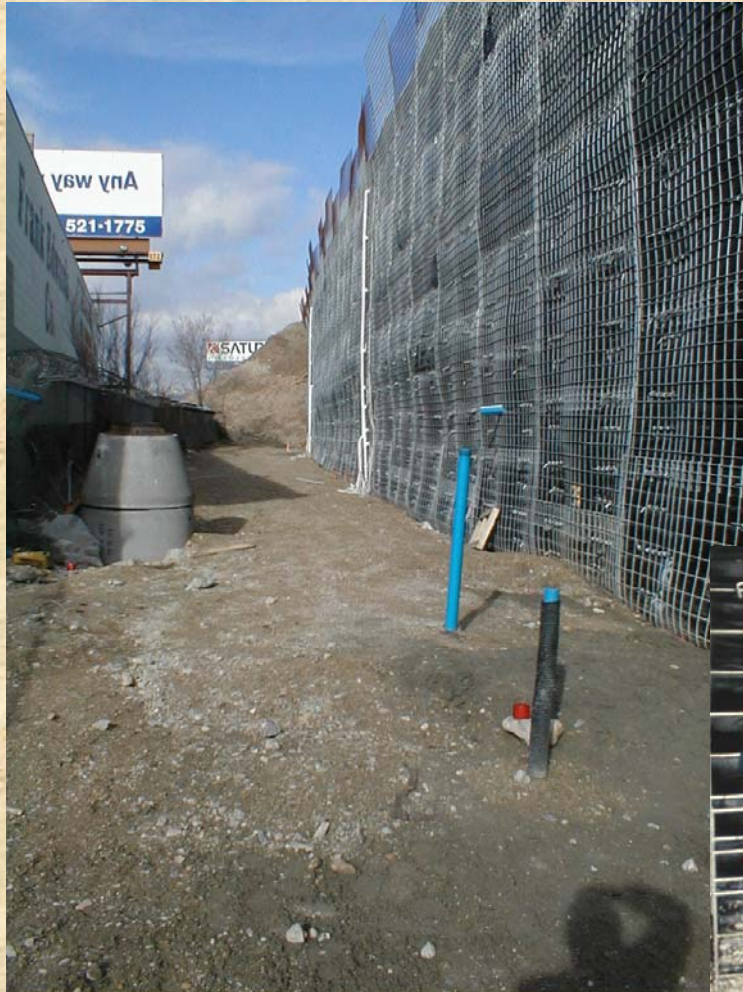
**Inclinometer and Sondex
Locations**

**Reading of Sondex
Extensometer**

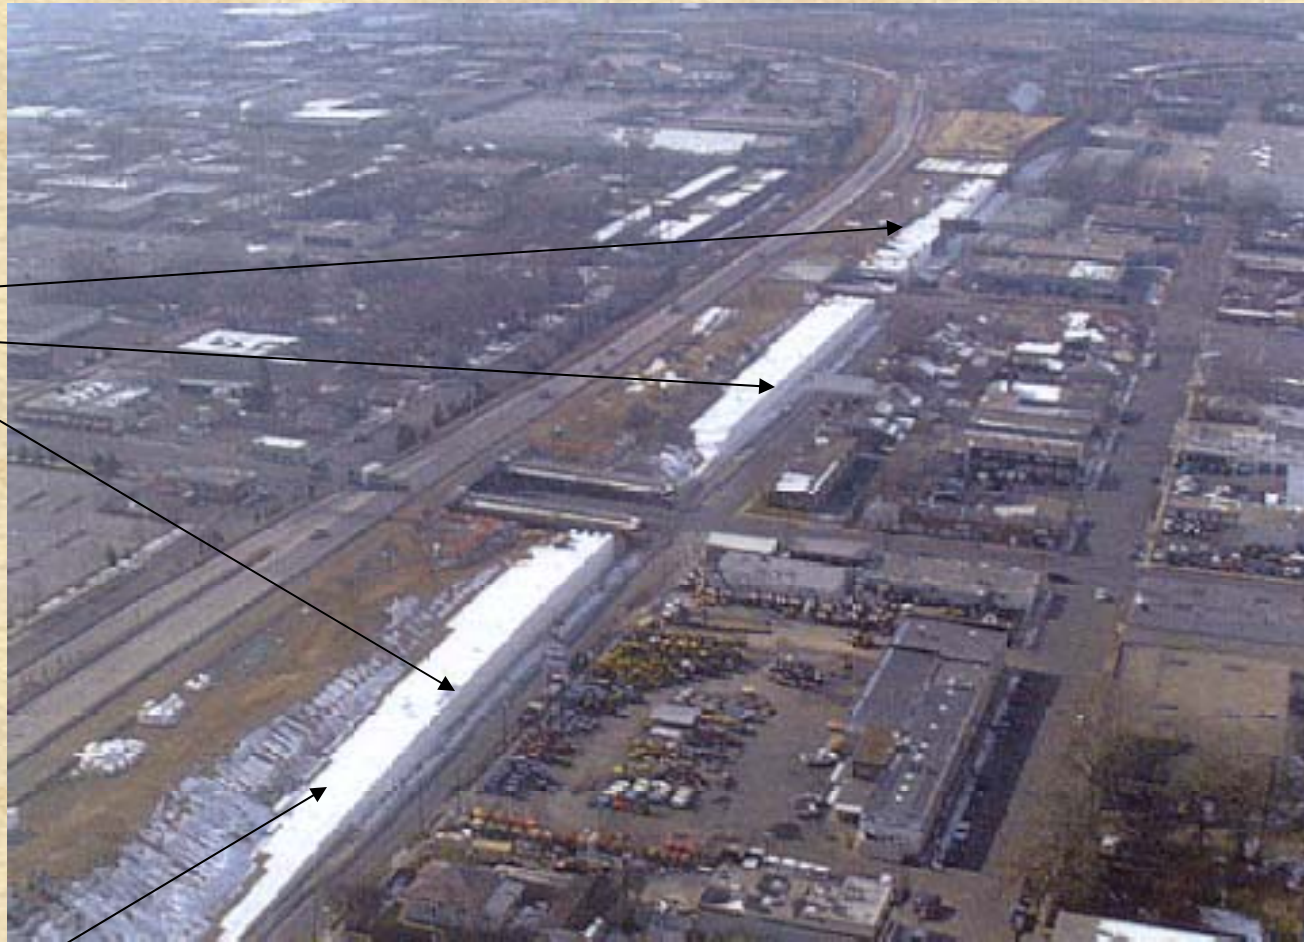
**Buried
Utilities**

**Geofoam Embankment from State St. to 200 W. Along
Interstate I-80, Salt Lake City, Utah**

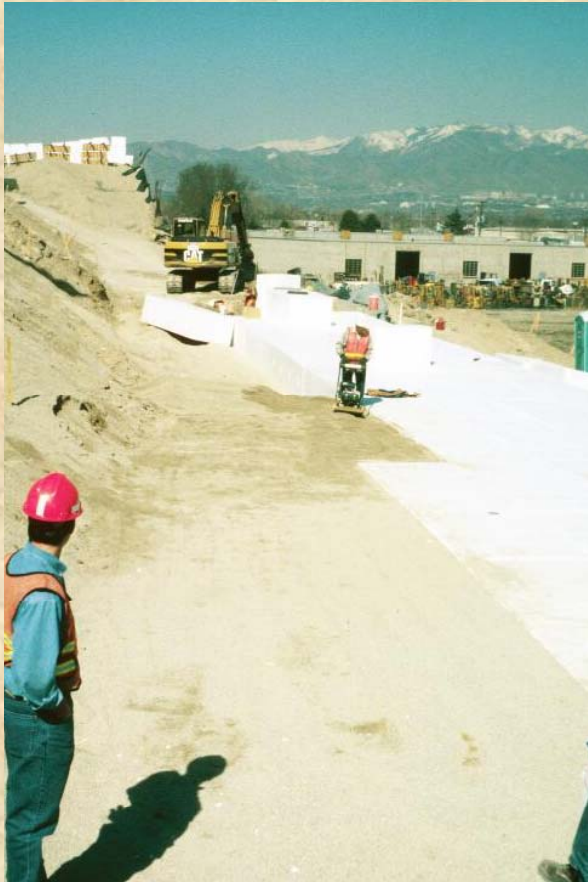
**Leveling Course of Sand
for Geofoam Embankment**

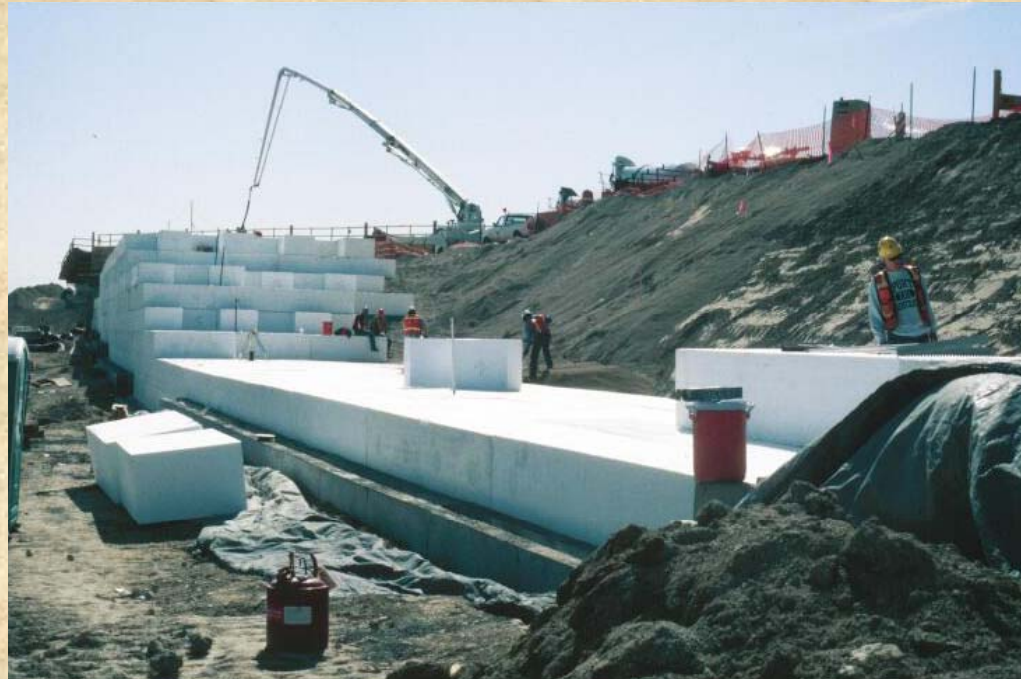
**Construction of Geofoam Embankment
and Footing for Tilt-up Panel Wall**

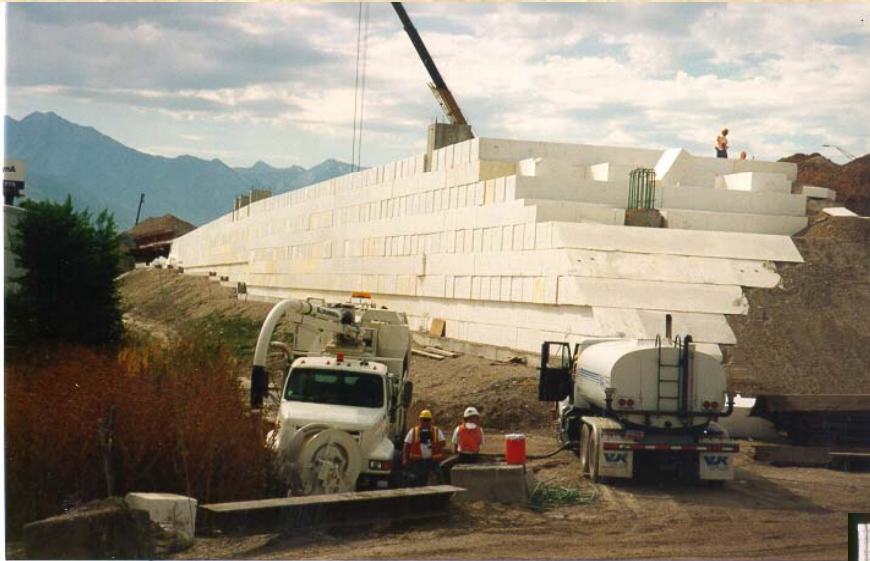
Nearly Completed Geofoam Embankment with Vertical Face

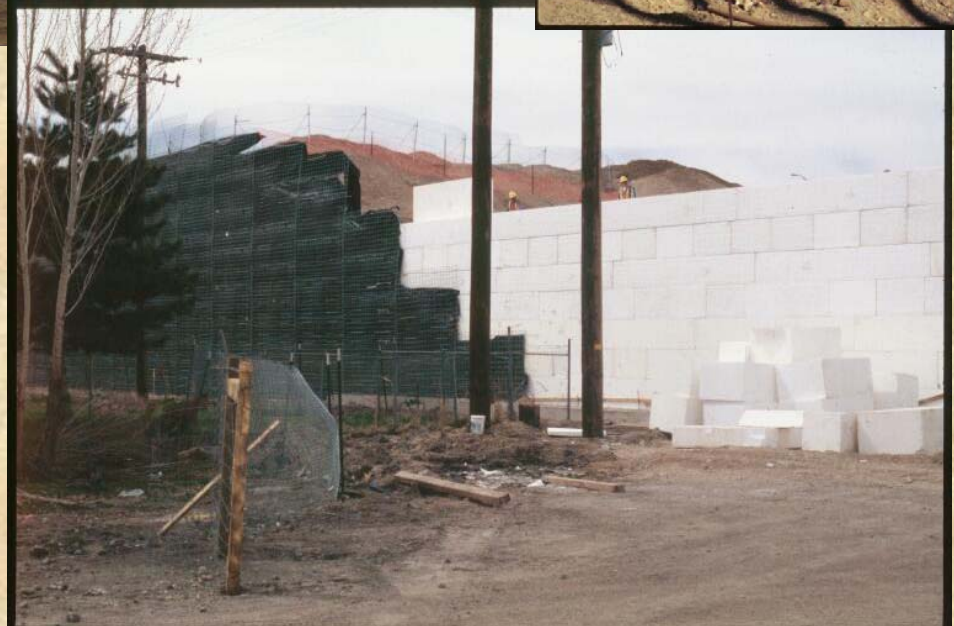
Transition Zone with MSE Wall

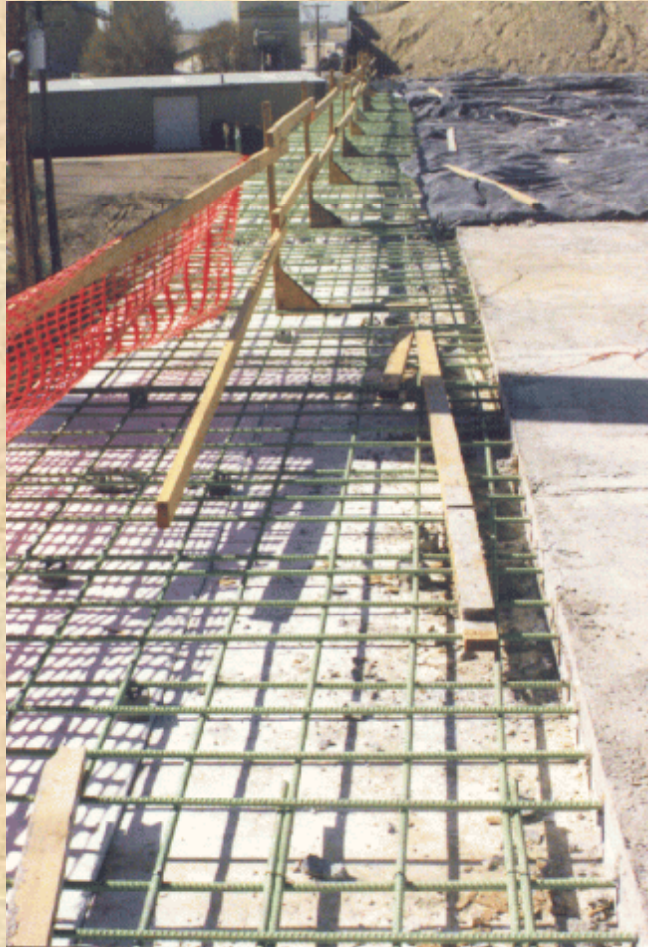
**Reinforced Concrete
Load Distribution Slab
atop Geofoam**

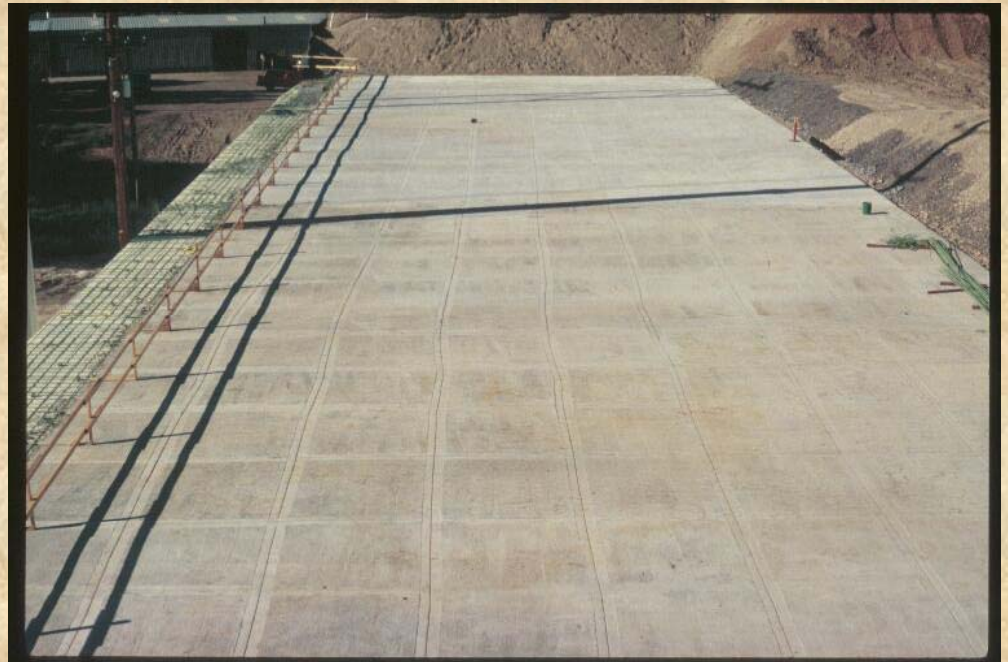
Completed Load Distribution Slab

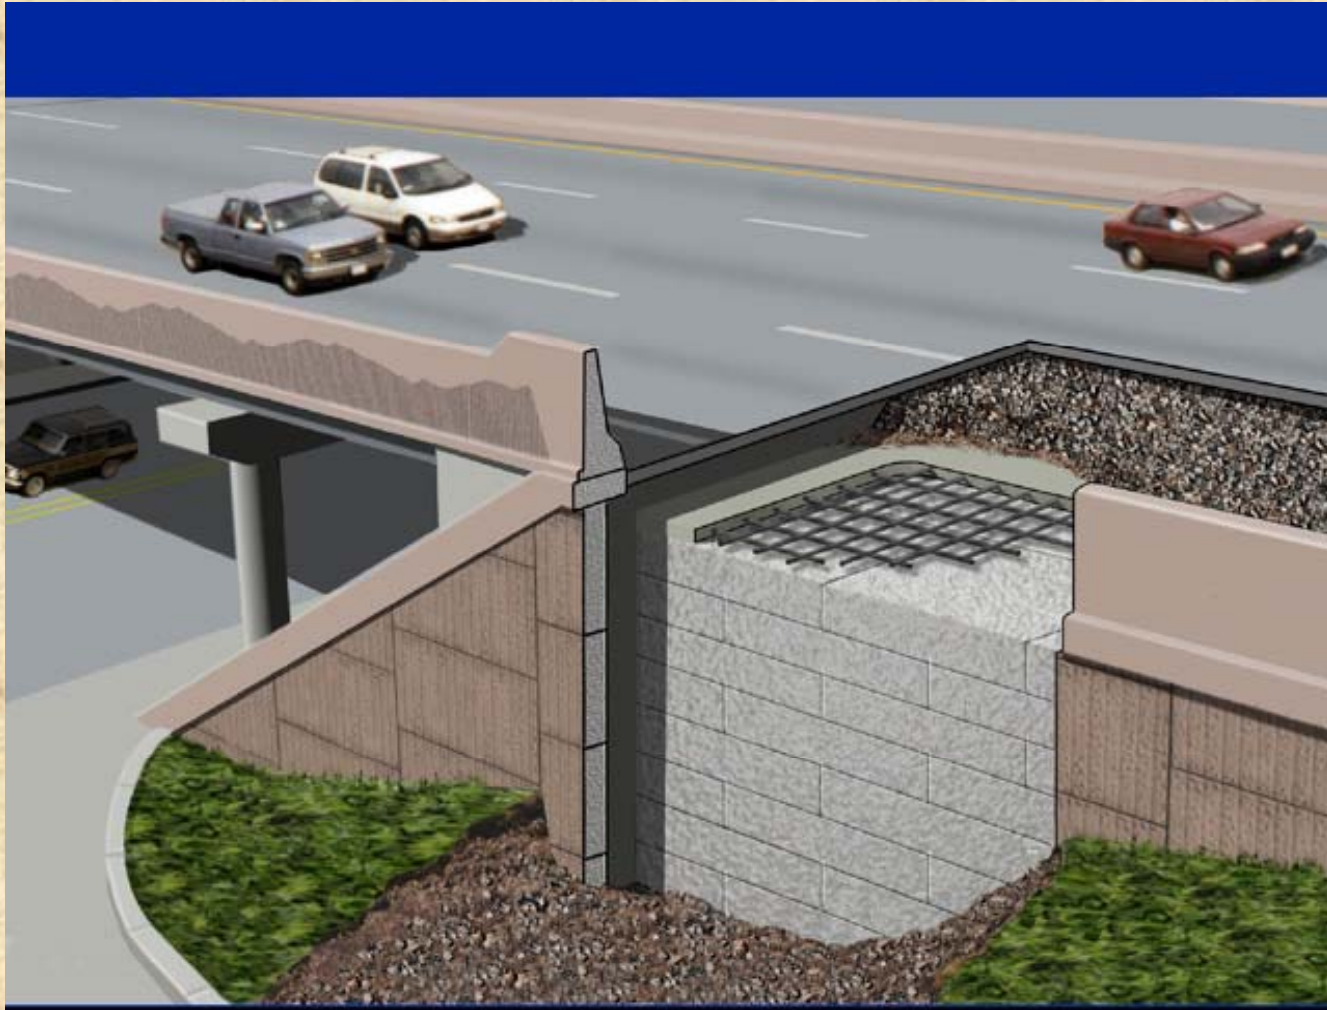
Geofoam (Finished Cross Section)

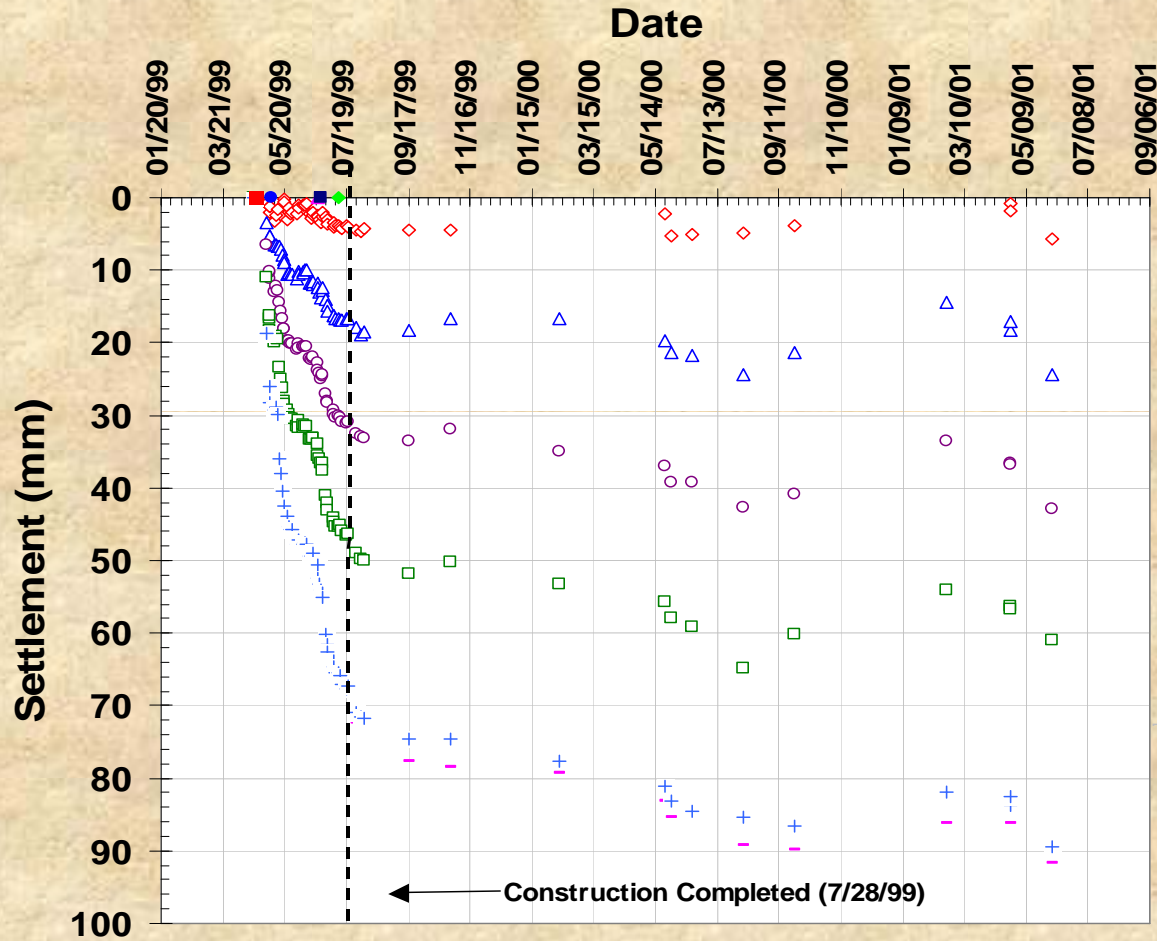
3300 South Magnet Extensometer Data

1% Construction Strain

- ◇ Level 0
- △ Level 2
- Level 4
- Level 6
- Level 8
- + Level 9
- Load Distribution Slab placed
- Load Distribution Slab Curb placed
- ▲ Granular Borrow
- Green Grouted Base

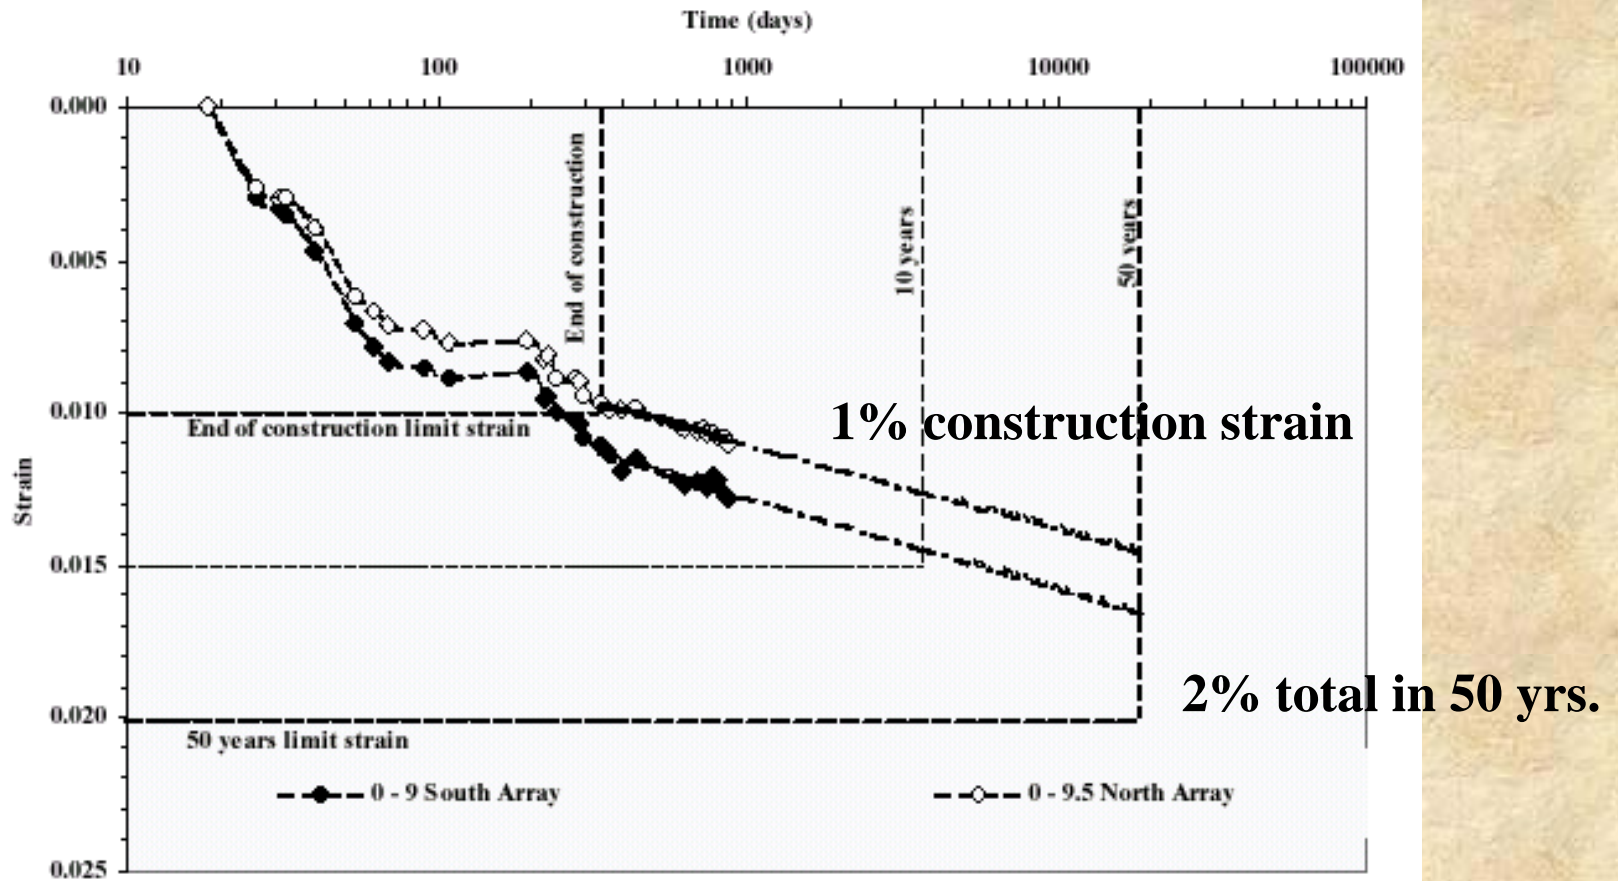
100 South Magnet Extensometer Data Post-Construction Settlement

Figure 37 – Projected settlement trend for I-15 geofoam at 100 South.

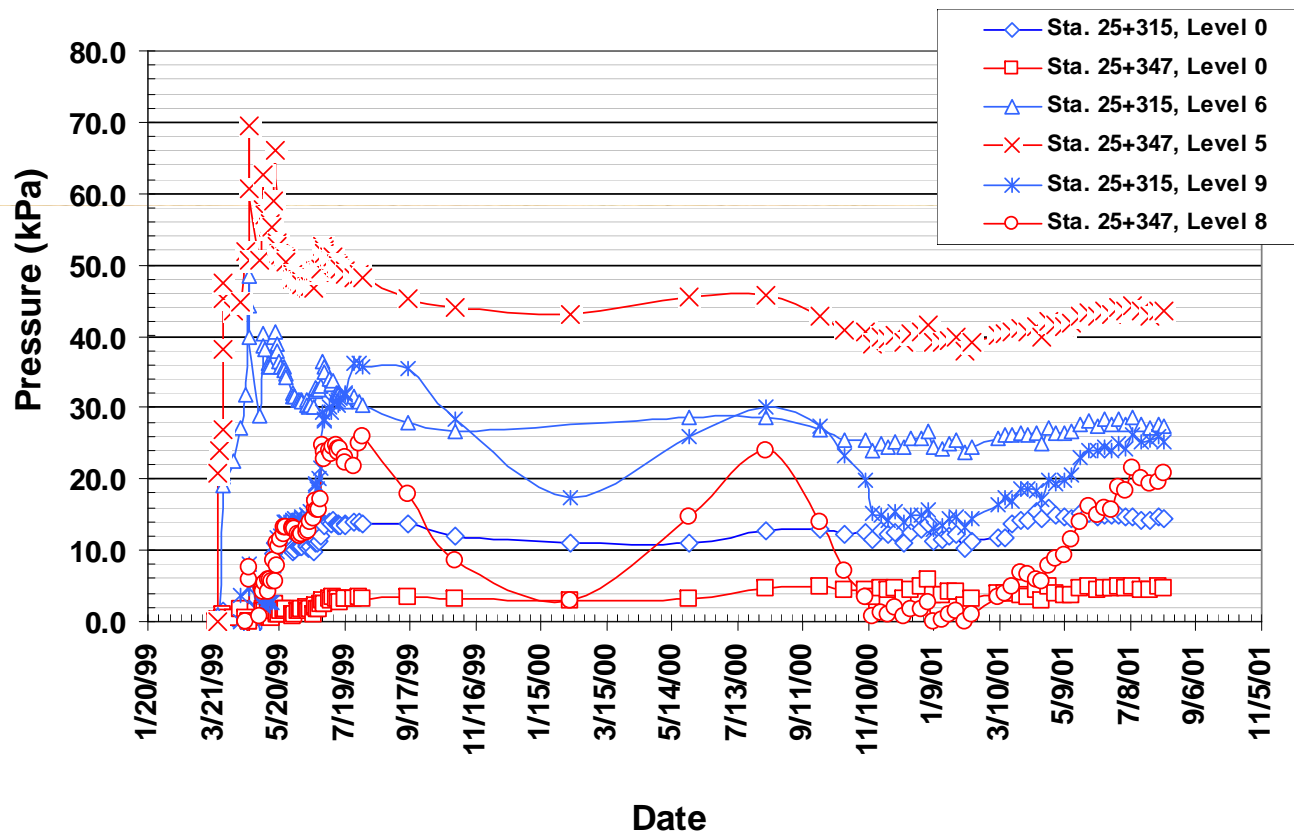
Pressure Versus Time
3300 South Street Geofoam Array

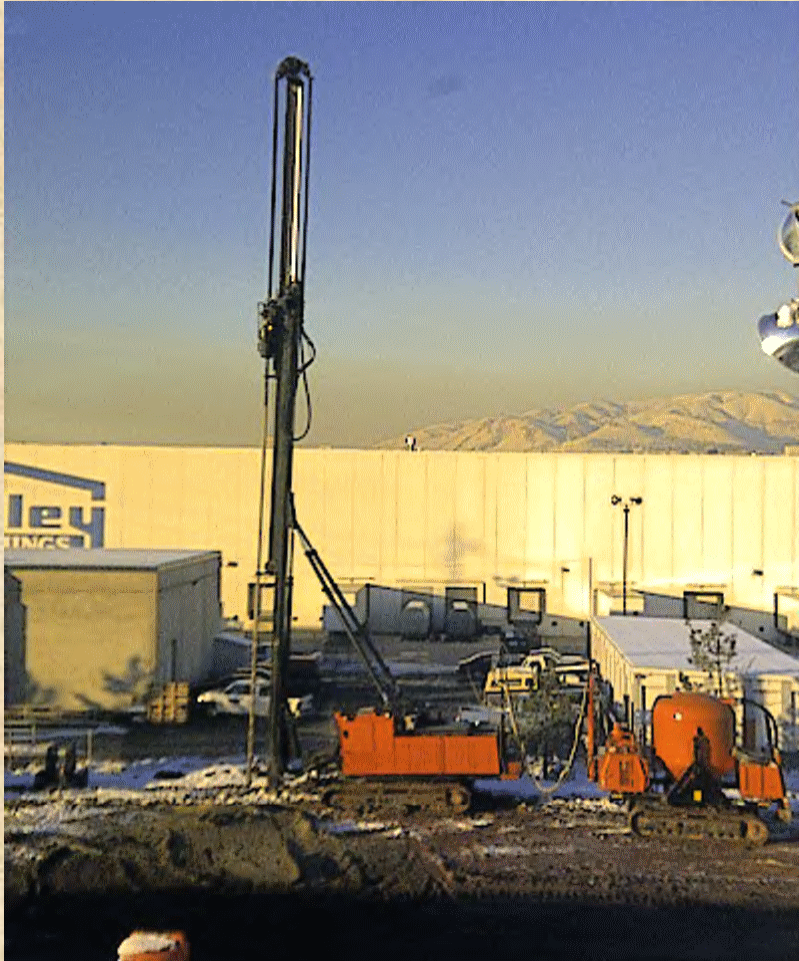
Lime Cement Column Rig

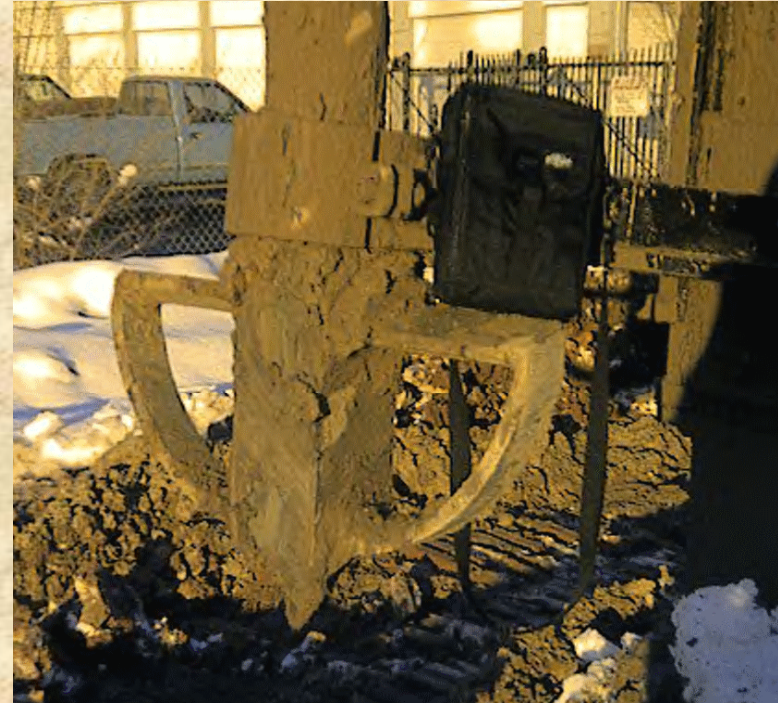
**Auger / Mixer for Lime
and Cement**

125 kg/m³ 15% lime 85% cement

M = 30 Mpa (design); Su 300 to 400 kPa

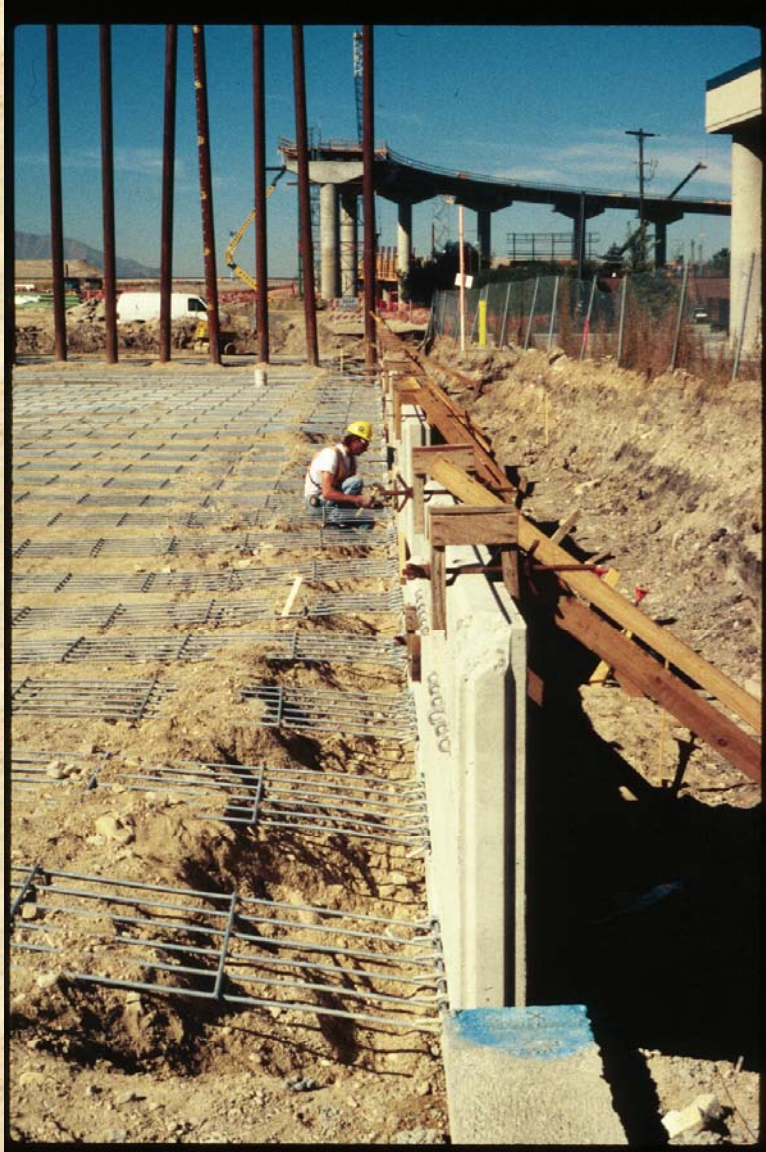
1-stage MSE placed over columns

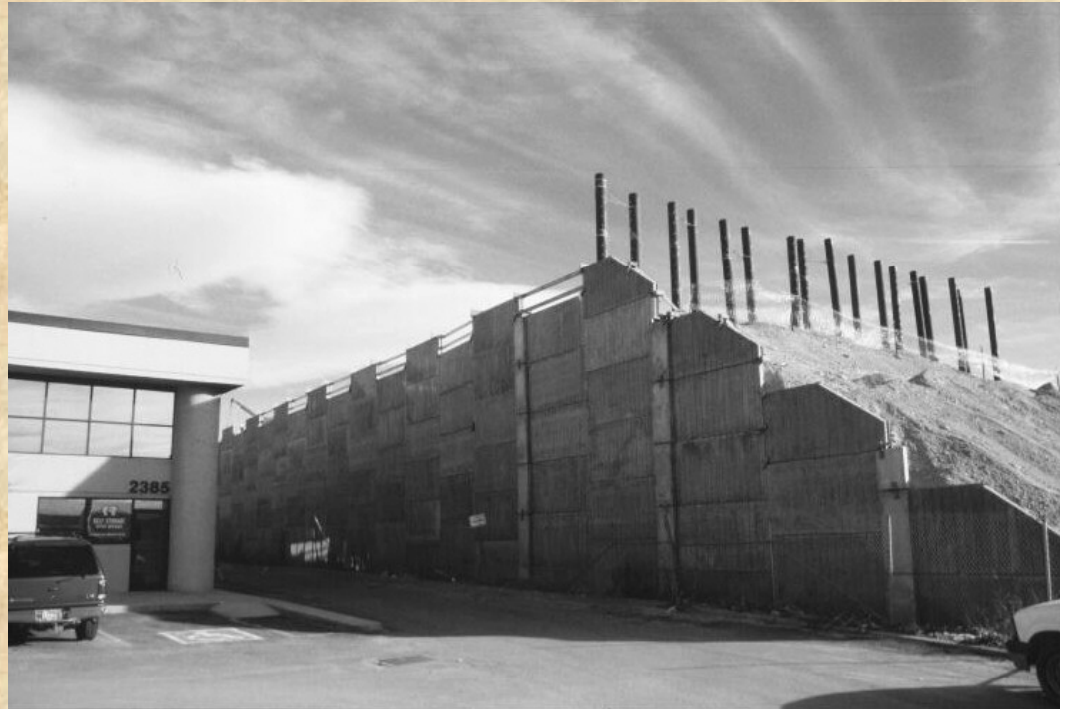
Finished MSE wall

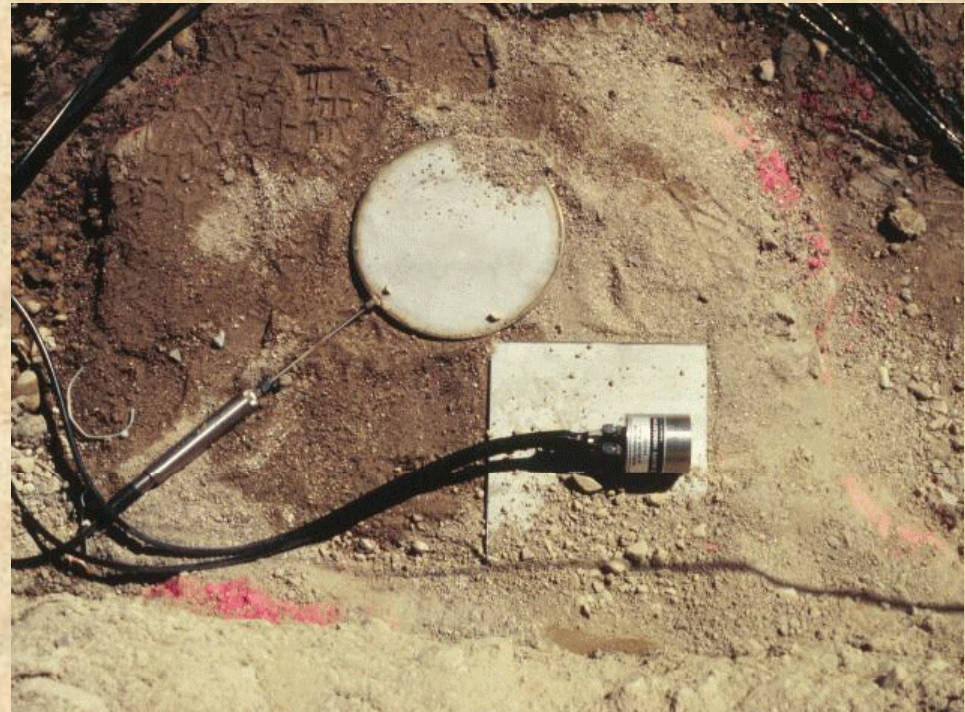
**Pressure and Settlement Cells
Atop Column**

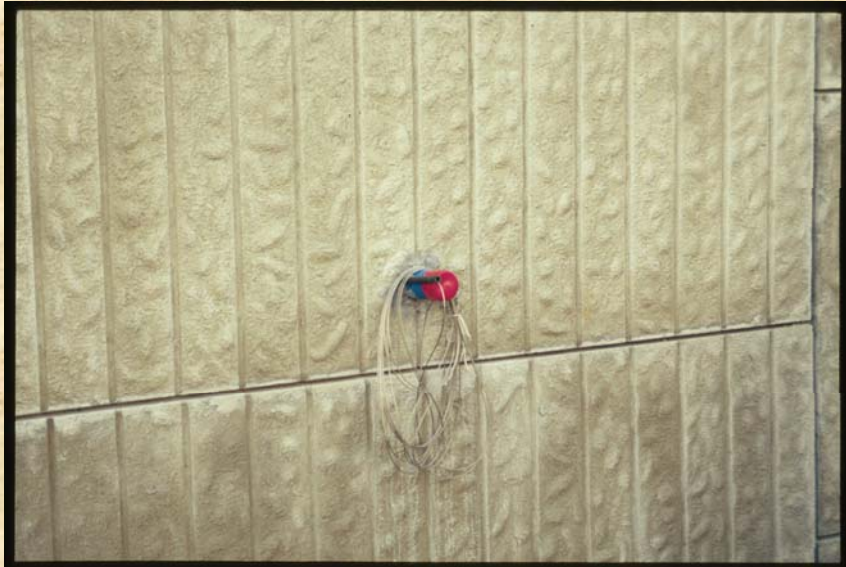
Horizontal Inclinerometer Systems, with and without dead-end pulley assembly

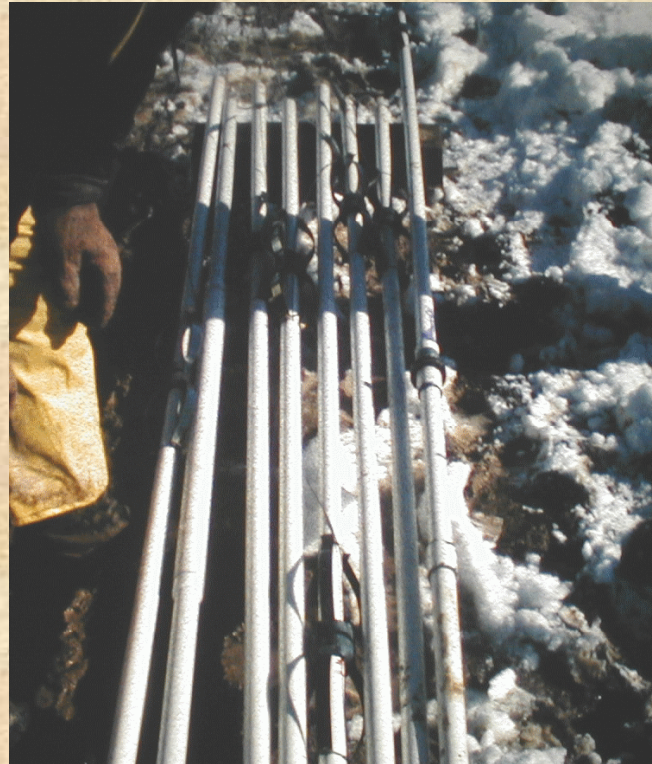
Borehole Magnetic Extensometer
