# INGENIOUS INFILL

*Before a deteriorating bridge from the 1930s could be removed in downtown St. Louis, project designers had to devise a way to fill in the 30 ft deep excavation beneath the ground-level structure without imposing lateral loads on adjacent buildings. The novel solution involved using blocks of lightweight expanded polystyrene near the buildings and traditional soil fill within the rest of the excavation.*

By Justin Anderson, P.E., M.ASCE, Patrick Poepsel, P.E., M.ASCE, and Kevin Kriete, P.E., M.ASCE

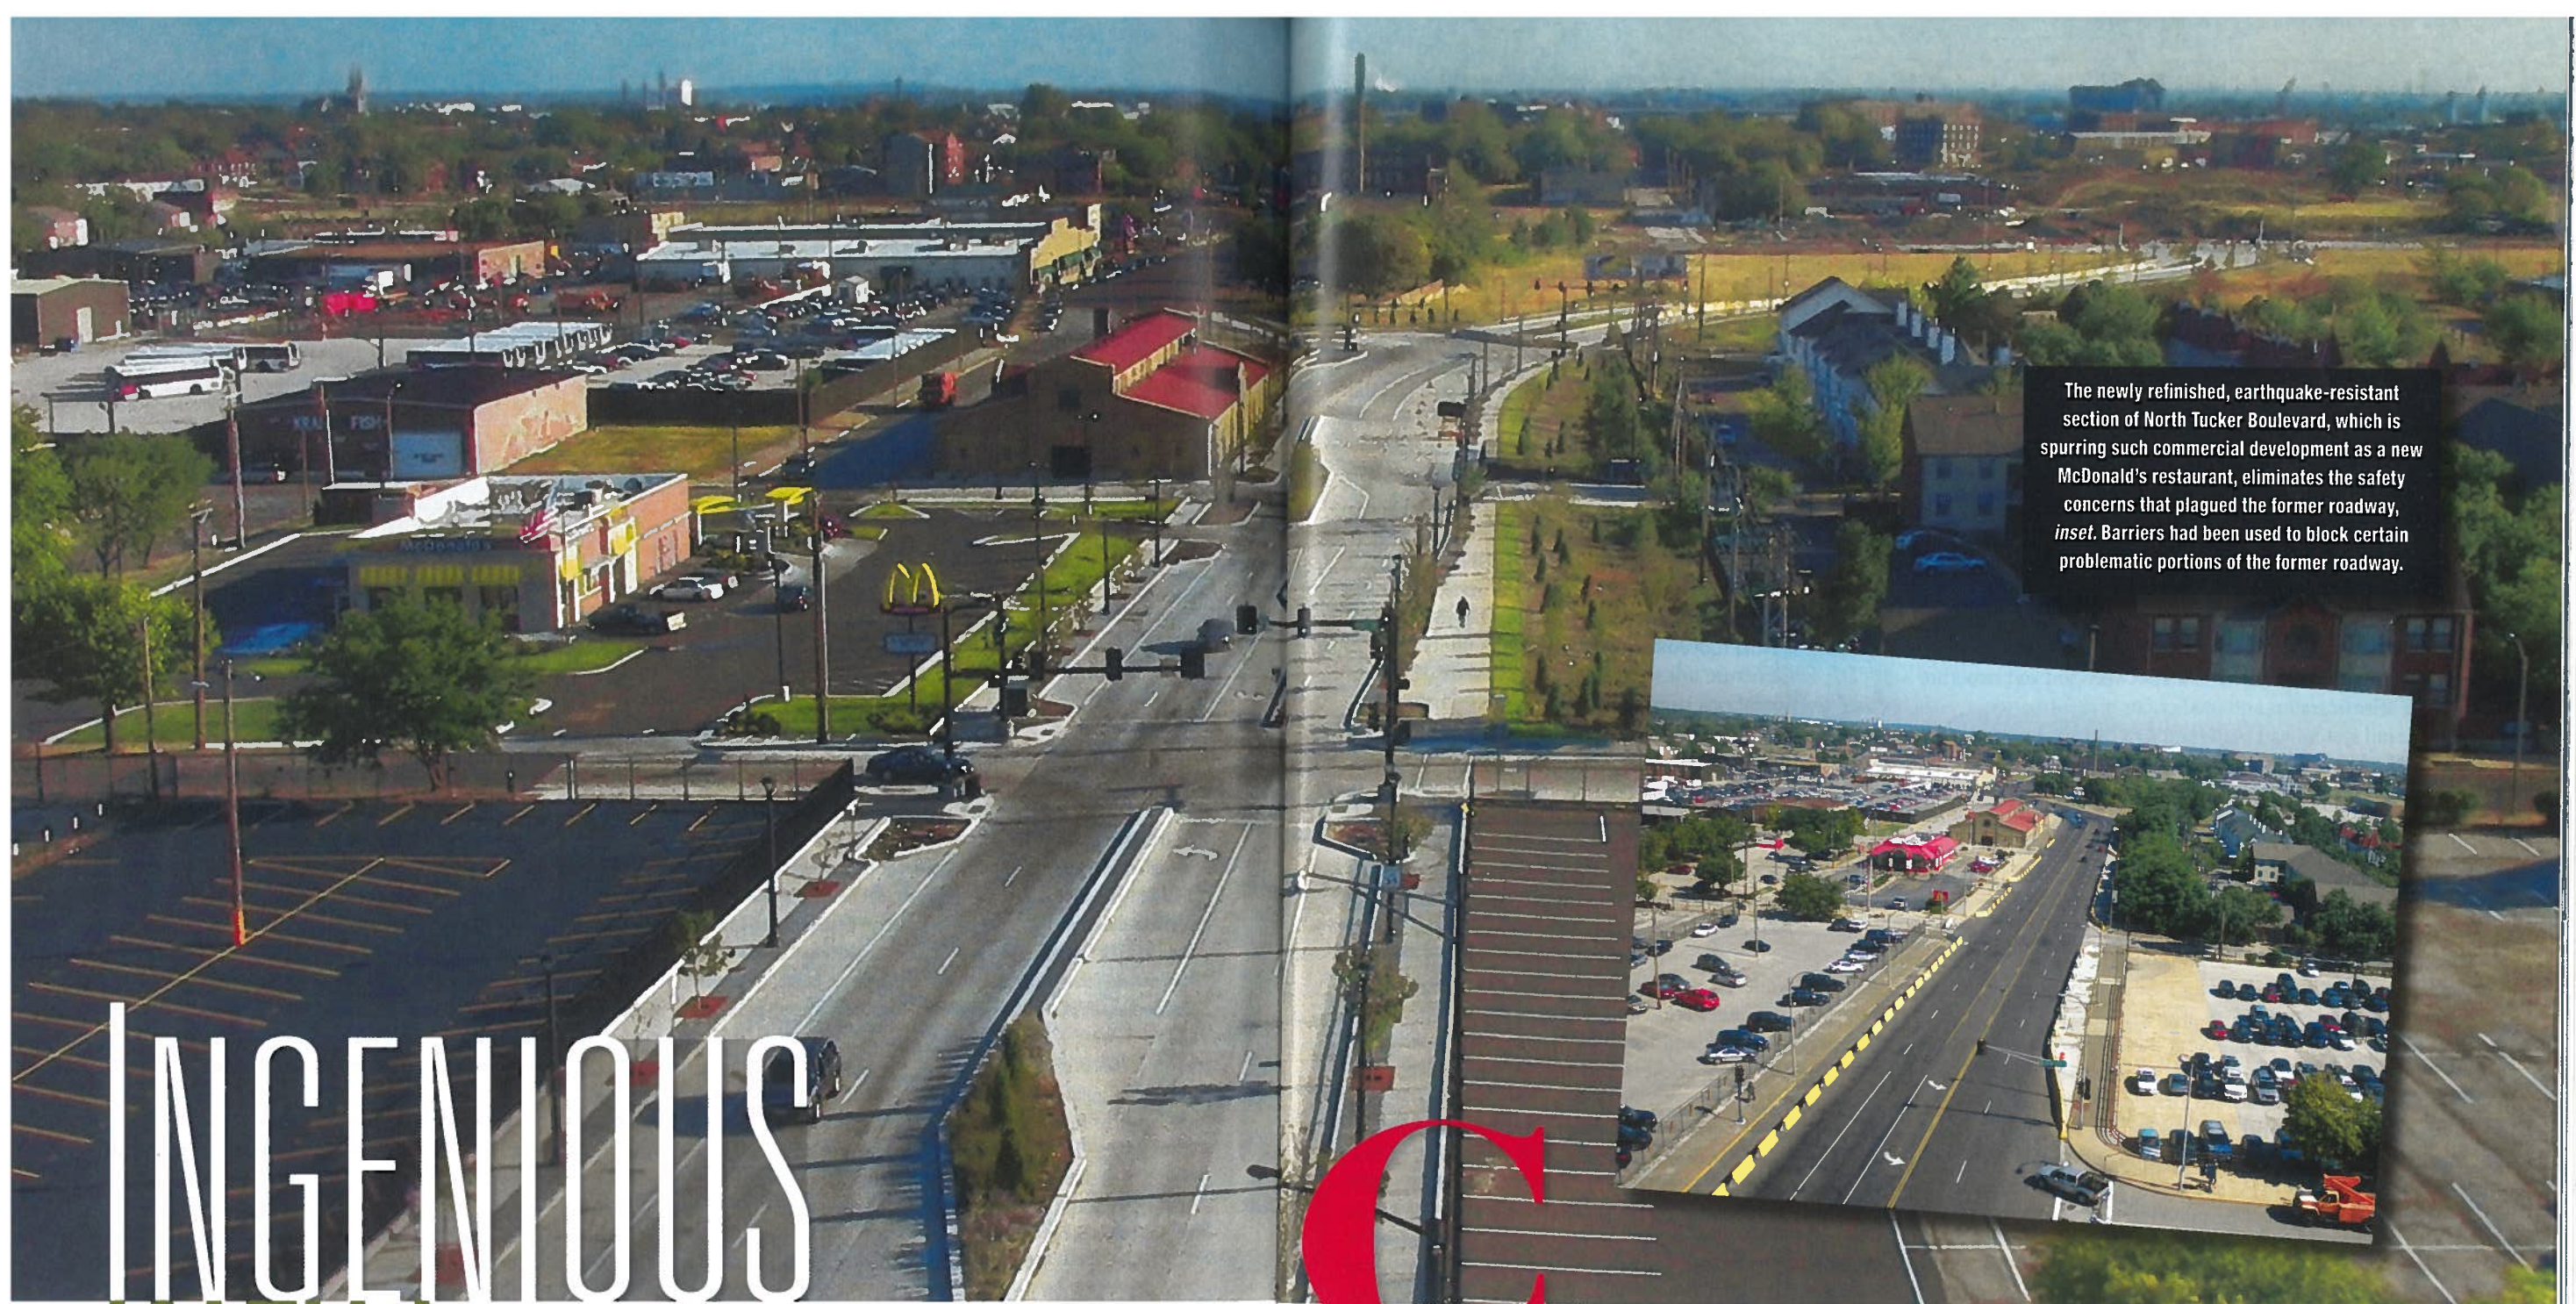
The newly refinished, earthquake-resistant section of North Tucker Boulevard, which is spurring such commercial development as a new McDonald's restaurant, eliminates the safety concerns that plagued the former roadway, inset. Barriers had been used to block certain problematic portions of the former roadway.

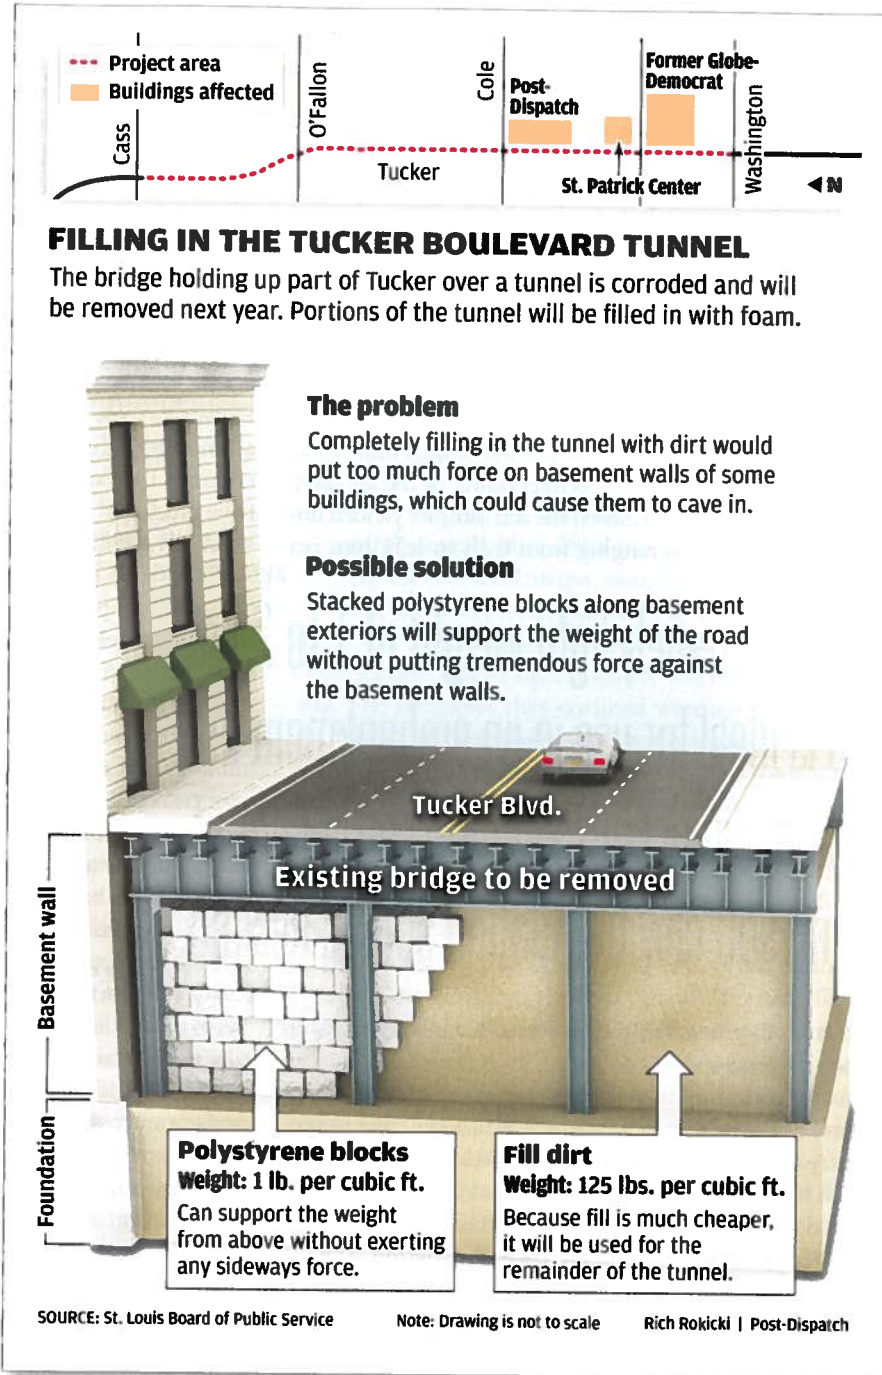
Given the presence of buildings immediately adjacent to the proposed roadway embankment, carrying out future inspections, maintenance, and repairs would be difficult or impossible without removing large portions of the embankment.

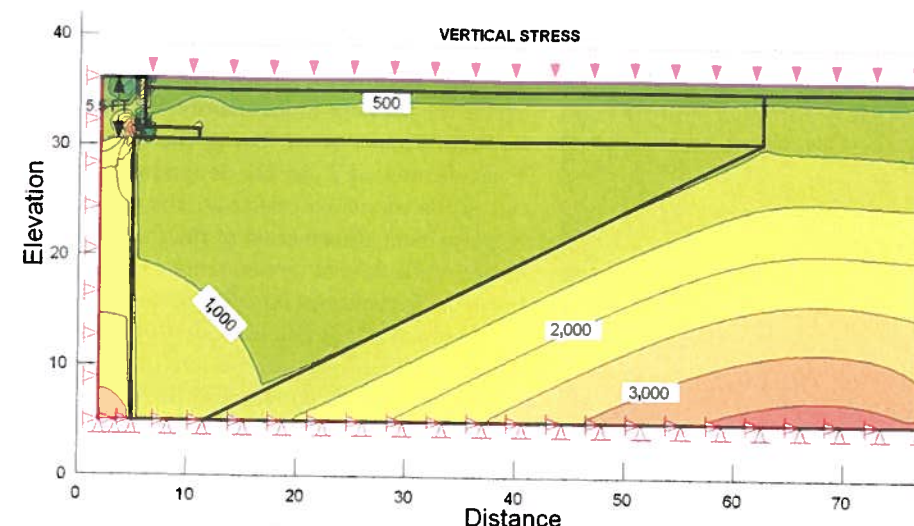
**SAMPLE VERTICAL STRESS DISTRIBUTION THROUGH EPS AND CONVENTIONAL FILL AND LOAD TRANSFER TO EXISTING BUILDING**

configuration when subjected to traffic and seismic loading. The program SIGMA/W—developed by GEO-SLOPE International Ltd., of Calgary, Alberta—was used to model the stress distribution and deformation of the EPS and to estimate the load transfer from the embankment to the building under traffic and seismic loadings. The design section consisted of a 6 ft thick soil planting layer, a 6 in. thick concrete load distribution slab, and about 25 ft of EPS fill extending down to native soils.

The figure on page 67 shows a typical design section of the EPS fill placed against the existing buildings and the conventional earth fill. A granular drainage layer was also placed along the interface of the EPS and the earth fill.

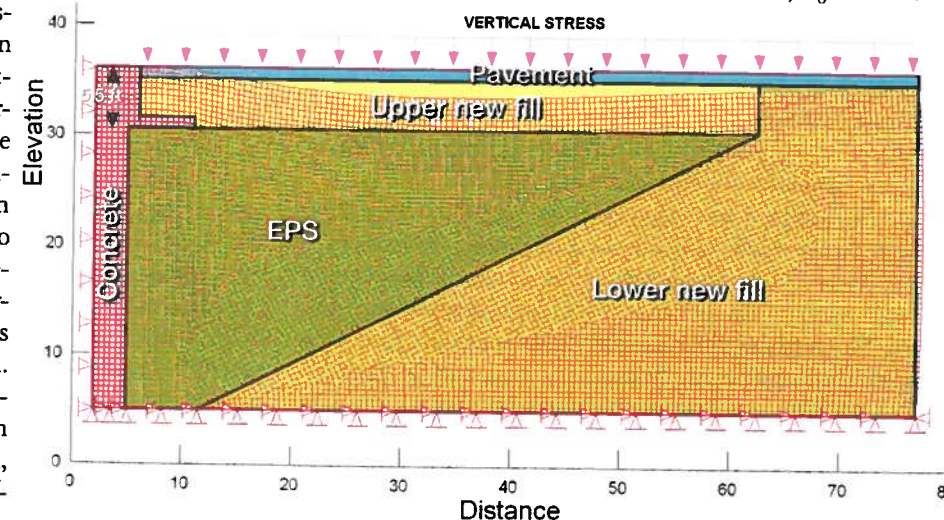
**SAMPLE ESTIMATED DEFORMATION OF THE EPS**

The SIGMA/W analyses were used to estimate the density of EPS fill required to resist the imposed stresses throughout various zones of the embankment. Finite-element analyses model linearly elastic properties, and because the linearly elastic properties of EPS, that is, the modulus of elasticity and the Poisson ratio, generally vary with density, several iterations were required to refine the model and converge on the required EPS density. Example output from the analysis showing the vertical stress distribution through the EPS and conventional fill, as well as the load transfer to an existing building, is shown in the figure above. Example output showing the estimated deformation of the EPS is shown in the figure at right. The visual representation of the deformation has been exaggerated by a factor of 100 to improve clarity. The maximum predicted vertical and horizontal deformations were estimated to total less than respectively 0.3 and 0.01 in. The results estimated minor, relatively uniform deformations within the EPS and across the soil section, indicating a low potential for dif-

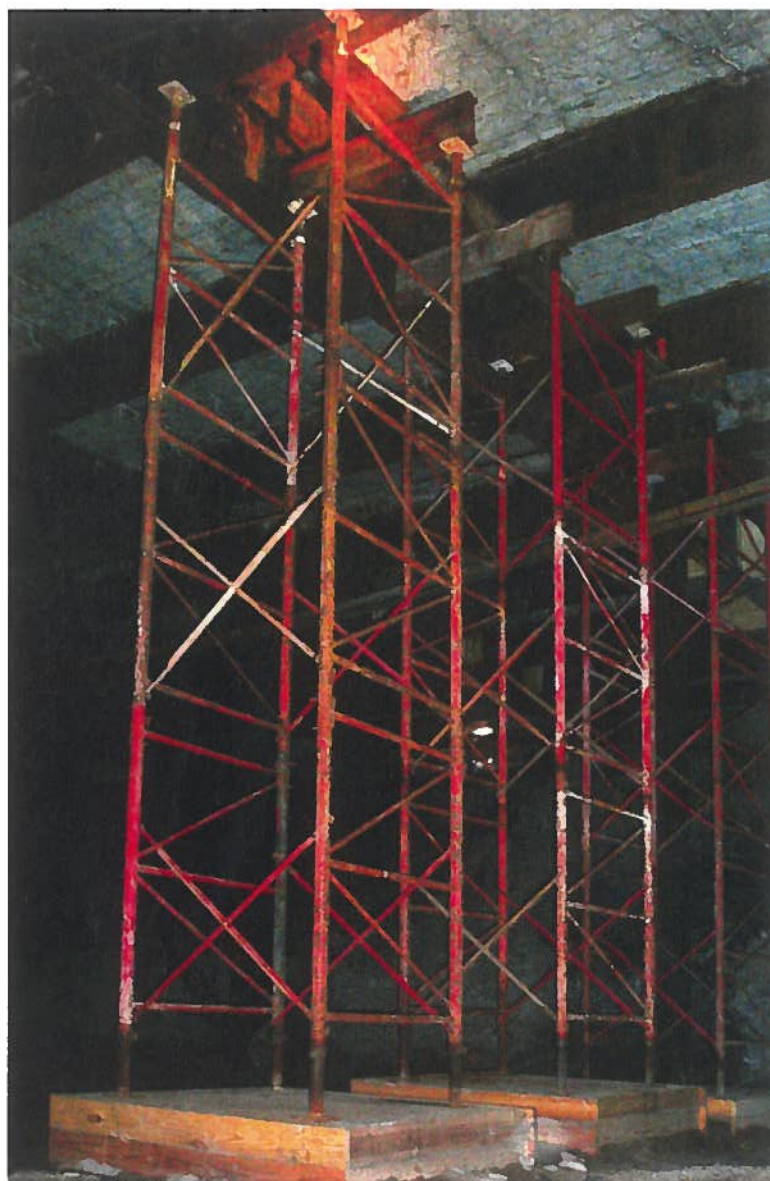
Before the reconstruction, the city used temporary shoring to support the failed ends of beams as a cost-effective way to keep the bridge open as long as possible.

The city had made numerous repairs to the bridge, primarily in the 1990s. Major repairs largely consisted of removing and replacing severely deteriorated portions of stringers near the expansion joints. In more severe cases, the entire beam and expansion pockets were replaced. In addition to other extensive repairs, the city installed temporary shoring at numerous locations to support the deteriorated stringers and prevent differential displacement of the bridge deck. These temporary supports were a cost-effective approach to keep the bridge functional until funding became available for total replacement. The steep railway excavation slopes

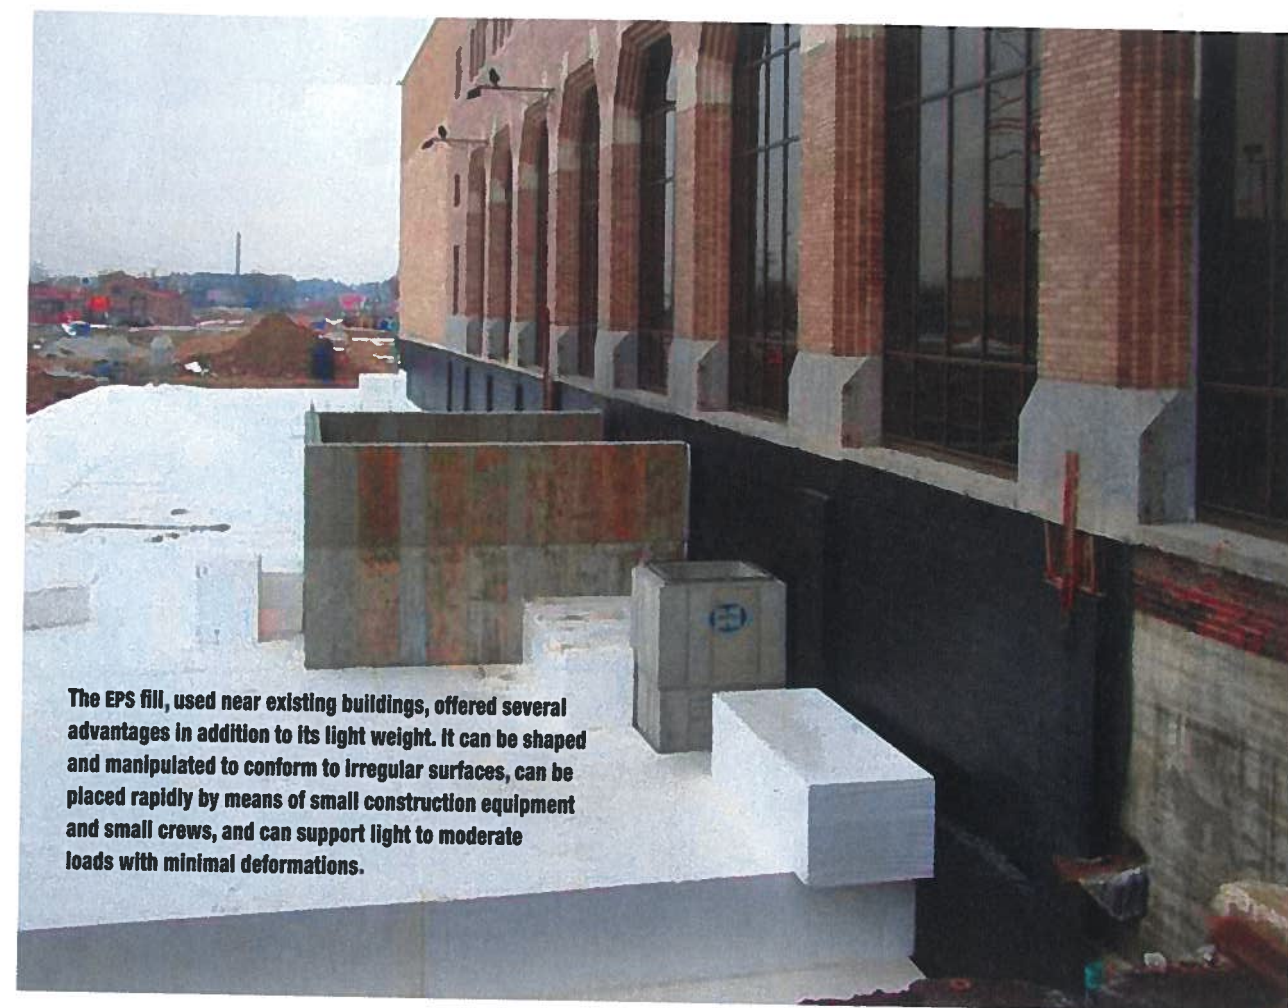
The EPS fill, used near existing buildings, offered several advantages in addition to its light weight. It can be shaped and manipulated to conform to irregular surfaces, can be placed rapidly by means of small construction equipment and small crews, and can support light to moderate loads with minimal deformations.

Because it is a lightweight soil alternative, EPS is typically used when excessive settlement is anticipated. For this project, two factors supported the use of EPS. The first was the ability of vertically stacked EPS blocks to support loads immediately adjacent to the existing buildings without inducing lateral loads on the buildings. The second was the relatively maintenance-free nature of the EPS material over the long term.
