Report No. UT-20.18

ASSESSING CLOSE-RANGE PHOTOGRAMMETRY AS AN ALTERNATIVE TO LIDAR TECHNOLOGY AT UDOT DIVISIONS

Utah Department of Transportation
Research & Innovation Division

**Final Report
August 2020**

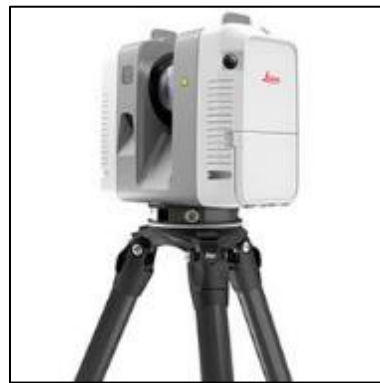
[Figure 2 - Leica LiDAR Scanner. "Leica RTC360", Spatial Technologies.](#)

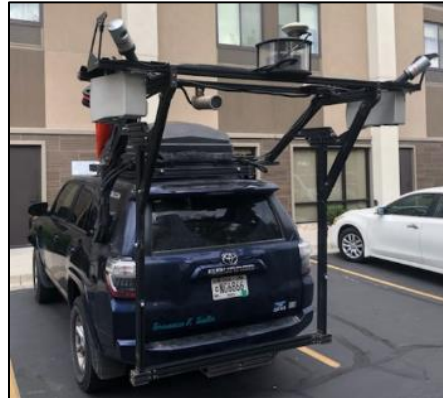
Figure 3 – Mandli’s Mobile LiDAR Vehicle

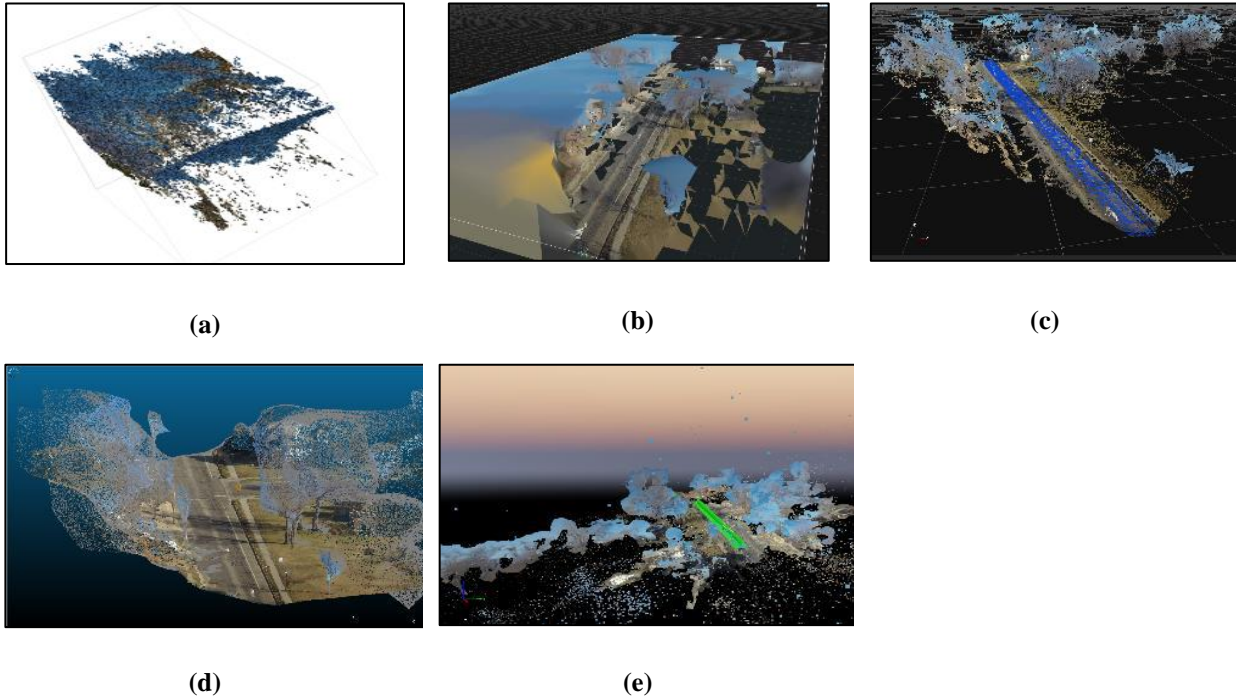
Figure 4 - Comparison of various software packages using the same control set of 163 images. (a) Agisoft, (b) Reality Capture, (c) 3DF Zephyr, (d) Context Capture, (e) Pix4D

variables such as registered images, processing time, number of points, and overall point cloud quality were evaluated [Table 1]. It is of utmost importance to choose the software packages that provide a dense point cloud output and clear enough data. After reviewing the data output from each software package, the conclusion was reached that for the asset management portion of this research, Context Capture and 3DF Zephyr provided the most comprehensive and complete point clouds (Figure 4, a-e).

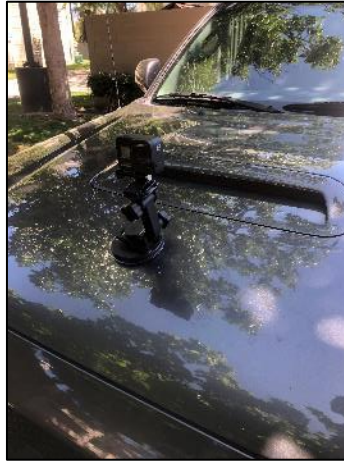
Figure 5 – GoPro mounted to hood of vehicle using suction cup mount

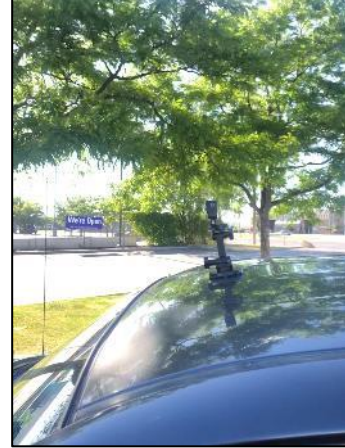
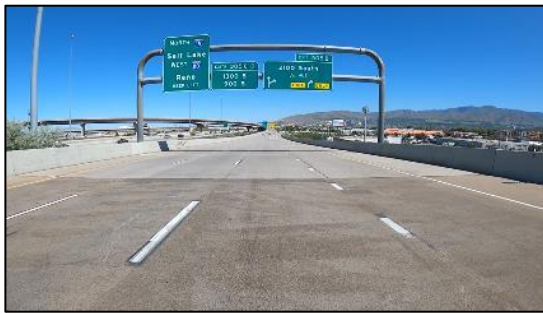
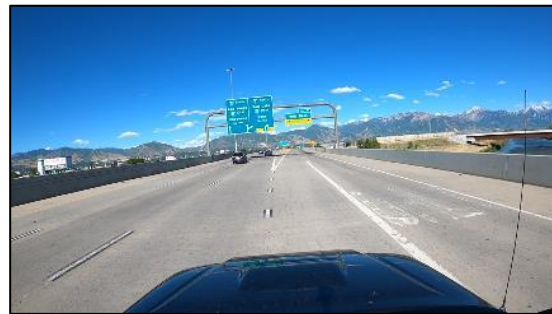
Figure 6 – Different mounting areas and their corresponding view. (a) Camera mounted on hood, (b) camera mounted on roof, (c) Field of view of hood-mounted camera, (d) Field of view of roof-mounted camera

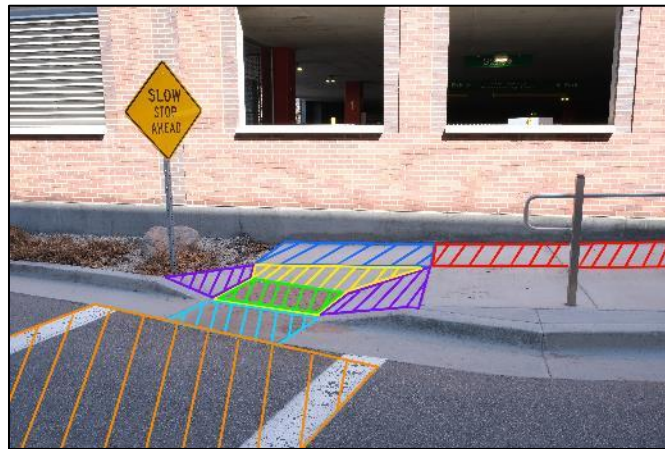
Figure 7 – Pedestrian Access Ramp Components. Red: Pedestrian Access Route (PAR); Blue: Turning Space (T); Yellow: Ramp; Purple: Flares; Green: Detectable Warning Surface (DWS); Light Blue: Clear Space; Orange: Crosswalk

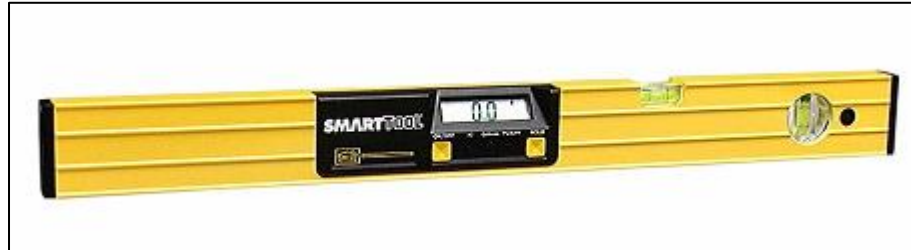
[Figure 8 – Smart Tool Smart level](#)

The inspections done by UDOT were carried out using a Smart Tool Smart Level [Figure 8], and a tape measure. The Smart Tool was used to measure the slope percentages of the various ramp components to ensure they were within the specified requirements, and the tape measure was used to ensure that various widths and distances of the ramp are also within

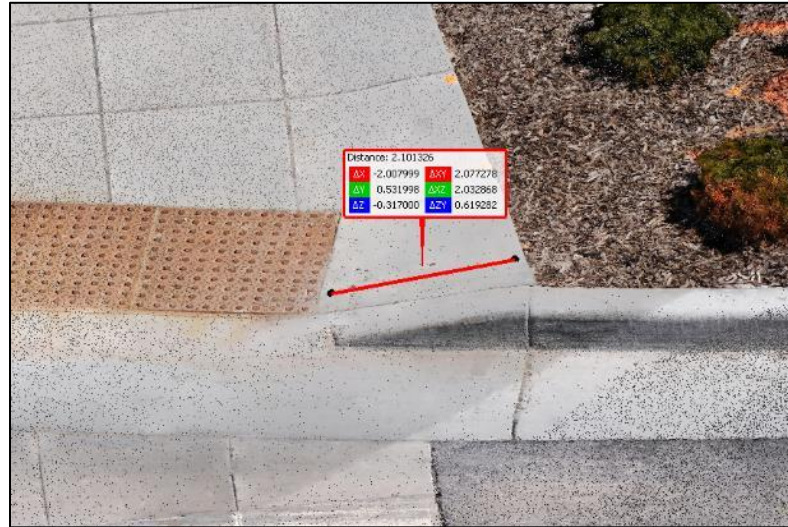
Figure 9 – Slope measurement of a flare component of a pedestrian access ramp. ΔZ is the change in elevation, ΔXY is the projected distance along the XY plane.

along with the density readings to see if the slopes extracted from the point clouds were similar to slopes extracted from the in-field inspections. Slopes were measured in the point clouds by picking two points on the surface of the ramp component in question, and then dividing the change in Z coordinates by the distance of the projection along the XY plane [Figure 9].

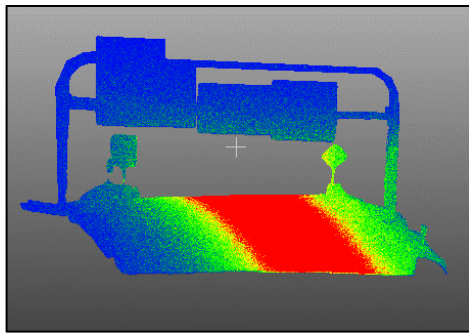
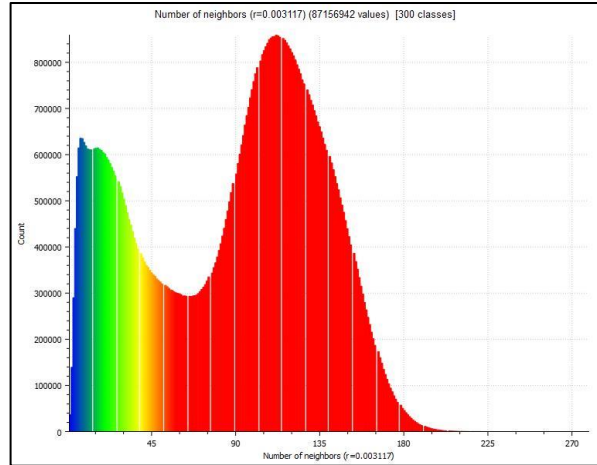
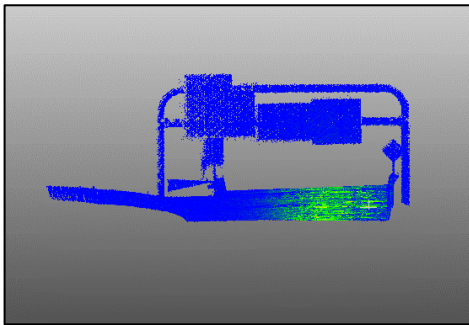
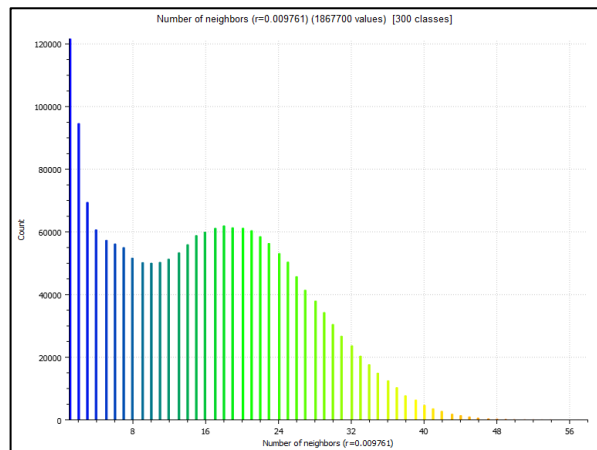
Figure 10 – Comparison of point cloud density for model 1. Number of Neighbors Density for (a) image-based model section saturation, (b) image-based model histogram, (c) LiDAR model section saturation, (d) LiDAR model histogram

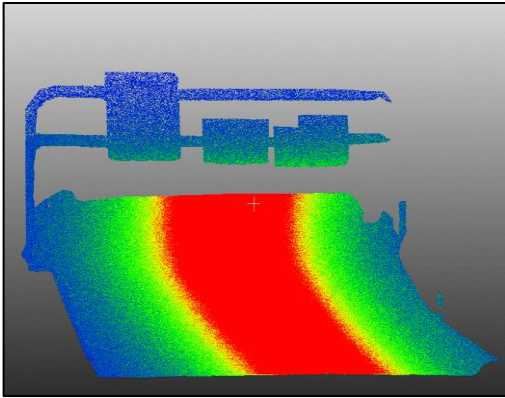
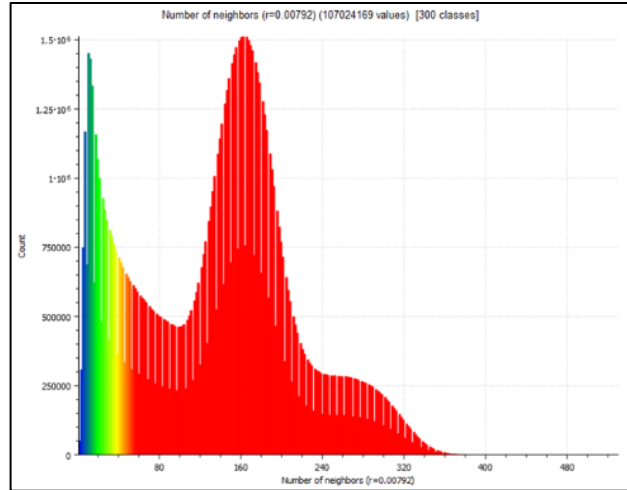
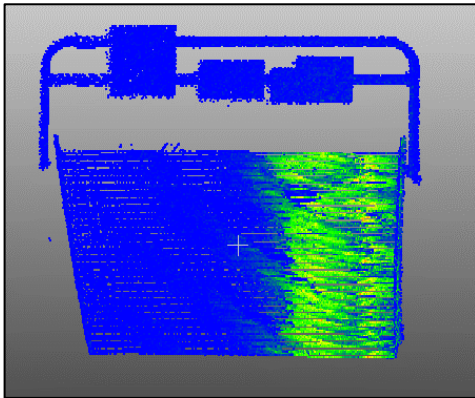
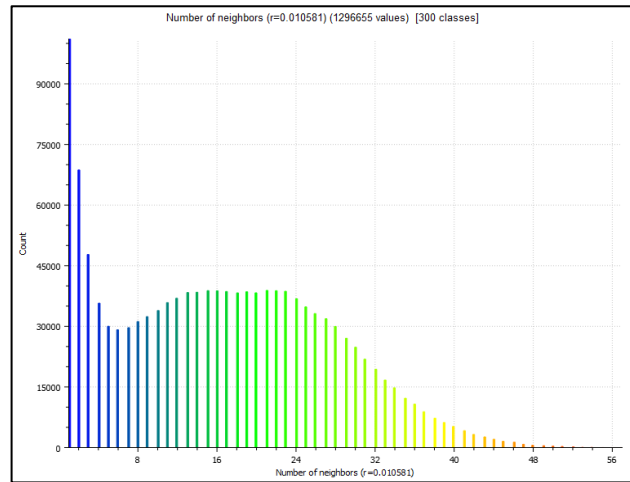
Figure 11 – Comparison of point cloud density for model 2. Number of Neighbors Density for (a) image-based model section saturation, (b) image-based model histogram, (c) LiDAR model section saturation, (d) LiDAR model histogram

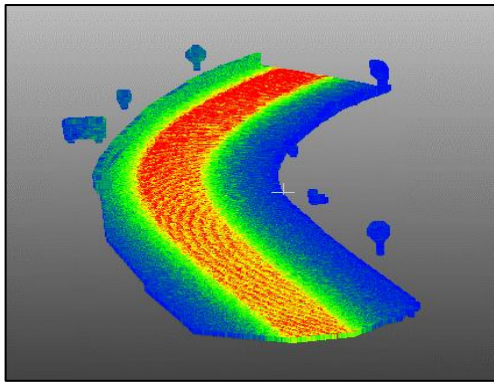
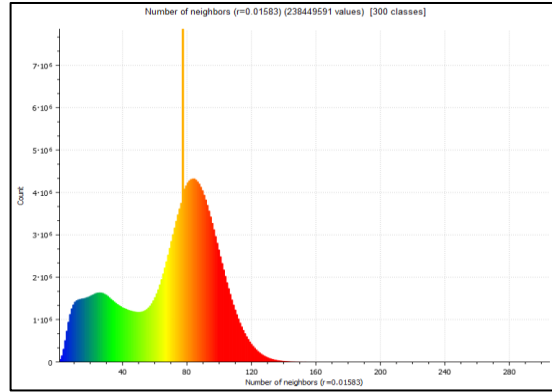
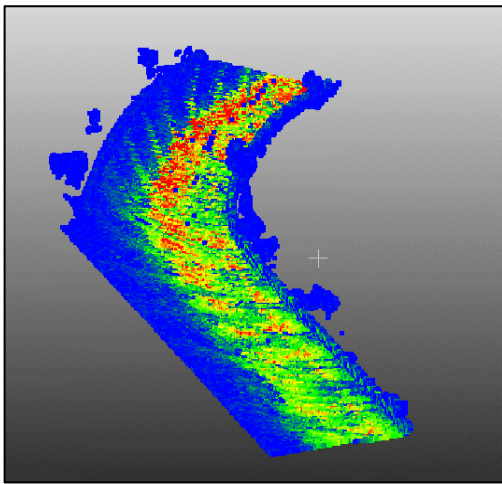
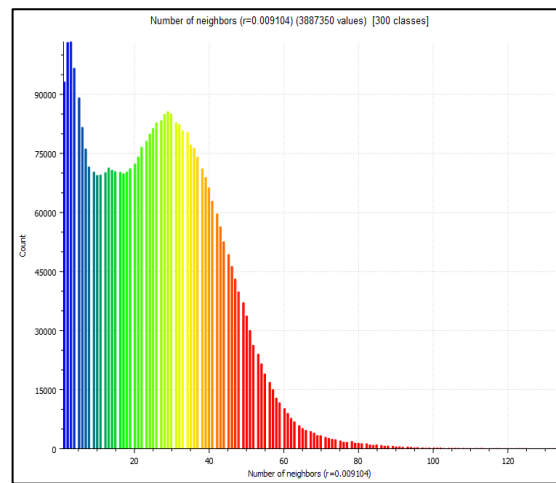
Figure 12 – Comparison of point cloud density for model 3. Number of Neighbors Density for (a) image-based model section saturation, (b) image-based model histogram, (c) LiDAR model section saturation, (d) LiDAR model histogram

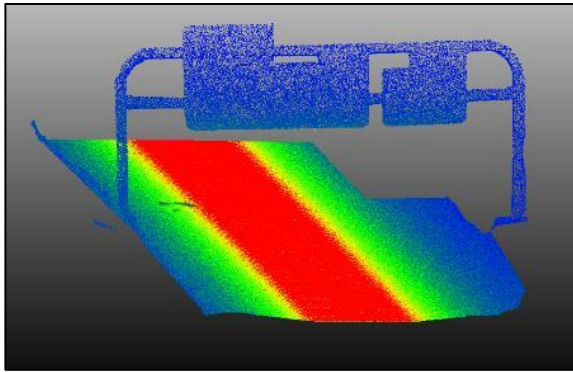
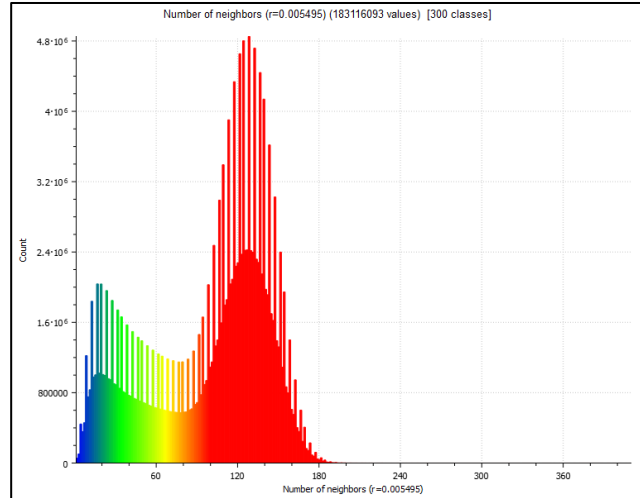
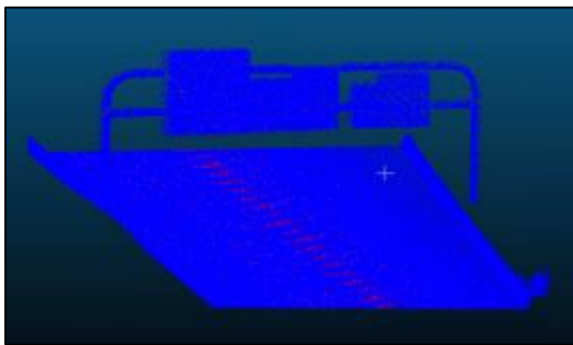
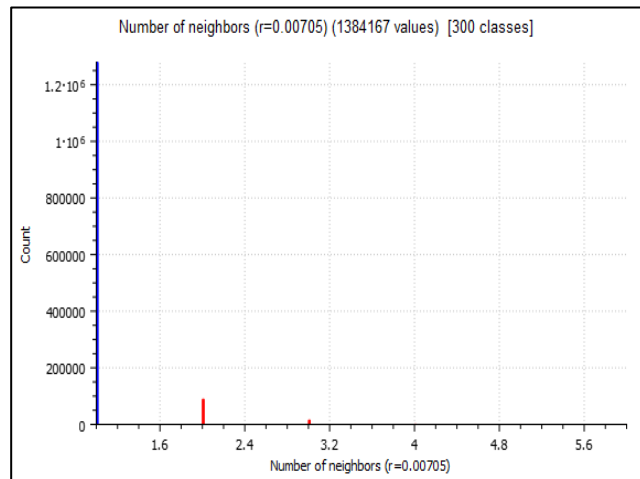
Figure 13 – Comparison of point cloud density for model 4. Number of Neighbors Density for (a) image-based model section saturation, (b) image-based model histogram, (c) LiDAR model section saturation, (d) LiDAR model histogram

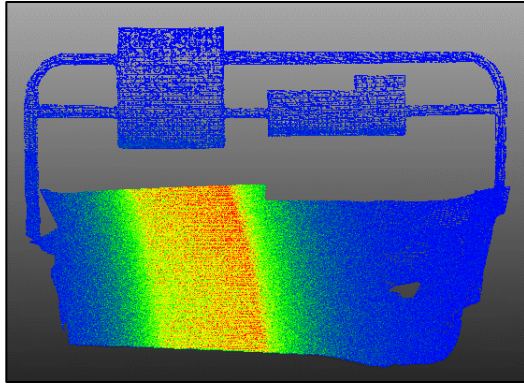
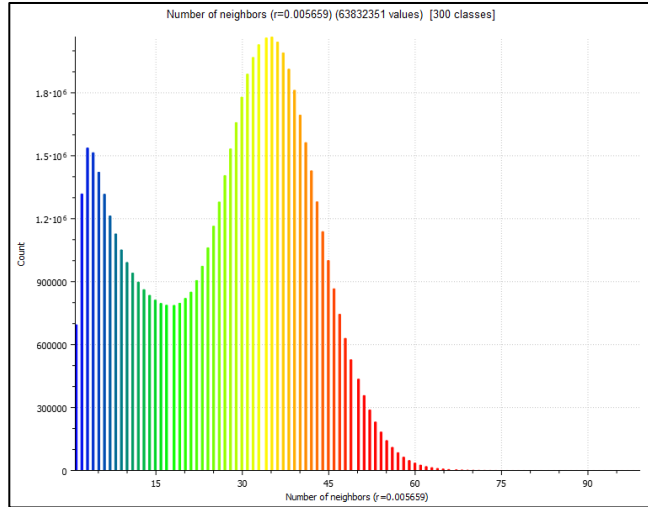
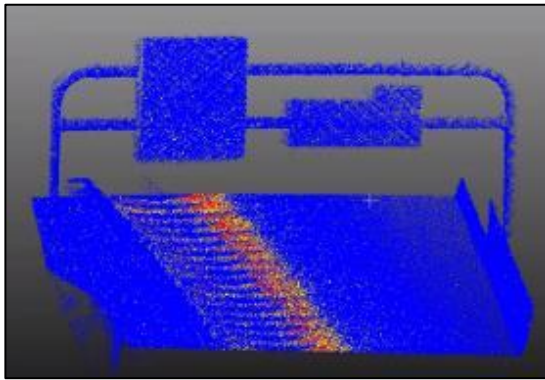
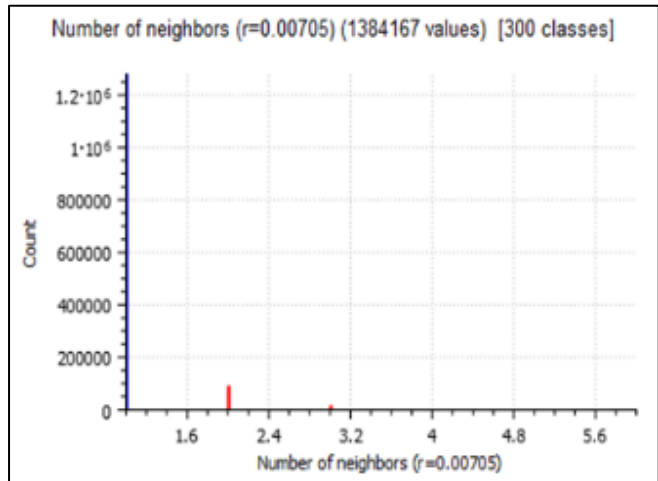
Figure 14 – Comparison of point cloud density for model 5. Number of Neighbors Density for (a) image-based model section saturation, (b) image-based model histogram, (c) LiDAR model section saturation, (d) LiDAR model histogram

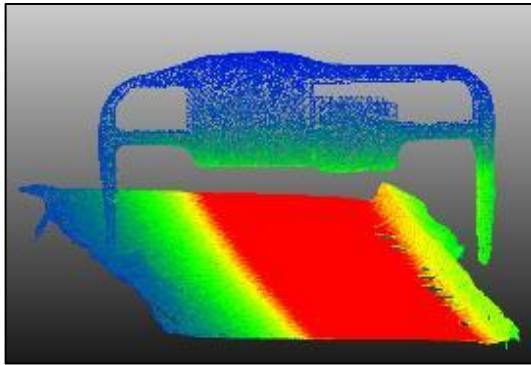
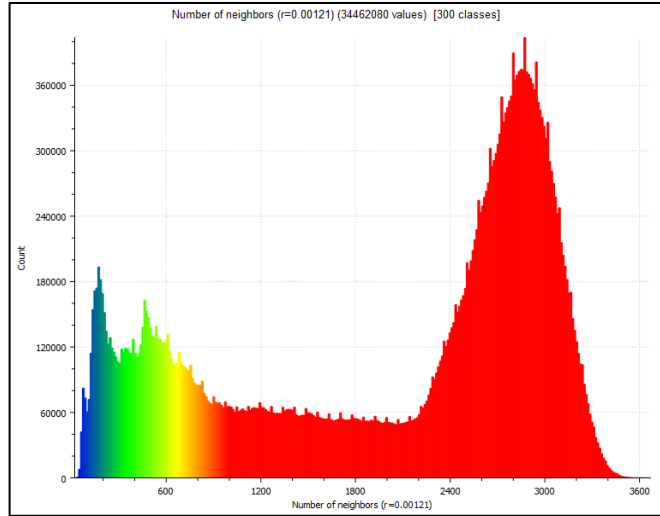
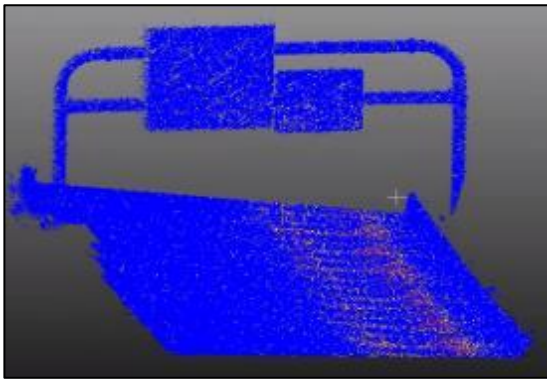
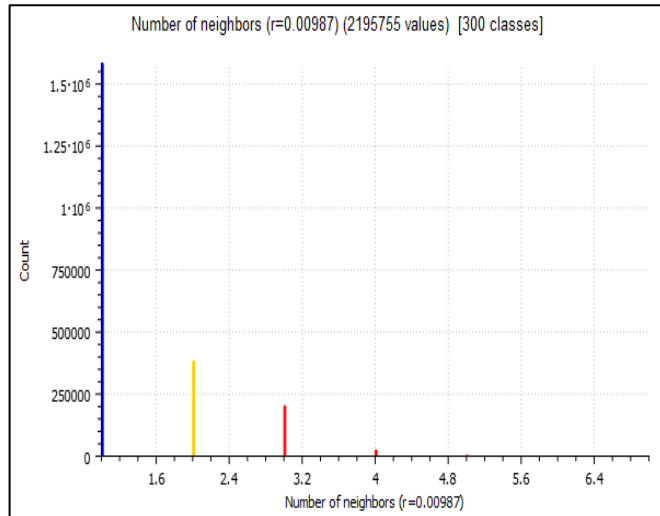
Figure 15 – Comparison of point cloud density for model 6. Number of Neighbors Density for (a) image-based model section saturation, (b) image-based model histogram, (c) LiDAR model section saturation, (d) LiDAR model histogram

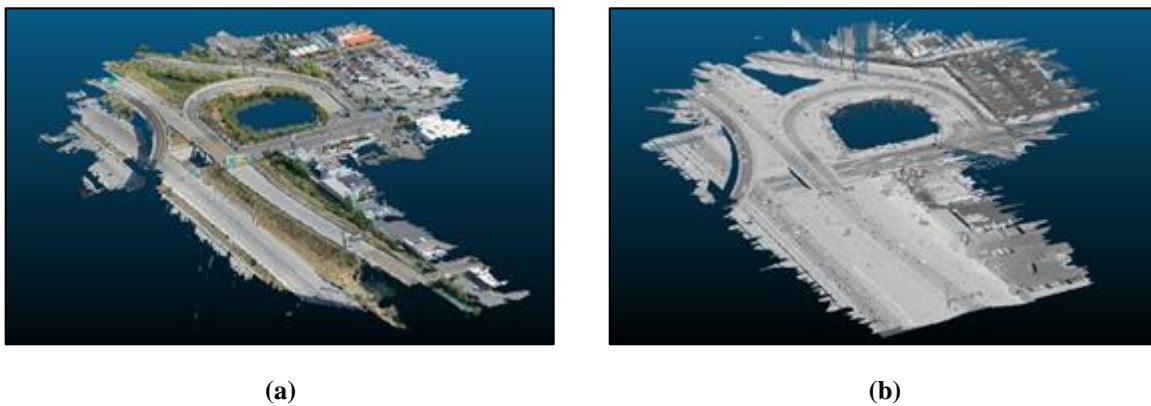
Figure 16 – Comparison between (a) DJI Mavic Pro 2 point cloud using photogrammetry and (b) DJI M600 Drone point cloud with LiDAR

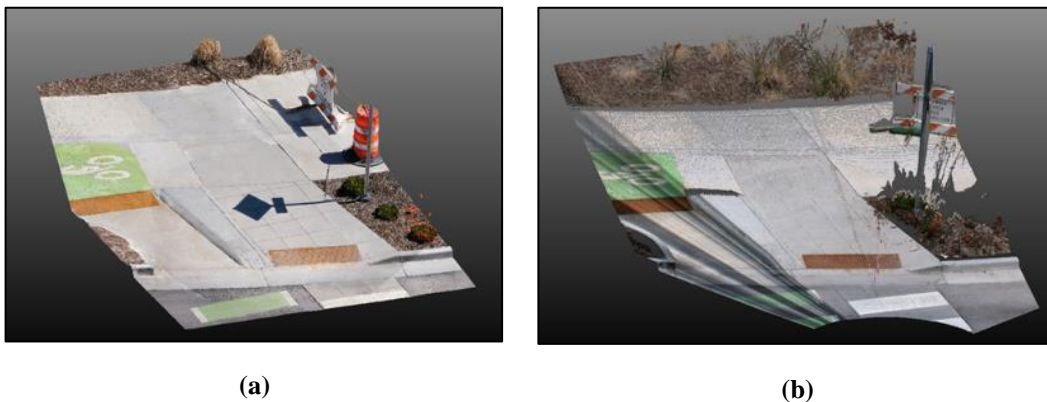
Figure 17 – Ramp 1 point clouds using (a) photogrammetry and (b) LiDAR

Ramp 1 is a pedestrian access ramp near University Hospital. As you can see below in Figure 18 (c), comparing the extracted measurements to UDOT's in-field measurements, the error between the measuring procedures was 0.6% for photogrammetry and 0.27% for LiDAR. This error is excluding the one outlier measurement of one of the flares of the pedestrian access ramp. It is believed that the measurement extracted from the point cloud is the more accurate measurement of the two. The flare is only about a foot long, and during the in-field inspections a four-foot-long level was used to measure the slope of this particular component. There was a lot of overhang of the level while measuring this area which leads us to believe that it could lead to a bad slope reading. Even after measuring the slope of that flare separately in the field with a Leica Disto D5, slope readings were around 22%, which corroborates the measurement extracted from the point cloud. Regardless of this one outlier, all other slopes are very close to the extracted slopes from the field.

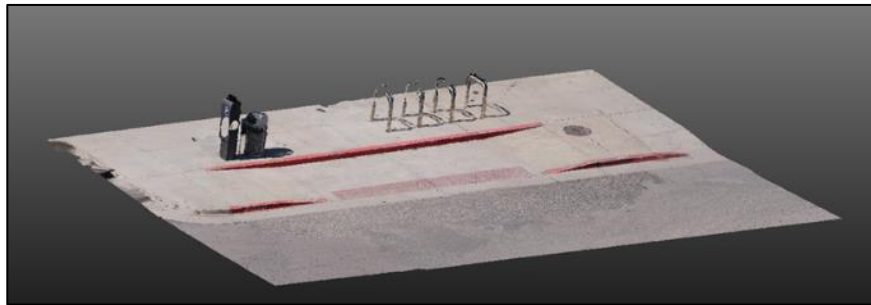
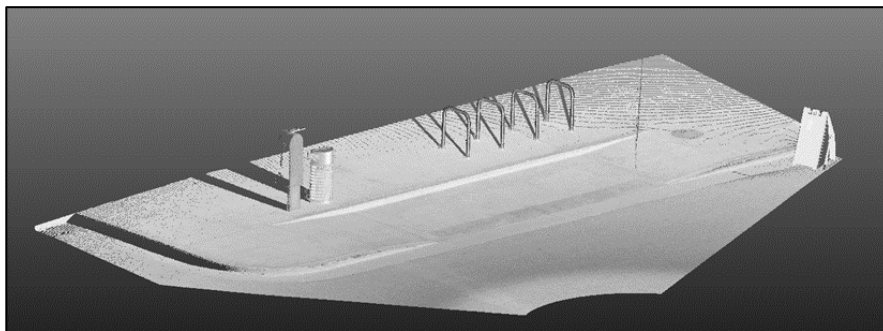
[Figure 19 – Ramp 2 point clouds using \(a\) photogrammetry and \(b\) LiDAR](#)

Ramp 2 is a pedestrian access ramp near the University (of Utah) Student Center. This ramp was chosen because it was built differently than the other access ramps in this project, yet the measurements are very accurate for this model as well. As you can see in Figure 20, the error between slopes extracted from the field and slopes extracted from the image-based point cloud model are 0.27%. The LiDAR error for this particular model was 0.19% (Figure 20 (c)). There were no outliers for this model and all extracted measurements were within a good range of the field measurements. The reason the LiDAR model is not shown in color is due to the fact that there was a heavy shadow cast over the ramp. While viewing this cloud with RGB colors, the ramp is shown very dark due to the shadow, which is why the model is shown in gray scale.

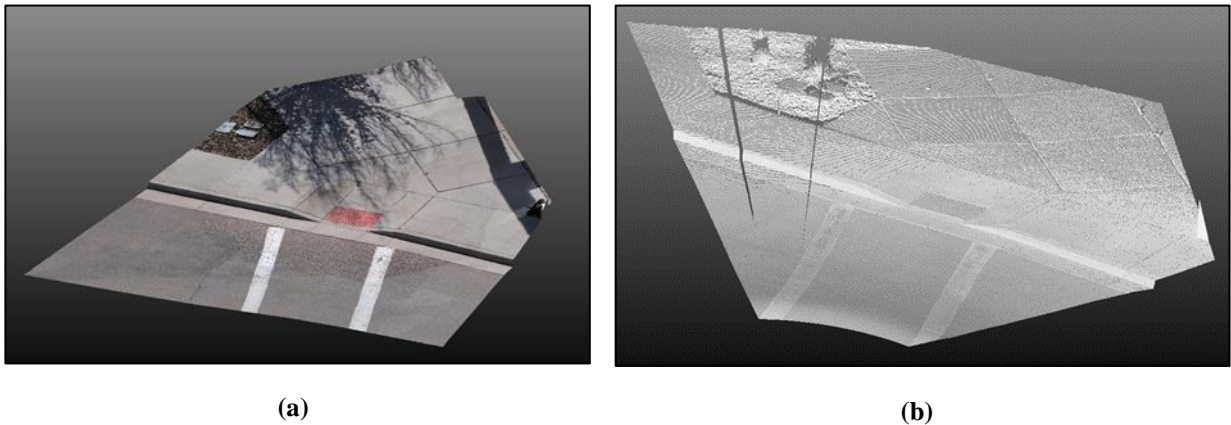
Figure 21 – Ramp 3 point clouds using (a) Photogrammetry and (b) LiDAR

Ramp 3 was another ramp near the university and was also chosen because of the different construction from other ramps in this portion of the project. Again, extracted measurements from the point clouds were very accurate, with an overall error of 0.28% for photogrammetry, and an error of 0.16% for LiDAR [Figure 22 (c)]. There were no problems with this access ramp's measurements and all extracted measurements were within an acceptable requirement to the in-field measurements. There was also a heavy shadow on this ramp, so the LiDAR model is shown in gray scale.

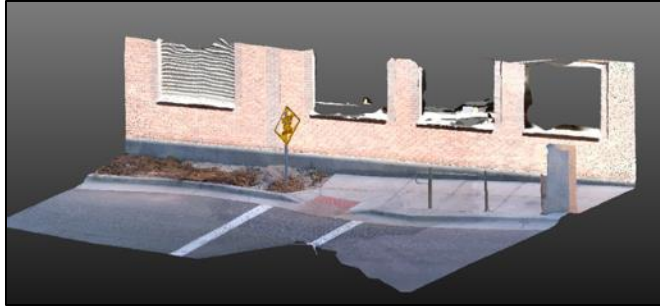
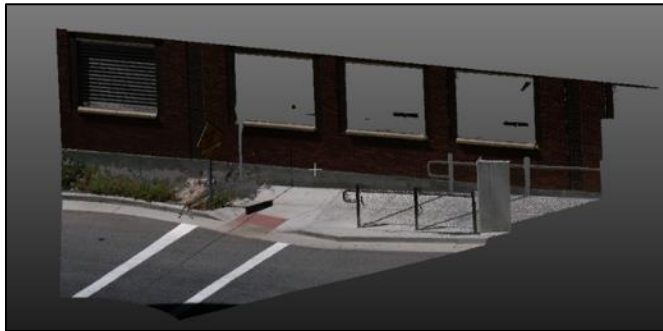
Figure 23 – Ramp 4 point clouds using (a) Photogrammetry and (b) LiDAR

Ramp 4, much like other access ramps in this project, was chosen because of its differing features and ramp components. This particular ramp had a higher overall error between in-field measurements and image-based point cloud measurements, however the error was still only 0.35%. The LiDAR point cloud is still consistent with an error of 0.19%. There are two measurements that could be considered outliers and those measurements are the flares of the pedestrian access ramp. However, as mentioned before, it is believed that the measurements from the point cloud are the more accurate measurements due to the accuracy of other extracted point cloud slopes. The smart level, too, was much too long to accurately measure the slope of each flare of the pedestrian ramp, and in-field measurements done with the Leica Disto D5 corroborated the measurements that were extracted from the point cloud.

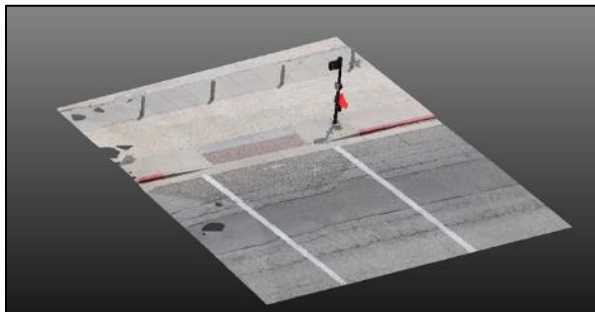
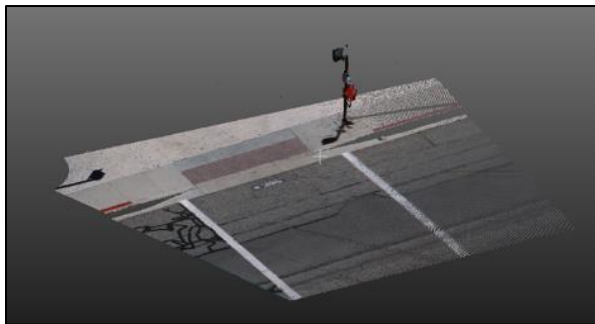
Pedestrian Ramp 5, much like the other ramps, also has a very high accuracy of measurements. The overall error for the image-based reconstructed point cloud is 0.24%. The LiDAR-reconstructed point cloud has an even lower error percentage of 0.18. Pedestrian access ramp 5 does not have a UDOT C-170 evaluation form due to the fact that the final two ramps, ramps 5 and 6, were not done with UDOT representatives. However, in-field evaluations were still carried out using the UDOT C-170 procedures, but instead of a Smart Level, in-field measurements were done with a Leica Disto D-5 measuring tool to measure slopes.

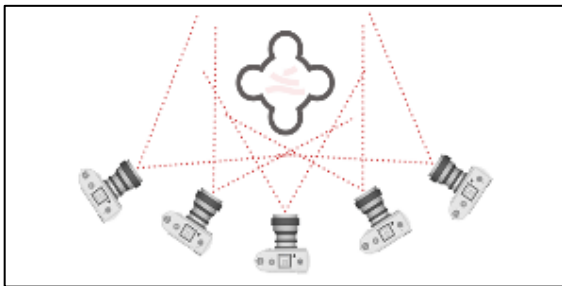
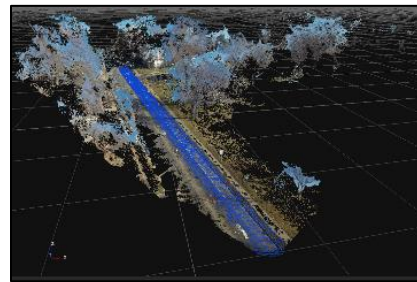
Figure 27 – Image acquisition pattern. (a) Recommended capture procedure and photo overlap, (b) Pattern of photo overlap and image acquisition pattern during asset management data collection. The blue linear objects in photo (b) are the extracted positions of extracted frames.

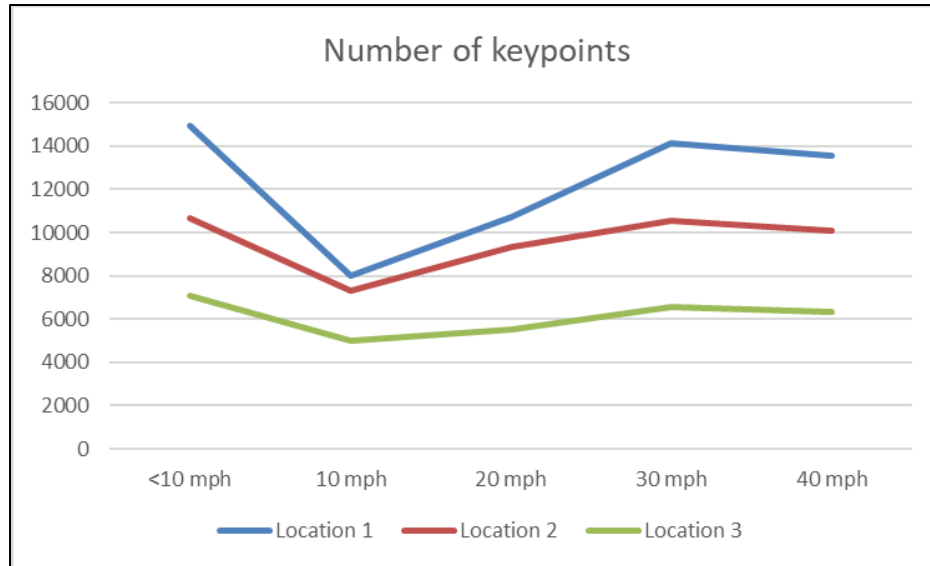
Figure 28 – Number of keypoints of 3 locations according to data acquisition speed.

One of the biggest limitations of asset management data collections using photogrammetry is the speed that one is able to travel and still acquire good data. During this research, it was concluded that videos gathered while traveling greater than 50 miles per hour were not able to be processed. One of the most important aspects of image alignment during photogrammetry reconstruction is having enough keypoints in each image to be able to have an accurate alignment. As you can see in the following Figure 28, keypoint alignment is best between 10-30 miles per hour. Good models were attainable at speeds greater than 40 miles per hour, however image alignment was much more difficult. Above 50 miles per hour, image alignment was unsuccessful, therefore a 3D point cloud model could not be created. A keypoint analysis was done using speeds from less than ten miles per hour, to a speed of 40 miles per hour. With the exception of location one, the total number of keypoints decreases as speed increases [Appendix A, Figure 36]. This is believed to be the reason for poor image alignment while going faster than 50 miles per hour.

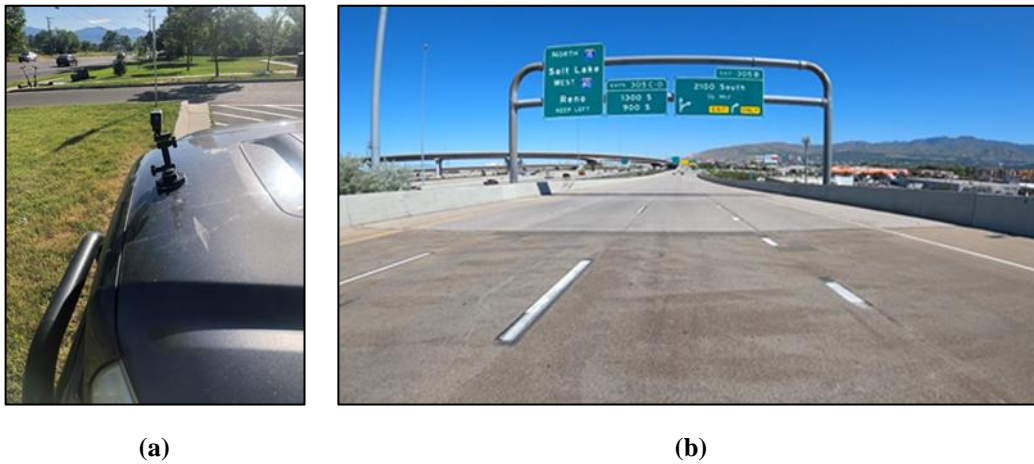
Figure 29 – (a) camera mounting area and (b) field of view for a hood-mounted camera

1. Choose the optimal time of day for data collection. Driving west is better early in the day etc.
2. Mount the camera to the hood of the vehicle ensuring that the field of view can capture all side and overhead signs while omitting parts of the vehicle from the FOV (see below).

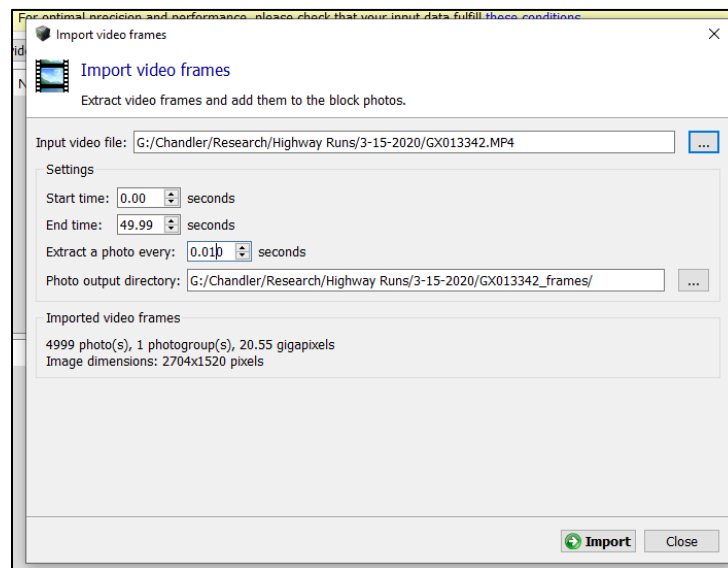
Figure 30 – Video frame extraction window

7. Begin a new project in context capture and save it to the desired locations.
8. Import the recorded video into the Context Capture software and select the desired number of frames to be extracted. You can specify the start time and end time of the extracted frames, as well as the frequency of extracted frames. Even though video was recorded in 120 FPS, photos were extracted every 0.02 seconds (50 FPS), and then increased to 0.015 (66 FPS) if the first iteration failed. The largest number of extracted frames used is 0.01 (100 FPS), to ensure the system isn't overloaded during processing.

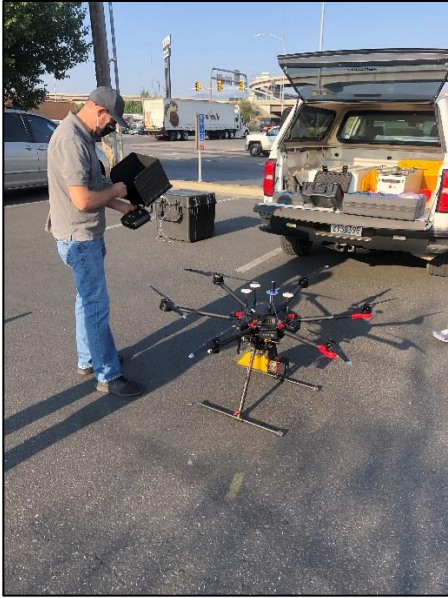
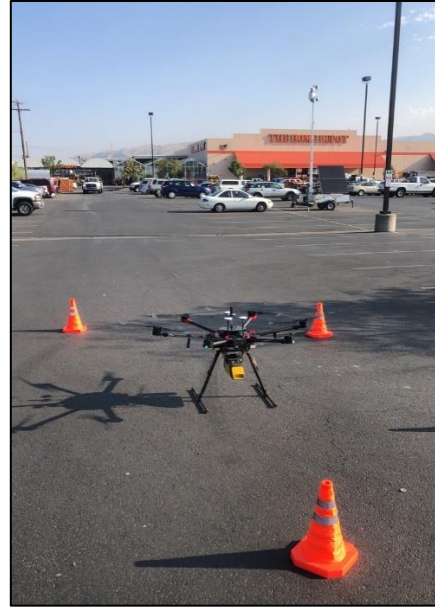
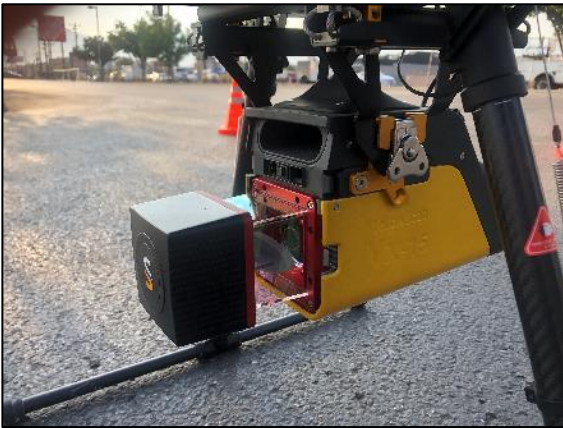
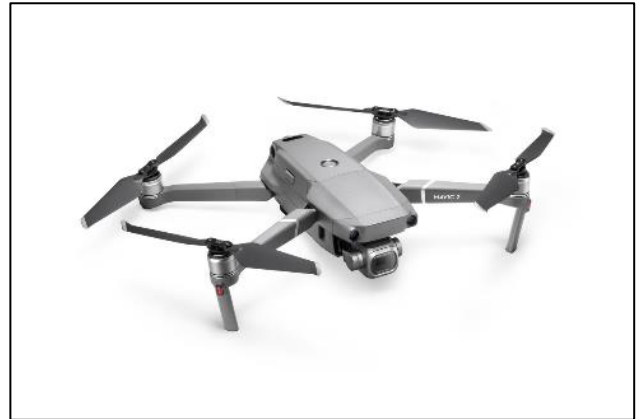
Figure 35 – (a-c) DJI M600 Drone with VX15 LiDAR Scanner. (d) DJI Mavic 2 Pro

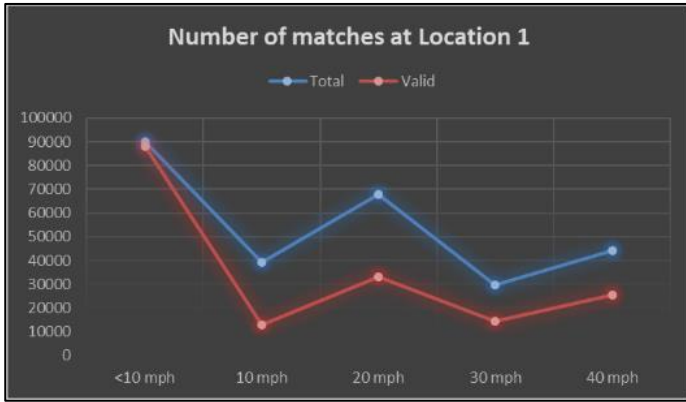
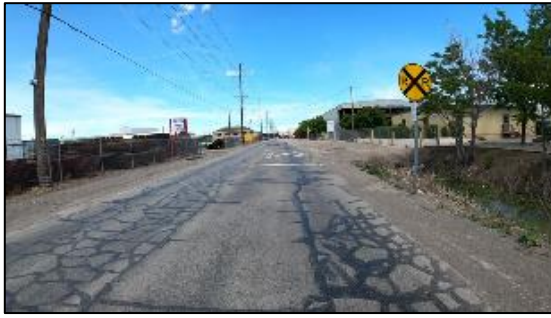
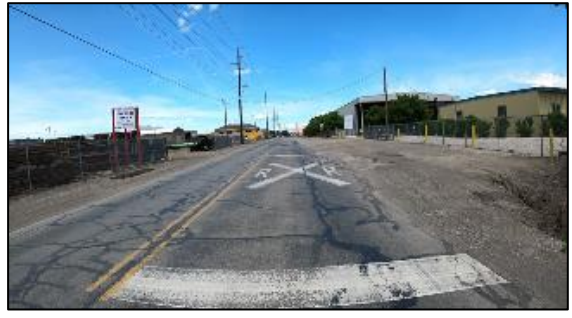
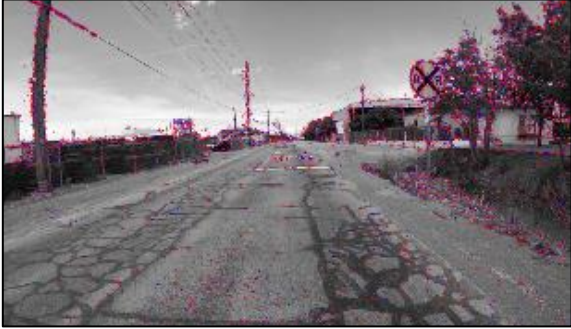
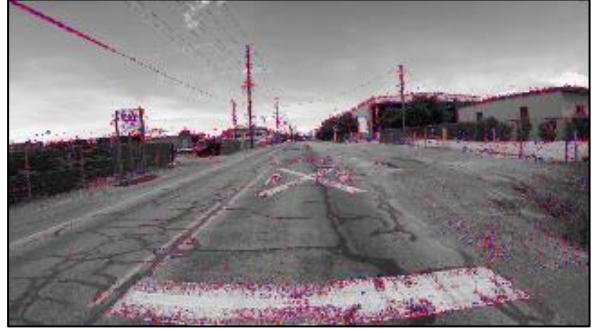
Figure 36 – Number of matches of keypoints at 3 locations. Images (a), (d), (g) are location 1. Images (b),(e),(h) are location 2. Images (c), (f), (i) are location 3.
