Earthquake Risk Study for Oregon's Critical Energy Infrastructure Hub

FINAL REPORT TO OREGON DEPARTMENT OF ENERGY & OREGON PUBLIC UTILITY COMMISSION

by
Yumei Wang,
Steven F. Bartlett,
and Scott B. Miles

August 2012

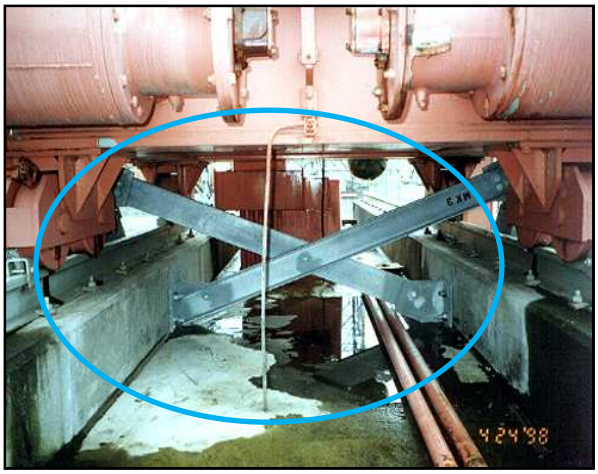
Photo shows the front view of an existing transformer with seismic anchorage including steel cross bracing as mitigation. (Photo: Leon Kempner)

The length of time to resume services after a Cascadia earthquake should be evaluated by each energy company to establish a baseline understanding, and improvements to achieve a satisfactory service level should be made. Improvements, for example, can involve adding stone columns to strengthen the ground against liquefaction-related damage and anchoring power transformers to prevent sliding-related damage.

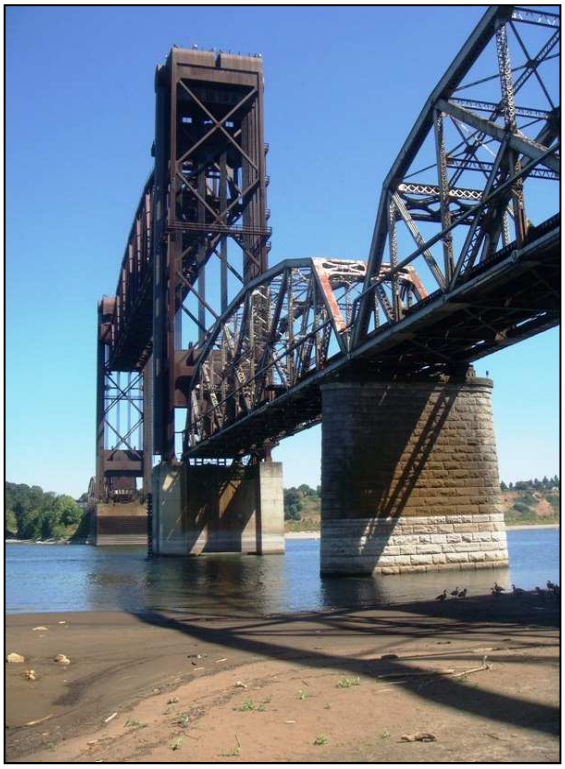
Figure 56: The 1908 BNSF rail bridge that crosses the Willamette River in the CEI Hub. The piers are seismically deficient. (DOGAMI photo)

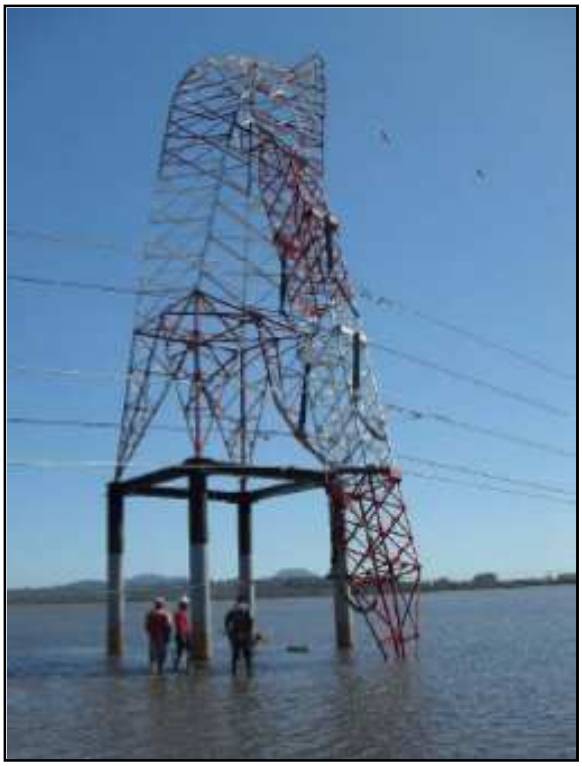
Figure 60: Structural damage to high voltage transmission tower located in river crossing in 2010 Chile earthquake. This limited electricity availability while temporary towers were installed (Technical Council on Lifeline Earthquake Engineering - TCLEE)

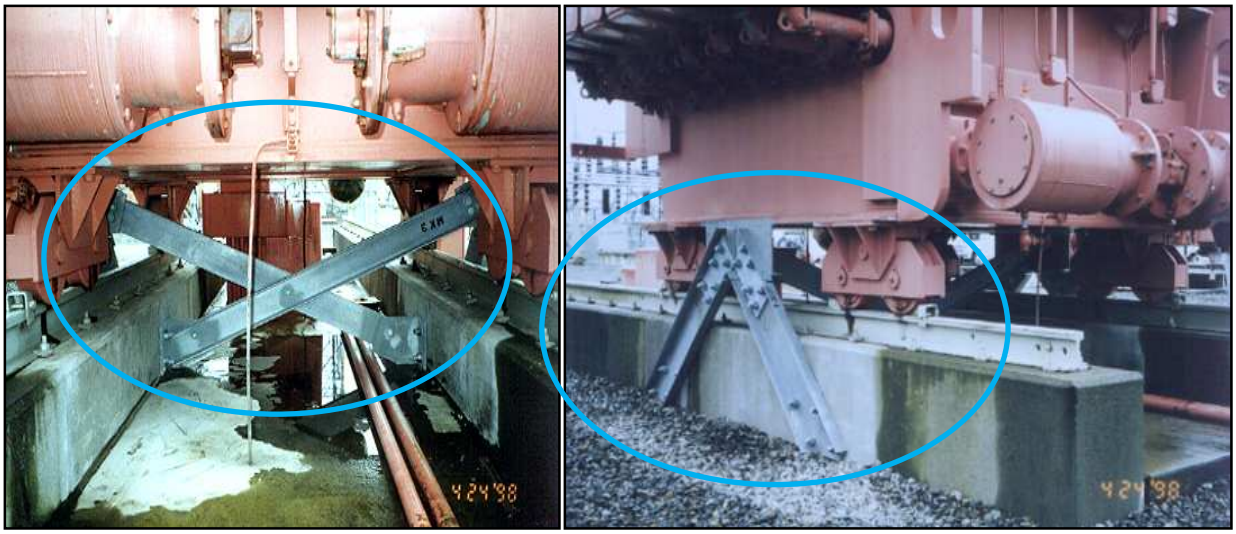
Figures 66 and 67: Left photo shows the front view of an existing transformer with seismic anchorage including steel cross bracing as mitigation. The right photo shows the side view of the same existing transformer with diagonal bracing. (Photos: Leon Kempner)
