40 years of experience with the use of EPS Geofom blocks in road construction

Roald Aabøe, Head of Geotechnical Section

The Norwegian Public Roads Administration, Directorate of Public Roads, roalda@vegvesen.no

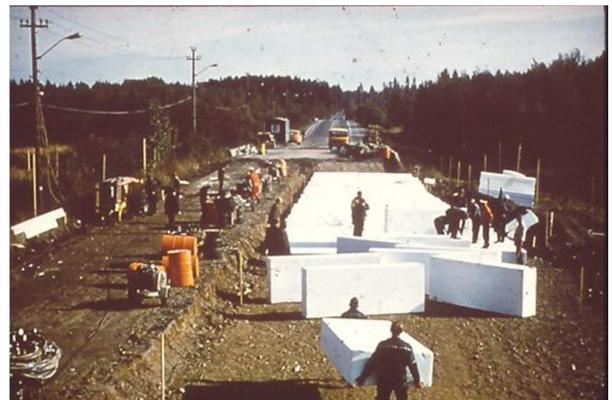
Figure 1. EPS used as lightweight fill material.

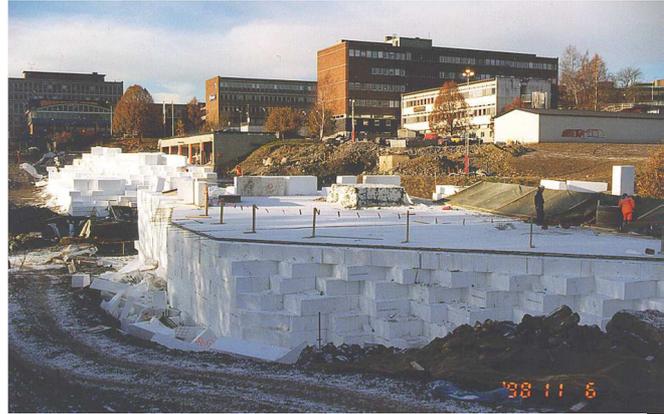
Figure 2. An EPS embankment for a city tramline in Oslo with vertical walls as an alternative to a bridge.

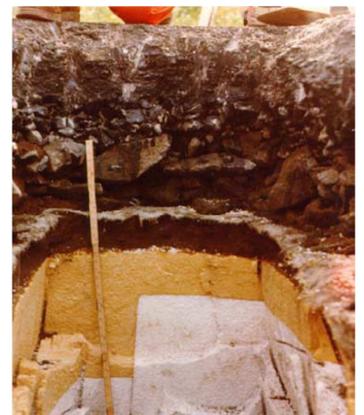
Figure 3. Excavation of the first EPS embankment at Flom bridge (EPS and polyurethane as protective layer).

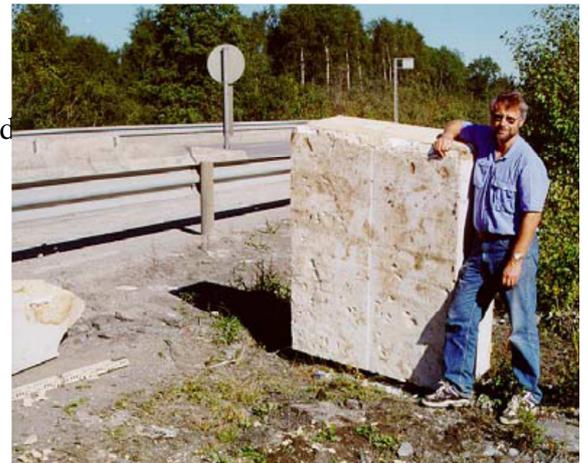
Figure 4. Excavation of a 24 years old EPS block from the first EPS embankment at Flom bridge.

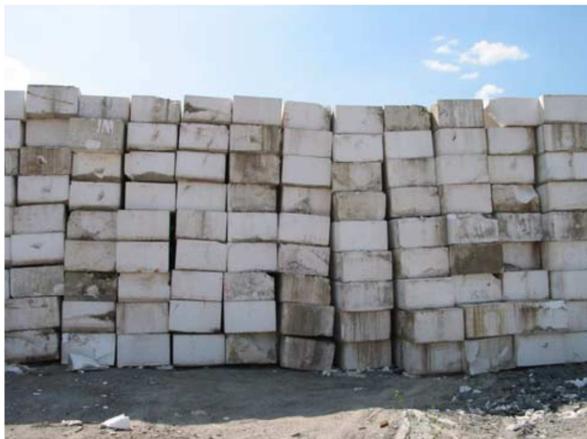
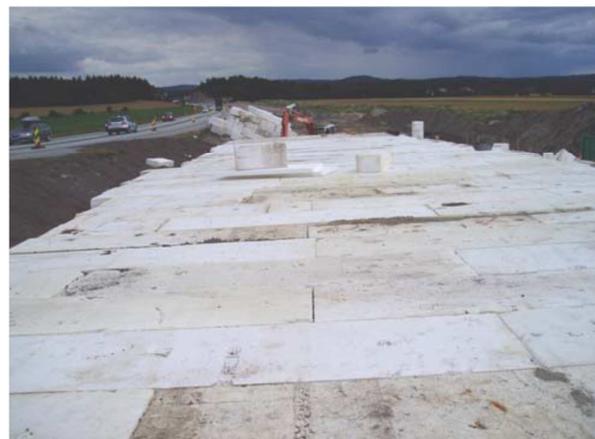
Figure 7 Reuse of EPS blocks from Løkkeberg Bridge

In 2006 two embankments on Euroroad 6 in the southern part of Norway (Løkkeberg Bridge and Hjelmungen Bridge) have been removed partly due to widening but also due to changes in the alignment of E6. These blocks have also been examined and checked as part of the monitoring programme and it was decided to reuse more than 5000 m³ EPS blocks on other EPS embankments connected to the E6 project. Again the results 17 years after the blocks were placed are well above that of a normal EPS quality (average value of $\sigma = 104.6$ kPa for 20 kg/m^3 material).

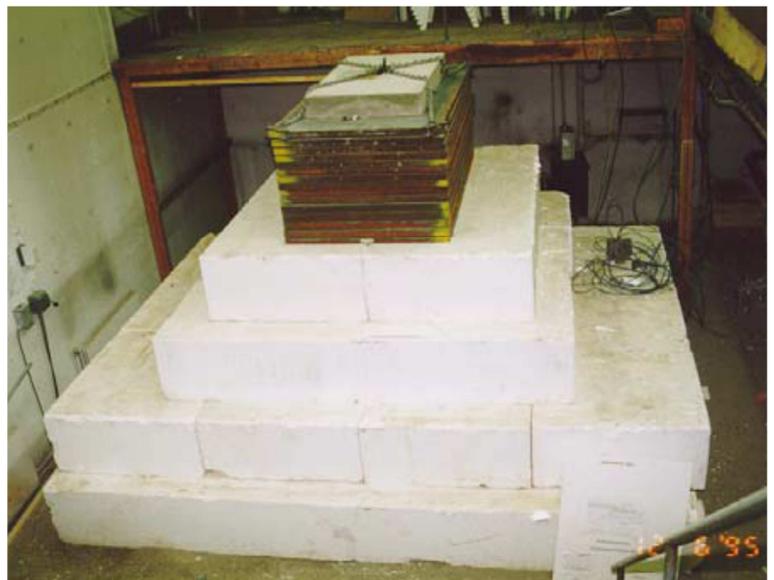
Figure 9. EPS test embankment at the Norwegian Road Research Laboratory.

In a laboratory test at the Norwegian Road Research Laboratory (now the Traffic Safety, Environment and Road Technology Department) a test embankment of height 2 m with normal size blocks and a compressive strength $\sigma = 100 \text{ kPa}$ was loaded to a value of $q_{dw} = 52.5 \text{ kPa}$ and the resulting deformations observed over a period of 3 years. The results are shown in figure 10

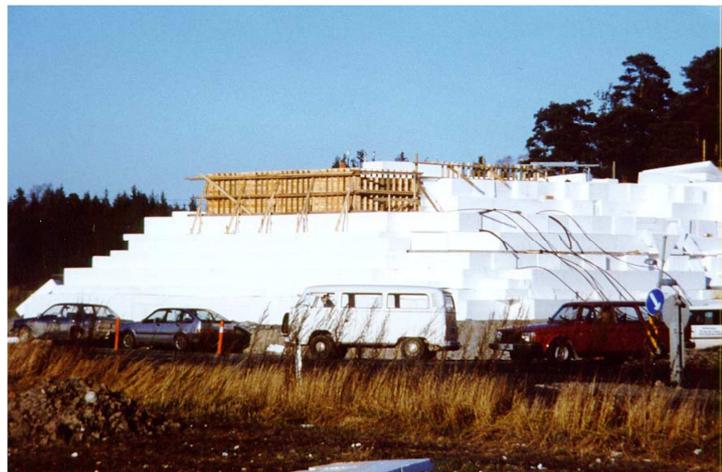
Figure 11. Construction of one abutment on the EPS embankments at Løkkeberg Bridge.

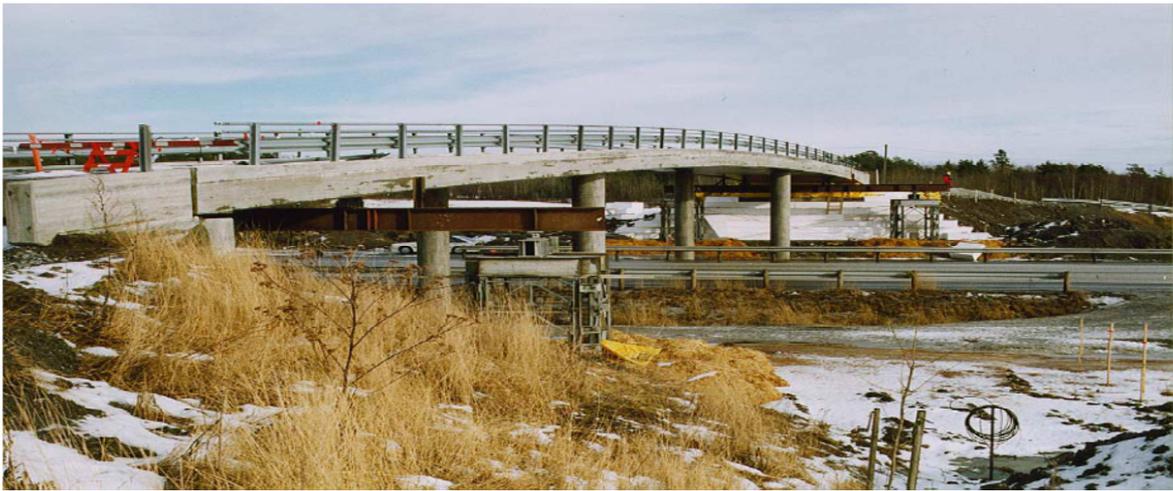
Figure 19. Temporary support of abutments at Hjelmungen

Repair works were initiated in December 1995 and completed in the spring of 1996. One abutment was treated at a time while the bridge deck was provided with a temporary support as shown in figure 19. Thickness and densities of the original fill materials were recorded as they were removed in order to have accurate data for control of load and settlement calculations. After removing the old abutments, the concrete piles were inspected regarding possible damage before being cut at ground level. No pile damage was observed. Construction of the EPS embankments could then start. In this case three different types of EPS were utilized. In the zone directly beneath the bridge abutment, as indicated by the trapezoidal shaped lines in figure 19, a material quality of $\sigma = 235$ kPa was specified for the first three block layers beneath the bottom slab of the abutment. Further down a material quality of $\sigma = 180$ kPa was specified within the indicated zone.

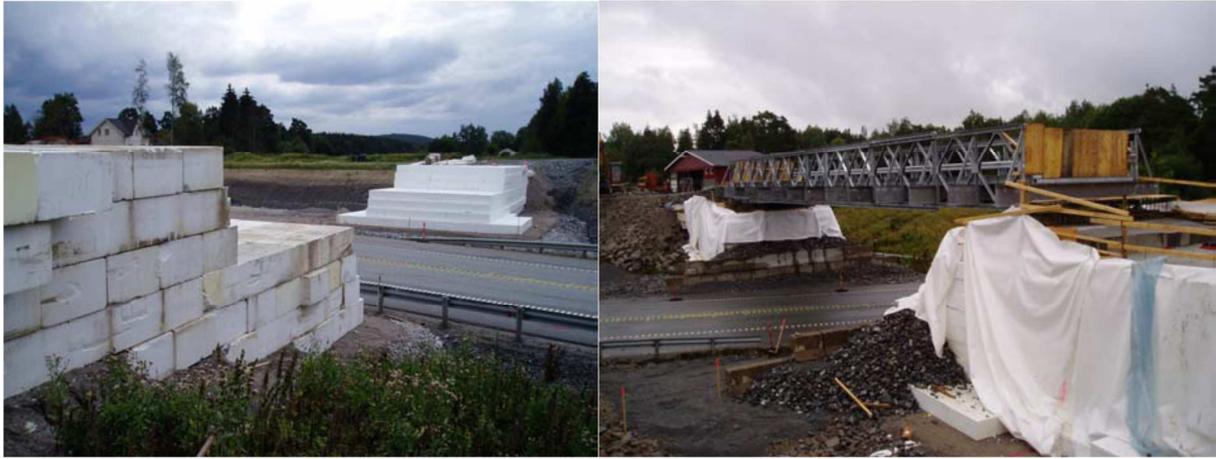
Figure 21. Grimsøyvegen Bridge

The Grimsøyvegen Bridge is a single lane temporary steel bridge with a single span of 30 m crossing Eutroroad E6. The bridge was built in order to temporarily (3 months) replace the permanent bridge at the site which had to be extended with a new span. The EPS design solution with bridge abutments directly on top of the EPS embankments (height 4.5) on both sides was used as an alternative to placing the bridge abutments on piled foundations. Due to low bearing capacity and expected large settlements, lightweight fill materials (EPS) were necessary in the embankments adjoining the bridge. The EPS embankment was partly built up with reused EPS blocks from the Løkkeberg Bridge.
