Construction and Long-Term Performance of Transportation Infrastructure Constructed Using EPS Geofoam on Soft Soil Sites in Salt Lake Valley, Utah

Bartlett, Steven¹, Negussey, Dawit², Farnsworth, Clifton³, Stuedlein, Armin⁴

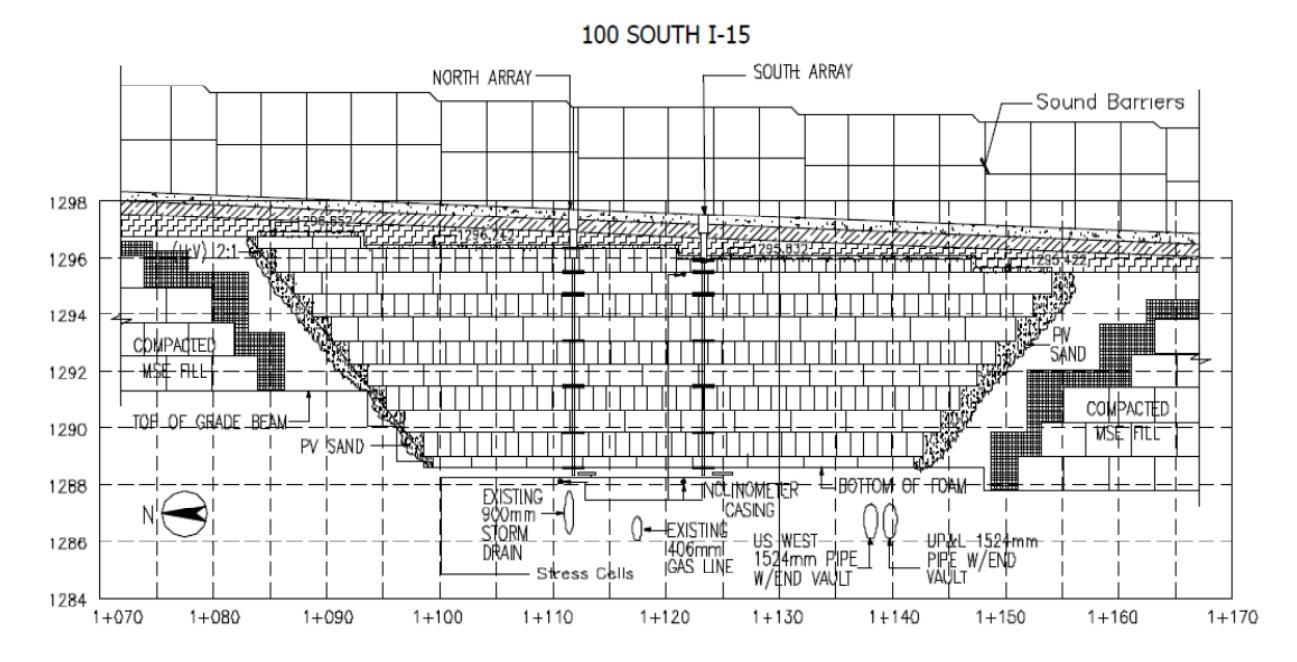
Figure 1 Profile view of the EPS embankment and instrumentation at 100 South Street, Salt Lake City, Utah, I-15 Reconstruction Project (Negussey and Stuedlein, 2003).

The I-15 Reconstruction at 100 South Street required raising and widening of the existing embankment to the limits of the right-of-way. The geofoam fills in both the north and southbound directions were placed over a 406-mm high-pressure natural gas line and other buried utilities (Figures 1 and 2). The southbound portion of this embankment employed approximately 3,400 m³ of EPS 20, and the height of the embankment decreased southward to conform to the roadway elevation. The embankment height (not including the pavement thickness) decreased from 8.1 to 6.9 meters, corresponding to 10 to 8.5 layers of geofoam blocks, respectively (Figure 1). The geofoam embankment transitions to two-stage MSE walls on both the north and south sides. In this area, the top part of the existing embankment was sub excavated and replaced with scoria fill to raise the roadway grade within the utility corridor without causing primary consolidation in the underlying, compressible, foundation soils.

The instrumentation installed at this location consisted of: (1) basal vibrating wire (VW) total earth pressure cells placed in sand underneath the EPS, (2) horizontal inclinometers (one placed near the base and one near the top of embankment) and (3) two magnet extensometer placed within the geofoam fill (Figures 1 and 2) (Negussey and Stuedlein, 2003). The magnet plates for the extensometers were placed at EPS layers 0, 1.5, 3.5, 5.5, 7.5, 8.5 and 9.5 at the northern (i.e., left) location and at layers 0, 1.5, 3.5, 5.5, 7.5, 8.5, and 9 at the southern (i.e., right) location (Figure 1). All extensometer measurements were referenced to their respective base plate underlying the geofoam fill (and not the top of the riser pipe) hence, these data represent deformations of the geofoam fill with time and do not include any settlement of the foundation soils.

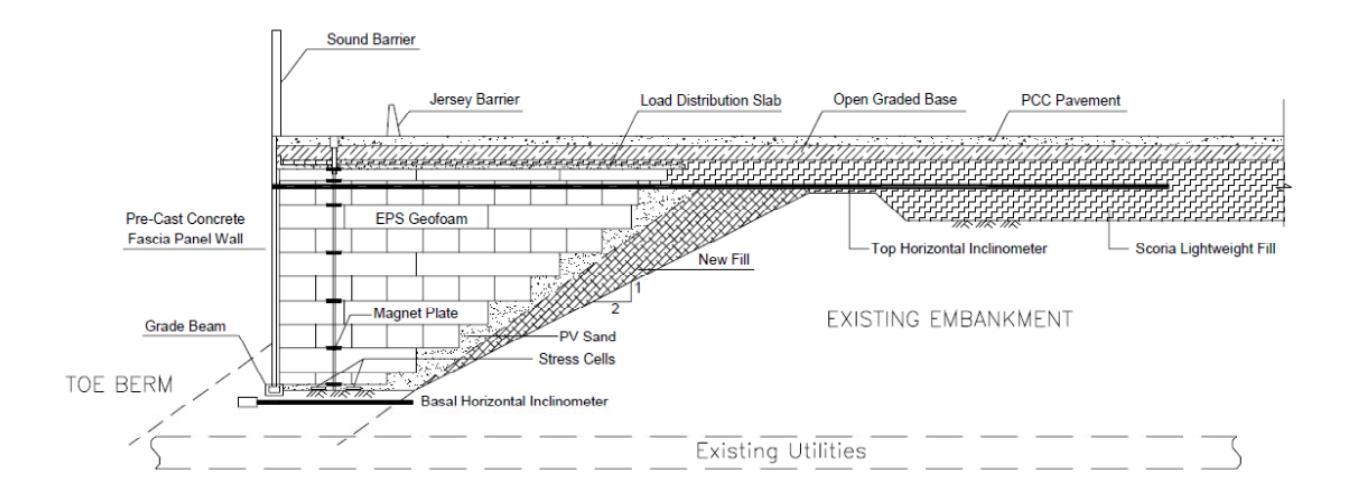
Figure 2 Cross section view of the EPS embankment and instrumentation at 100 South Street, Salt Lake City, Utah, I-15 Reconstruction Project (Negussey and Stuedlein, 2003).

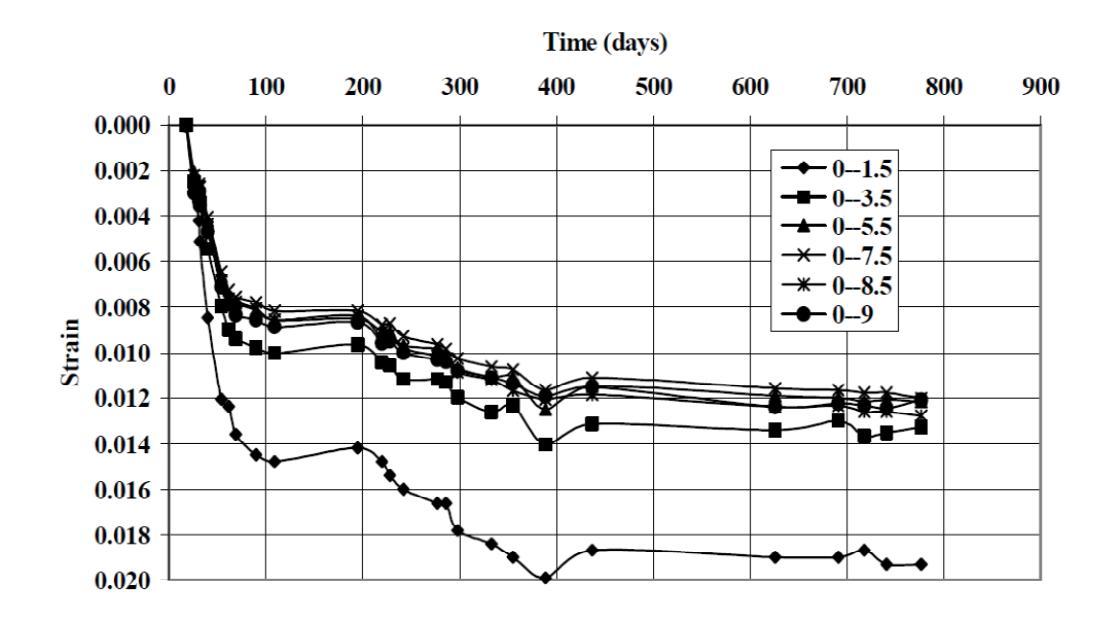
Figure 3 Construction and post construction strain in EPS measured in southern magnet extensometer, I-15 Reconstruction Project (Negussey and Stuedlein, 2003).

Figure 3 shows the construction and postconstruction strain time history of the southern location as calculated from the magnet extensioneter observations. The basal layers (0 to 1.5 m) underwent 1.8 percent vertical strain by end of construction. The total strain of the EPS

embankment (0 to 9 m) was about 1 percent at end of construction at this same location (Figure 3). Figure 4 shows the construction and postconstruction strain of the entire embankment (0 to 9 m). The vertical strain at the southern location is about 1.5 percent after 10 years of monitoring and is projected to be about 1.7 percent creep strain after 50 years.

The postconstruction settlement trend of Figure 4 is consistent with the limit 2 percent global strain in 50 years assumed in the I-15 design. Figure 3 shows that the lowest geofoam interval experienced more vertical strain when compared with the relatively uniform strain that occurred

in the overlying layers. It should be noted that the foundation footing for the adjacent panel wall laterally restrains the lowest geofoam layer. As a result, the mean normal stress in the lower geofoam layers is probably somewhat higher than the corresponding states of stress in the overlying geofoam layers. This effect would produce more vertical strain and also suggests that the influence of confinement may need to be considered in future design evaluations, as appropriate.

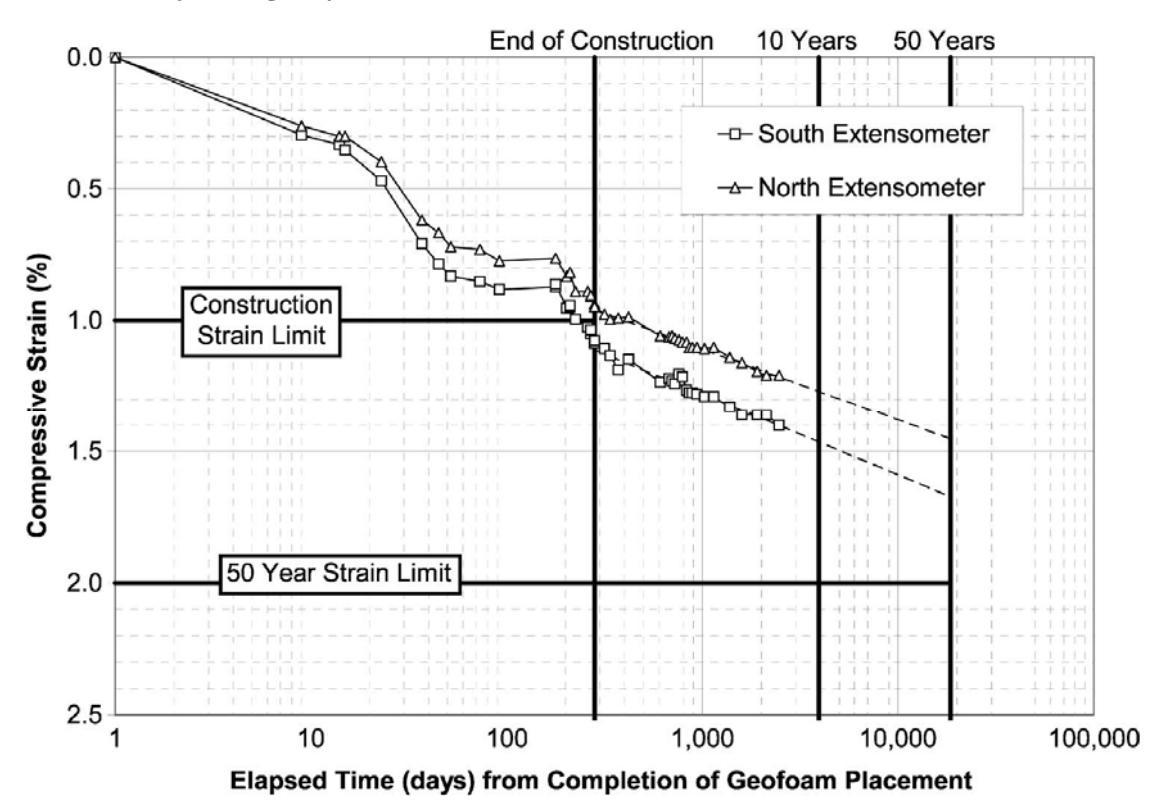
Figure 4 Construction and post construction global strain of entire thickness of EPS embankment, I-15 Reconstruction Project (Farnsworth et al., 2008).

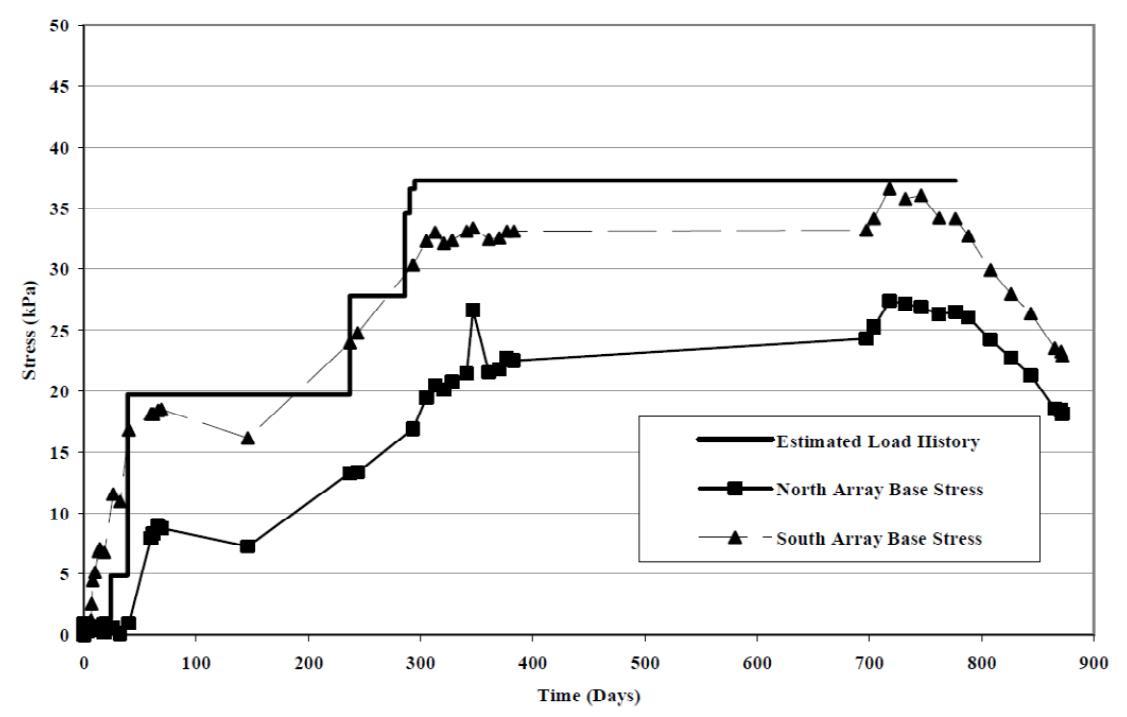
Figure 5 Loading history and total pressure cell measurements at the 100 South Street site (Negussey and Stuedlein, 2003).

The loading history and total stress observations from the VW pressure cells indicate that the measured internal vertical stress levels are in reasonable agreement with the design criterion (Figure 5). (The factored working stress design criterion of about 30 kPa for EPS 20 was selected during the design phase to limit the construction compression to 1 percent vertical strain at the end of construction period and to 2 percent compressional strain over a 50 year period.) Thus, we conclude that this design criterion has been validated given the strain measurements presented in Figure 4. However, we note that the 1 percent vertical strain measured during the construction period (Figure 4) does not entirely consist of elastic compression of the EPS block. Undoubtedly, some of this vertical strain has also resulted from small gap closure of the slightly curved block that occurred upon initial loading of the geofoam embankment. Complete seating and gap closure probably did not occur in the geofoam embankment until the final load was in place, which consisted of the combined weights of the load distribution slab (LDS), roadway base materials and pavement. Undoubtedly, a portion of the initial 1 percent strain during loading can be attributed to seating and gap closure (Negussey et al. 2001). This issue and the numerical modeling of these effects and the compressional behavior of the geofoam arrays are further discussed in Newman et al. (2010).

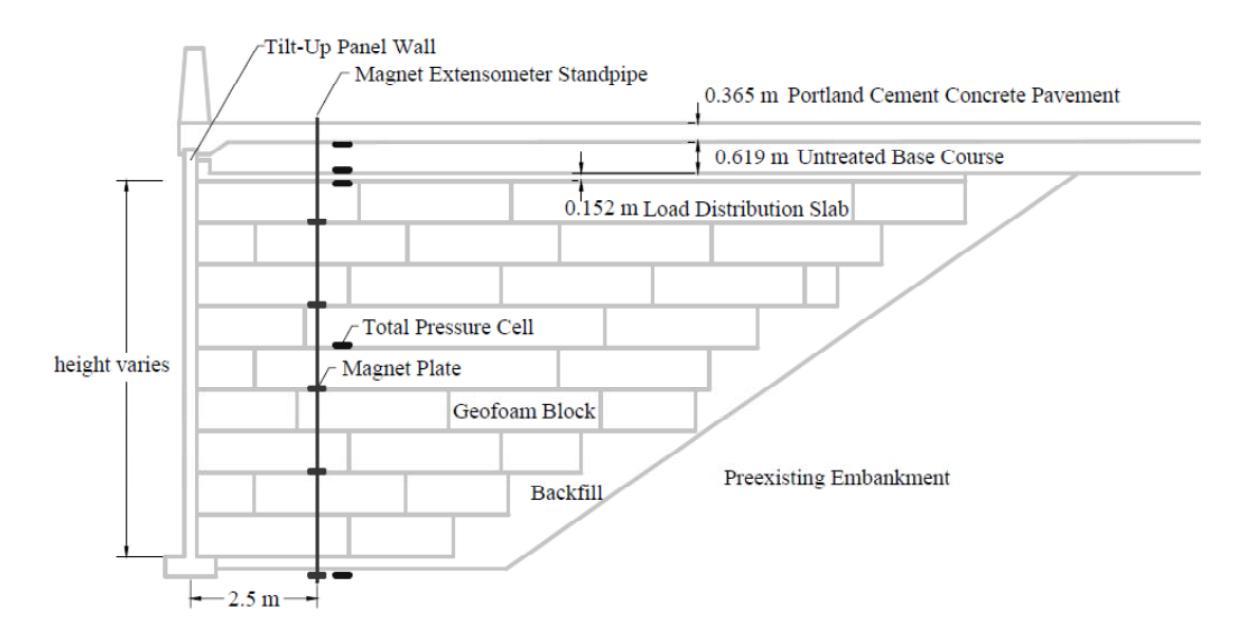
Figure 6 Typical instrumentation layout used at the 3300 South Street site (Newman et al. 2010).

The 3300 South Street geofoam array consisted of geotechnical instrumentation and highprecision digital level elevation surveys to measure the vertical compression and stresses that developed within the geofoam / foundation soil / pavement system. Two instrument arrays were installed at this site at mainline stationing 25+347 m, and stationing 25+315 m, respectively. At stationing 25+315, nine levels of geofoam were placed, making the total height of the geofoam approximately 7.3 m. Eight levels of geofoam were placed at stationing 25+347, making the total height of geofoam approximately 6.6 m. Figure 6 is a typical cross-section showing the instrument layout used at the 3300 South Street arrays.

Each array consisted of magnet extensometers, VW total pressure cells and survey points. Magnetic extensometers were used to monitor settlements of the foundation soil and deformations of the geofoam at various height intervals. Each extensometer stand-pipe was placed 2.4 m from the wall face and the 1.25-cm thick base plates were supported in the sand leveling course below the first layer of geofoam. Vibrating wire total pressure cells were installed in the base sand below the first level of geofoam block, approximately midway in the geofoam fill, at the top of the geofoam fill, immediately above the load distribution slab and immediately below the concrete pavement (Figure 6).

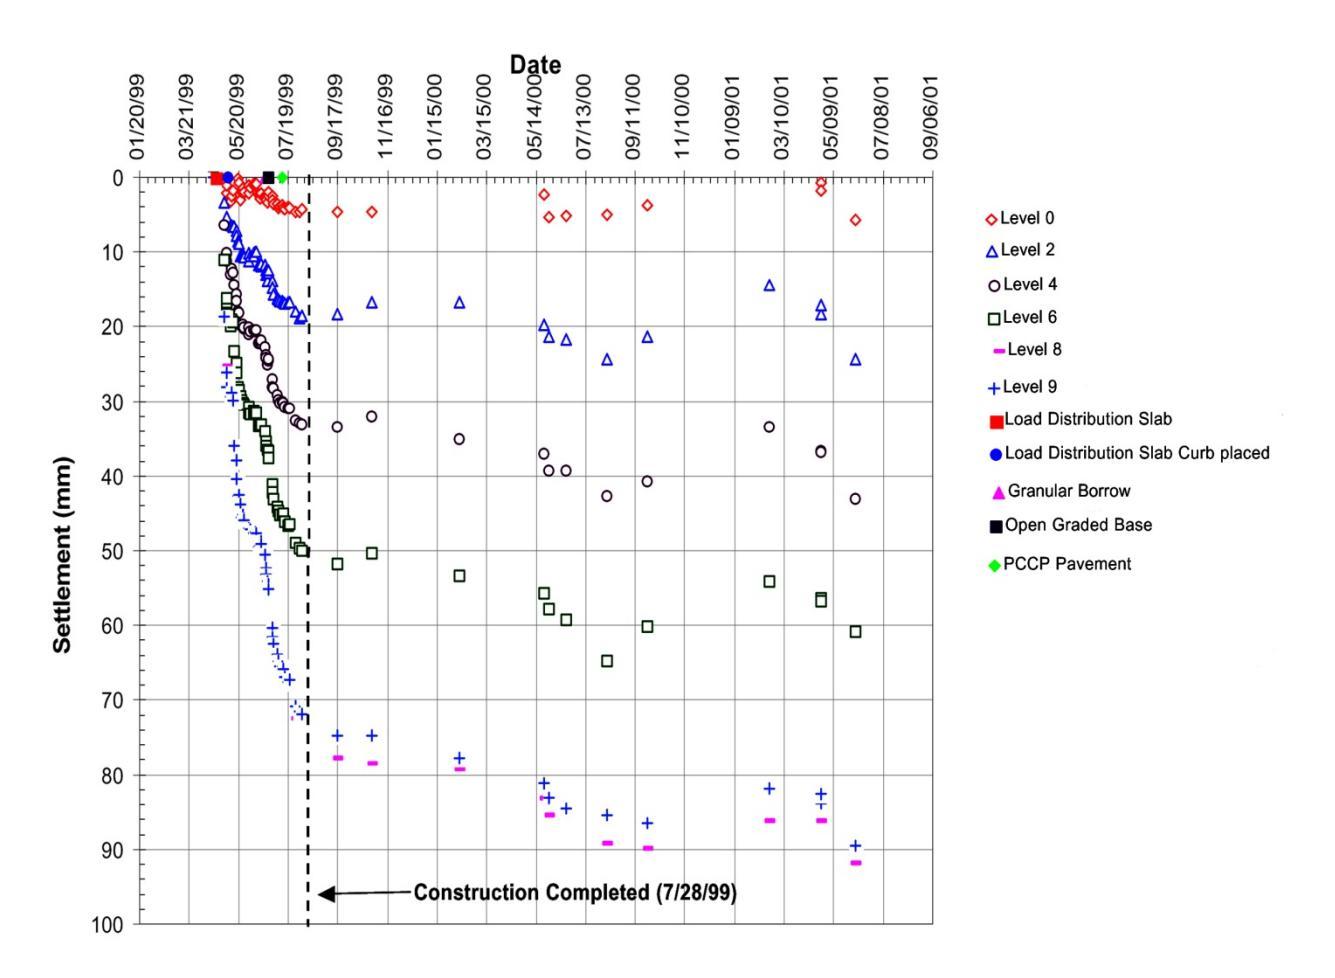
Figure 7 Vertical displacement versus time for geofoam array at station 25+347, 3300 South Street, I-15 Reconstruction Project (Bartlett et al., 2001).

Approximately 70 mm of construction related compression was measured within the geofoam mass during construction of the embankment at station 25+315 (Figure 7), which corresponds to about 1 percent global vertical strain within the entire EPS mass. Similar strains were measured at stationing 25+347 (Bartlett et al., 2001). The compression was a result of elastic compression of the geofoam, and seating and gap closure resulting from the placement of the load distribution slab, untreated base course and Portland cement concrete pavement. Unfortunately, the 1 percent vertical strain that occurred during load placement was sufficiently large to damage some of the fixed connections that secured the tilt-up panel wall to the load distribution slab (LDS). The damaged connections were subsequently repaired by drilling through the face of the panel wall at the elevation of the LDS and setting epoxy anchored dowels into the LDS.

These vertical stress measurements presented in Figure 8 indicate that the stress through most of the geofoam upper part mass is about 25 to 30 kPa, which is approximately equal to the working stress design criterion of 30 kPa. The creep displacement has been about 20 mm (Figure 7), which corresponds to 0.27 percent over a two-year period and is consistent with the rate measured at 100 South Street for this same post construction period (Figure 4). Subsequent monitoring of the magnet extensometer at this location was terminated due to safety concerns as the interstate became operational.

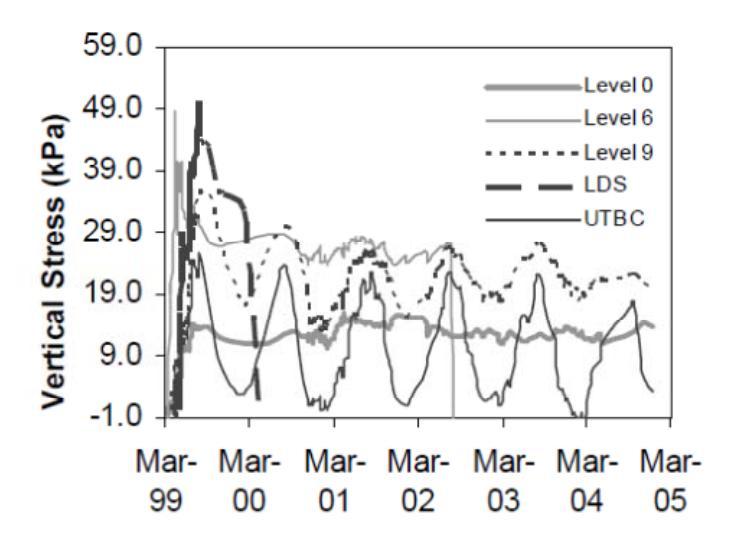
Figure 8 Measured vertical stresses within the embankment at various levels for station 25+347, 3300 South Street, I-15 Reconstruction Project (Newman et al. 2010).

The vertical stress histories measured by the VW pressure cells are shown in Figure 8. The pressure cells located near the roadway surface in the untreated base course (UTBC) and just underneath the LDS show a strong seasonal cycling of vertical stress. This cycling is attributed to thermal expansion and contraction of the geofoam, LDS and/or PCCP, and potential interaction of the LDS and the tilt-up panel wall at their connection (Figure 6). Potential thermal loading/unloading was most pronounced for pressure cells placed at the top or above cells placed just above and below the LDS (Figure 8). In addition because the granular borrow and road base were compacted against the back of the adjacent panel wall, this can also cause vertical stress transfer due frictional stress that exists along this contact surface. Also, although not intended by the design, the top of the panel wall may be interacting with the cantilevered pavement slab. (The design typical drawing required a gap to be constructed between the pavement slab and the top of the tilt-up panel wall and the overlying pavement system; however, there probably is some interaction that is ongoing, as suggested by the cycling of the VW pressure cell measurements (Newman et al., 2010).

The pressure cells located just above the LDS recorded positive values for several months and then began to record slightly negative values (Figure 8). This behavior may be due to malfunctioning of the pressure cells, but it may also represent complex interactions and potential unloading that is occurring near the connection with the tilt-up panel wall. The LDS has a somewhat rigid connection with this wall, thus any expansion and contraction of the geofoam mass or overlying pavement section could transfer vertical loads to the wall and subsequently change the vertical pressure recorded near the LDS.

The measured stresses at locations deeper into the geofoam mass show less thermal cycling and are easier to interpret (Figure 8). To verify these measurements, simple one-dimensional calculations and two-dimension numerical modeling predict that the vertical stress should be about 27 kPa in the top of the geofoam at level 9 and about 25 kPa at level 6 (Figure 9) (Newman et al., 2010). These VW pressure cell measurements were model with a 2D finite difference program using a bilinear elastic constitutive relation for the EPS (Figure 10) with a Poisson's ratio of 0.103 (Newman et al., 2010). These calculations neglected any thermal effects (and hence could not predict the complex interaction with the LDS, which has been labeled as a "suspect data point" in Figure 9. For VW pressure cell measurement with the EPS, the average stress level at level 9 is about 24 kPa, with a cycling variation that varies between about 19 to 29 kPa (Figure 8). The measured vertical stress at level 6 varied from about 27 to 30 kPa, until this pressure cell went out of service (Figure 8).

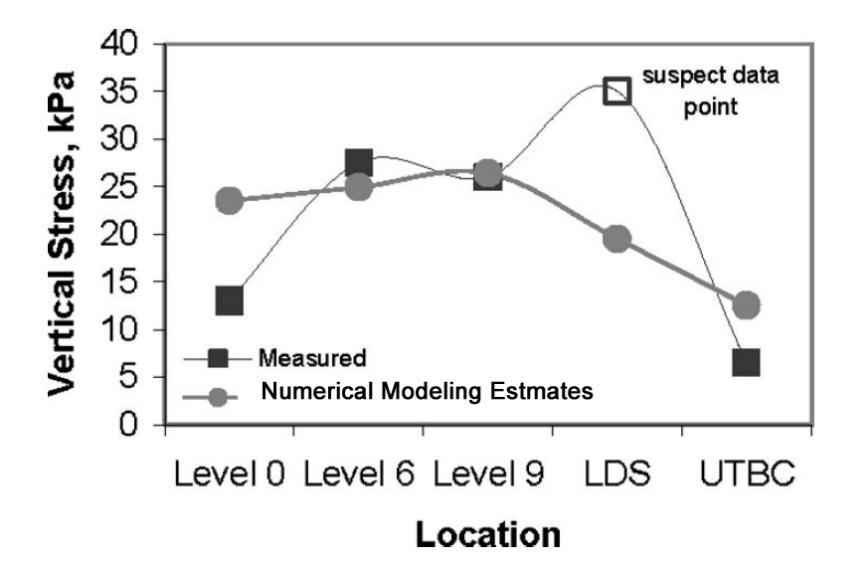
Figure 9 Measured and calculated vertical stresses within the embankment at various levels for station 25+347, 3300 South Street, I-15 Reconstruction Project (Newman et al., 2010).

We note that the vertical stress measured in the base sand of about 15 kPa is less than the predicted values from the numerical modeling (Figure 9). Based on this analysis, we believe that the base sand (level 0) and overlying geofoam block have partially lost contact pressure in some manner leading to an incomplete transfer of vertical stress to the VW cell positioned in the base sand. This led us to the conclusion that perhaps some other phenomenon, not accounted for in the

numerical model, has affected the measurement of vertical stress in the base sand. For example, it is possible that the curved contact surface of the untrimmed geofoam blocks are creating a partial arch which, in turn, is not allowing for a uniform contact surface and equal distribution of vertical stress in the underlying sand at this location (Newman et al., 2010).

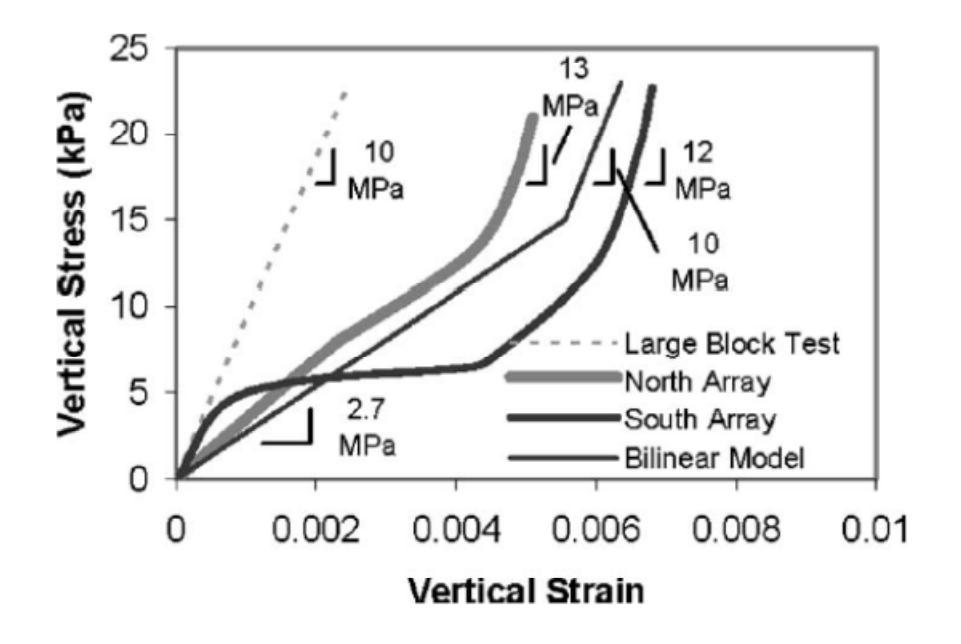
Figure 10. Bilinear constitutive relation used to model EPS embankment for the I-15 Reconstruction Project (Newman et al., 2010).

Because of the complexity of the stresses that developed at this location, 2D numerical modeling was used to interpret and verify the field measurements in the same manner as was done for other arrays (Newman et al., 2010) using the bi-linear constitutive relationship shown in Figure 10 and a Poisson's ratio of 0.103. Figure 14 shows that the modeling approach reasonably estimates the measured stresses at and near the bridge abutment and that the measured vertical stress within the EPS is approximately 25 kPa at this location.

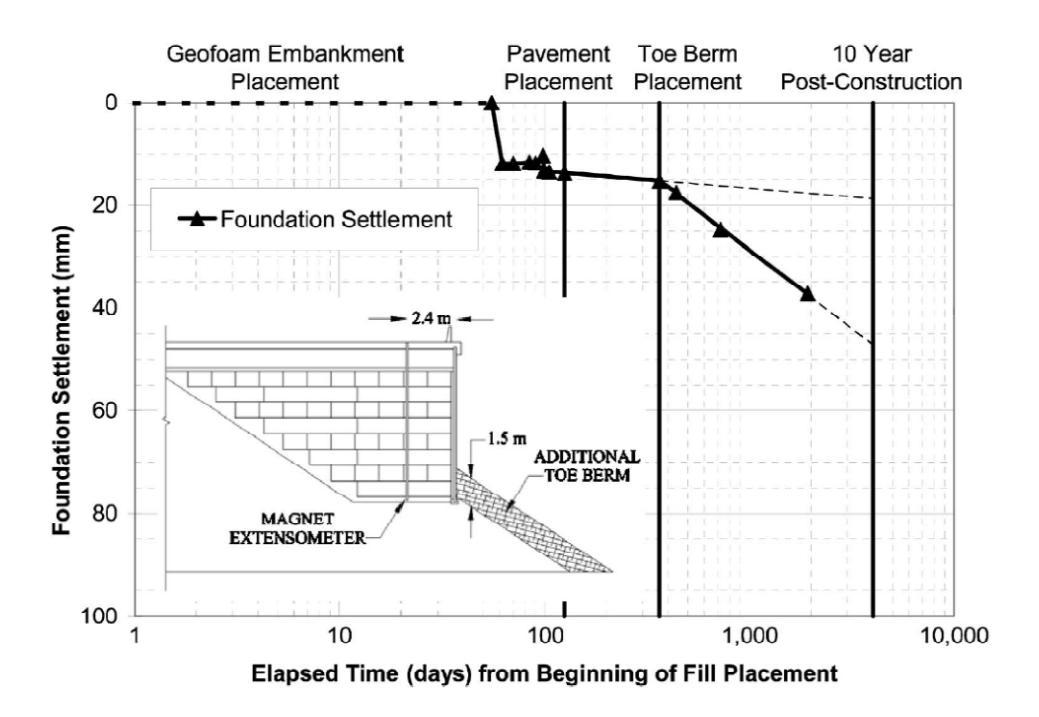
Figure 11 Foundation settlement versus time for the geofoam embankment at 3300 South Street, I-15 Reconstruction Project (Farnsworth et al., 2008).

The long-term consolidation settlement of the foundation soils underlying the 3300 South Street embankment is continuing (Figure 11). This data show about 40 mm of post construction foundation settlement has occurred in a 5.5-year post construction period. About 15 mm of this settlement occurred from the placement of the fill and pavement materials atop the EPS. The additional 25 mm of settlement occurred due to the placement of the toe berm, which was constructed at the base of the wall. The projected foundation settlement is about 50 mm in a 10-year post construction period. These data show that the usage of geofoam embankment at this location has met the I-15 Reconstruction period (Farnsworth et al., 2008), despite the additional load produced by the toe berm.

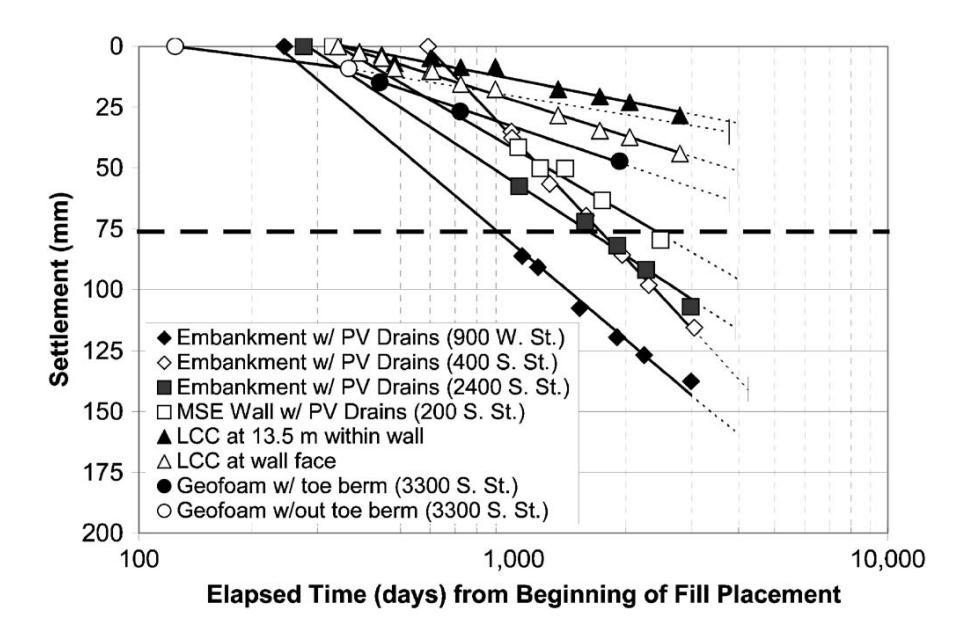
Figure 12 Rate of foundation creep extrapolated to 10 years post construction (dashed lines) compared to the design criteria of 75 mm of post construction settlement over 10 years for lime cement columns, geofoam fill, two-stage MSE wall at wall face, and large earth embankments with PV drains at full height, I-15 Reconstruction Project (Farnsworth et al., 2008).

Figure 12 presents a summary plot of postconstruction settlements measured at the various locations along the I-15 alignment and represent the various geotechnologies employed on the project (i.e., sloped earthen embankment with PV drains, MSE wall with PV drains, lime cement column (LCC) treatment of foundation soils and geofoam embankment) (Bartlett and Farnsworth, 2004; Farnsworth et al. 2008). The rate of postconstruction settlement at the 3300 South Street geofoam embankment with the placement of the 1.5-m toe berm and a projected rate had the toe berm not been placed are also shown. Figure 11 also shows the rate of secondary settlement for foundation settlements of the lime cement column (LCC) array at two locations: One set of data shows the rate of settlement at the wall face and the other shows the rate occurring 13.5 m inside the wall using horizontal inclinometer observations (Bartlett and Farnsworth, 2002). These data suggest that the LCC soil mixing technology will meet the 75 mm 10-year postconstruction settlement goal.

However, the two-stage MSE wall with PV drains installed in the foundation soils for the 200 South Street array is projected to exceed the 10-year postconstruction settlement goal at the wall face, where the most pronounced settlement is occurring (Figure 12). (Unfortunately, the horizontal inclinometer within the wall was damaged at the end of construction, thus postconstruction settlements within the wall footprint are not available.) In addition, postconstruction settlement trends at 2400 South, 900 West, and 400 South Street arrays show these large, sloped, earthen embankments have exceeded the 75 mm in 10-year postconstruction settlement goal (Figure 12). These earthen embankments were primarily constructed in areas of new alignment where preexisting embankment had not significantly preloaded the foundation

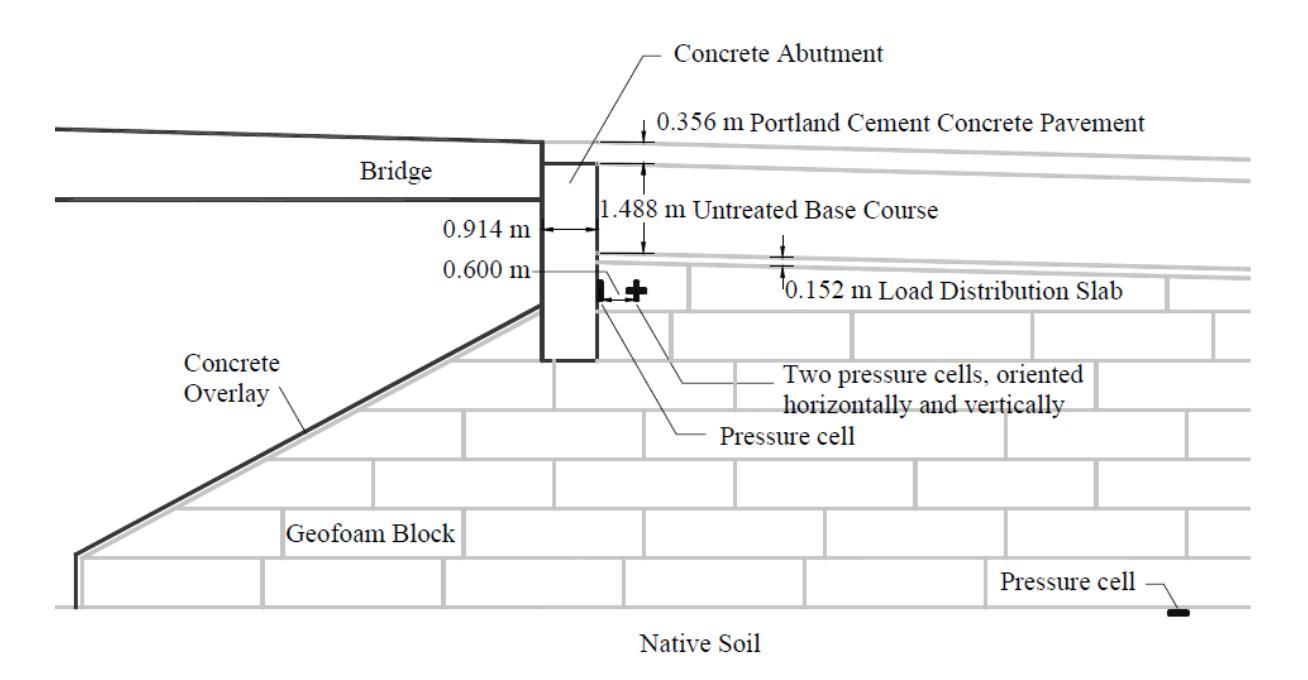
Figure 13 VW pressure cells installed adjacent to bridge abutment at State Street site, I-15 Reconstruction Project (Newman et al., 2010).

EPS was also placed at the State Street exit ramp to prevent settlement damage to buried utility lines that paralleled the interstate widening. At this location, a full-height geofoam embankment abuts against a pile-supported bridge on the west end of the State Street off ramp. Geofoam embankment supports the bridge approach slab and the adjacent pavement section. VW pressure cells were installed to monitor the stress that developed in the EPS adjacent to the bridge abutment (Figure 13).

At the bridge abutment, total pressure cells were oriented horizontally and vertically to measure the vertical and horizontal stresses that develop at the face of the concrete abutment and in the adjacent geofoam block. A VW pressure cell was cast in the face of the concrete abutment to measure horizontal stresses that developed at this contact. Two additional cells, one oriented vertically and the other oriented horizontally, were inserted in the adjacent geofoam block to measure the horizontal and vertical stresses, respectively (Figure 13). For the cell placed in the geofoam, a precision cut was made in the block by the block molder using a computerized hotwire cutter in order to produce an exact fit for the shape of the pressure cells positioned within the block. The instrumented blocks were subsequently placed within the embankment during construction.

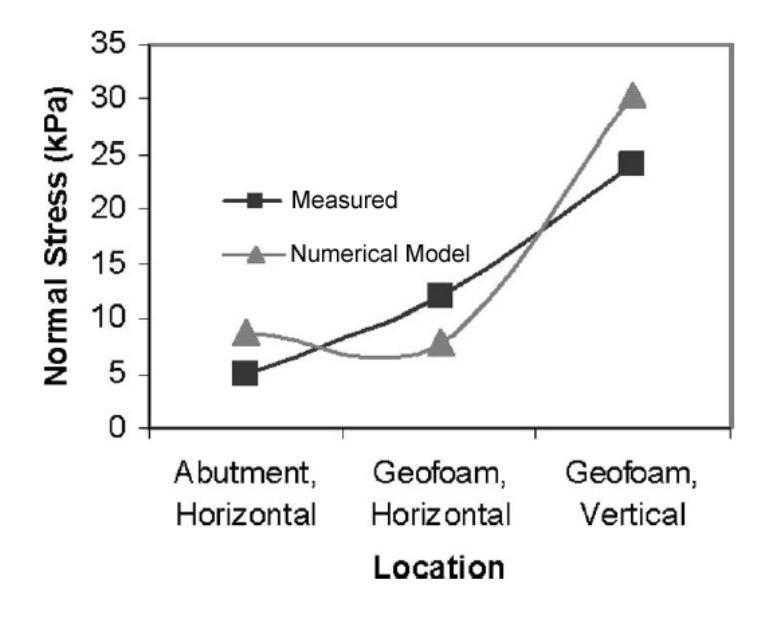
Figure 14 VW pressure cell measurements at bridge abutment at State Street site, I-15 Reconstruction Project (Newman et al., 2010).

Error! Reference source not found.14 shows the horizontal and vertical stresses measured at the abutment face and in the adjacent geofoam block. The first data point, labeled "abutment horizontal," represents the measured and predicted horizontal stresses corresponding to the pressure cell that was cast flush with the concrete abutment face. The points labeled "geofoam horizontal" and "geofoam vertical" represent the measured and predicted horizontal and vertical stresses, from a vertically and a horizontally oriented pressure cell, respectively, inserted in the adjacent geofoam block.
