#### UDOT RESEARCH & DEVELOPMENT REPORT ABSTRACT

1. Report No.	JT- <mark>XX.XX</mark>	2. Government Accession No.	3. Recipient's Catalog No.
4. Title and Subtitle Evaluation of Rapid Constru-	iction and Settlement of	5. Report Date December 2007	
Embankment Systems of S	Mbankment Systems on Soft Foundation Soils         6. Performing Organization Code		n Code

15. Supplementary Notes			
16. Abstract The I-15 Reconstruction Project in Salt Lake City, Utah required rapid embankment construction in an urban environment atop soft lacustrine soils. These soils are thick, highly compressible, have low shear strength and require significant time to complete primary consolidation settlement. Because of this, innovative embankment systems and foundation treatments were employed to complete construction within the approved budget and demanding schedule constraints. This report evaluates and compares the construction time, cost, and performance of three embankment/foundation systems used on this project: (1) one-stage MSE wall over lime cement column treated foundation, (2) expanded polystyrene (geofoam) embankment with tilt-up panel fascia walls, and (3) two-stage MSE wall with PV drain ins

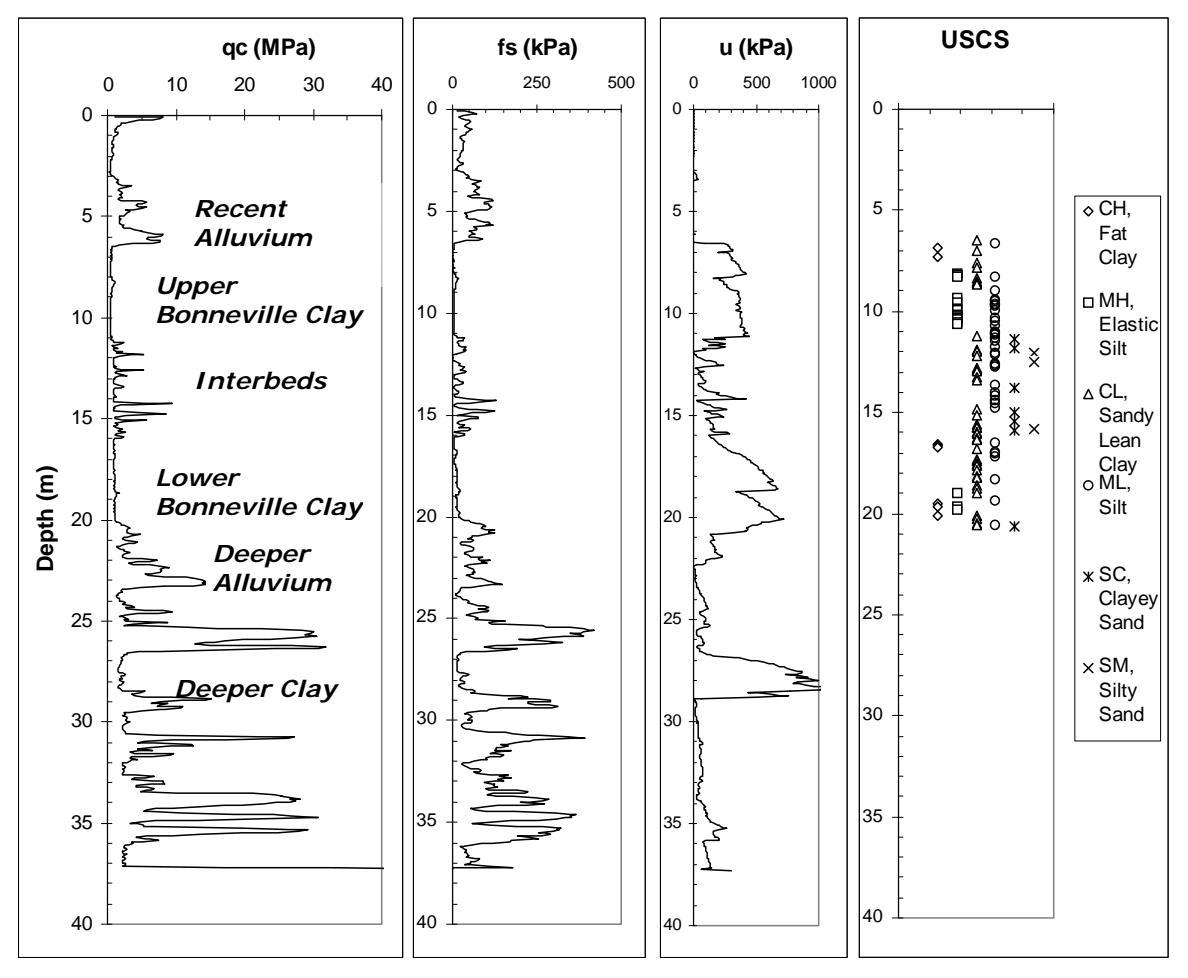
Figure 1-1. Typical cone penetrometer (CPT) log and soil descriptions for downtown segment of I-15 Reconstruction Project, Salt Lake City, Utah.

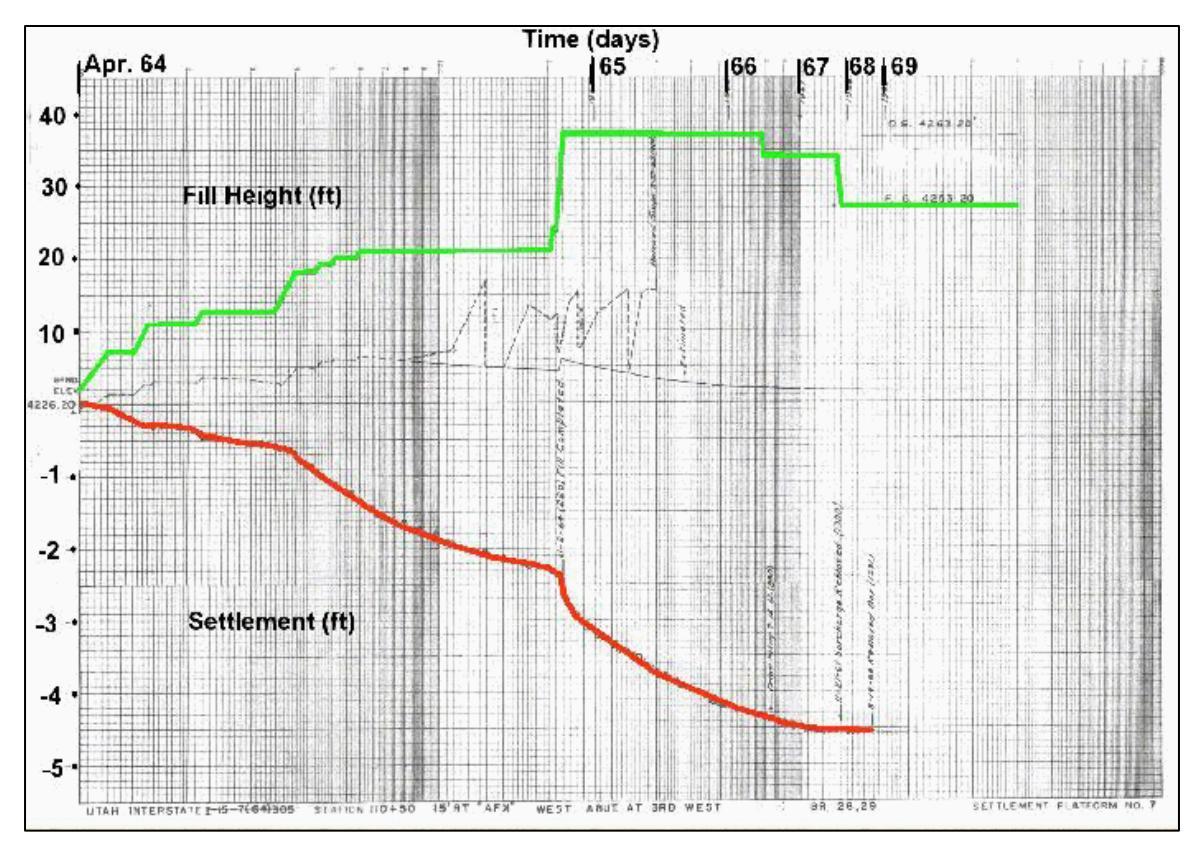
Figure 1-2. Typical settlement record from the 1960s construction of I-15 in the downtown area of Salt Lake City, Utah.

shows that fill placement was performed in multiple stages to reach the peak loading condition and then the primary settlement allowed to take place prior to removal of the surcharge. These large magnitudes of settlement and long consolidation settlement durations can be attributed directly to the soft thick compressible Lake Bonneville clay layers. In the 1960s, the bridge foundations, bridge, approaches and pavement were not placed until such settlement was essentially finished.

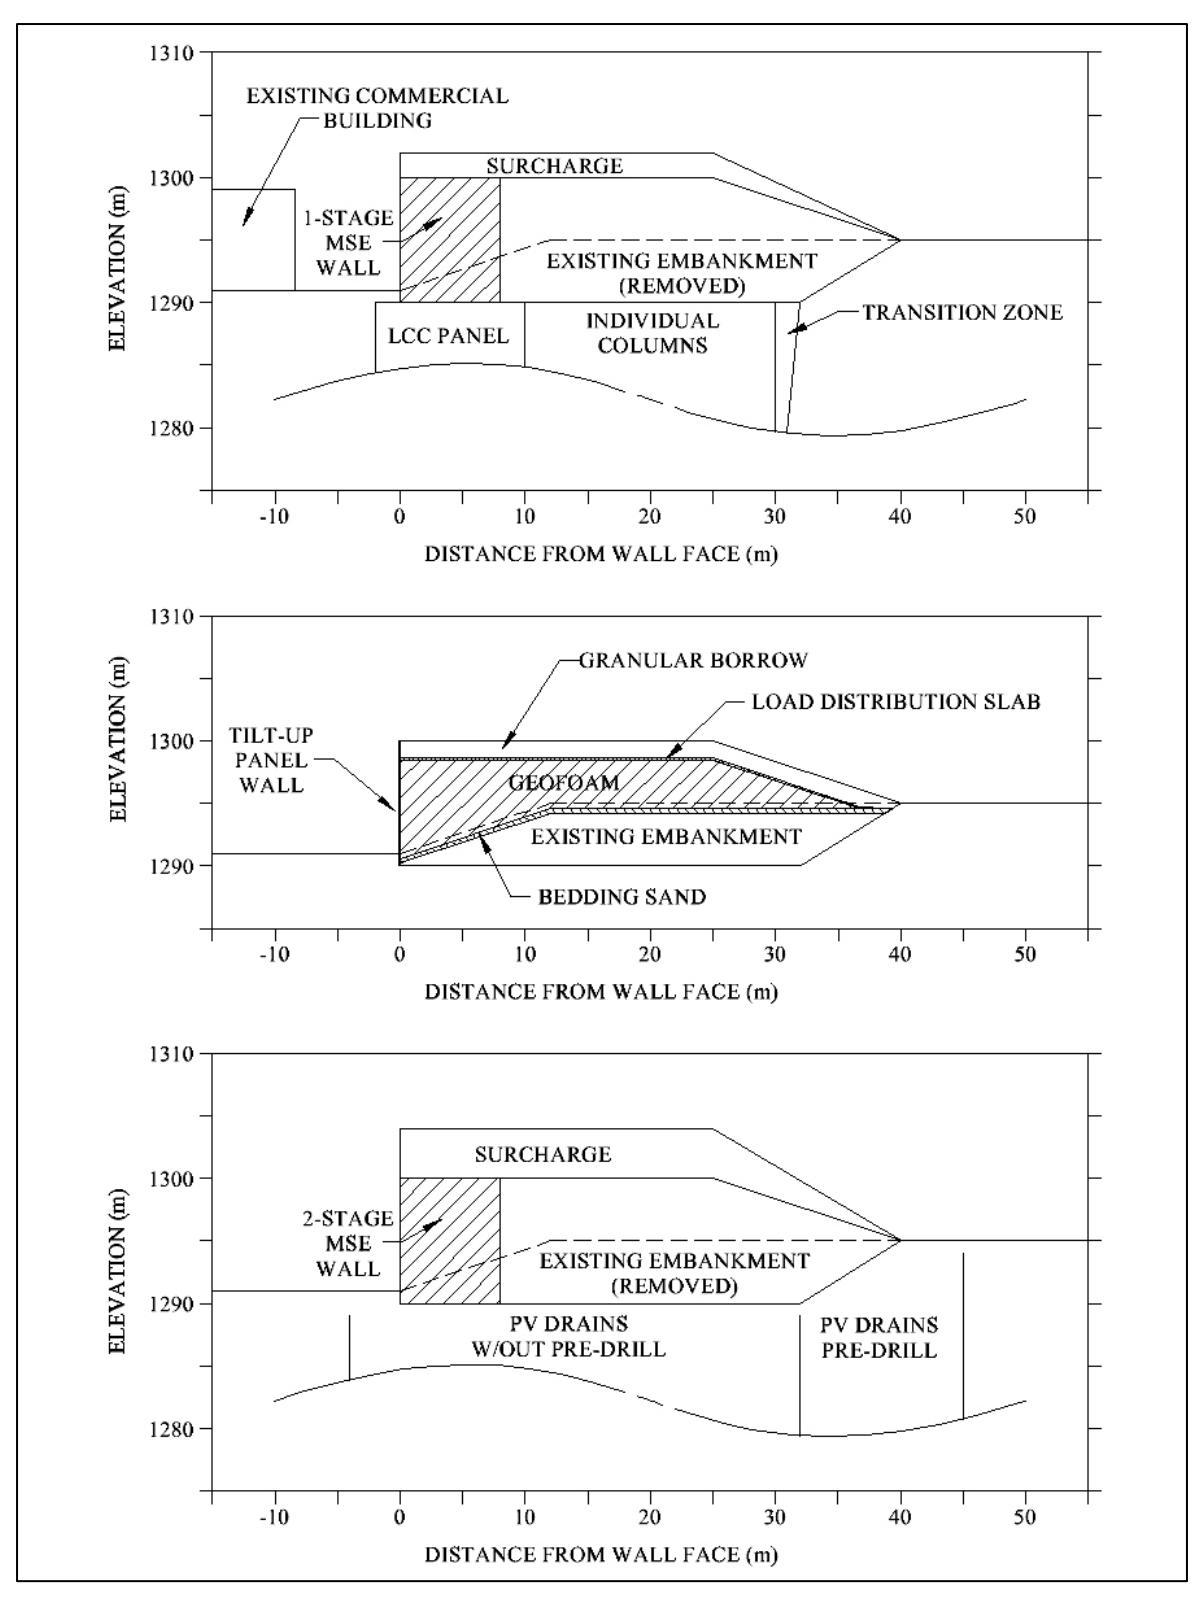
Figure 2-1. Comparative cross-sections for various geotechnologies including a) one-stage MSE wall with LCC stabilized soil, b) geofoam wall/embankment, and c) two-stage MSE wall with PV drains.

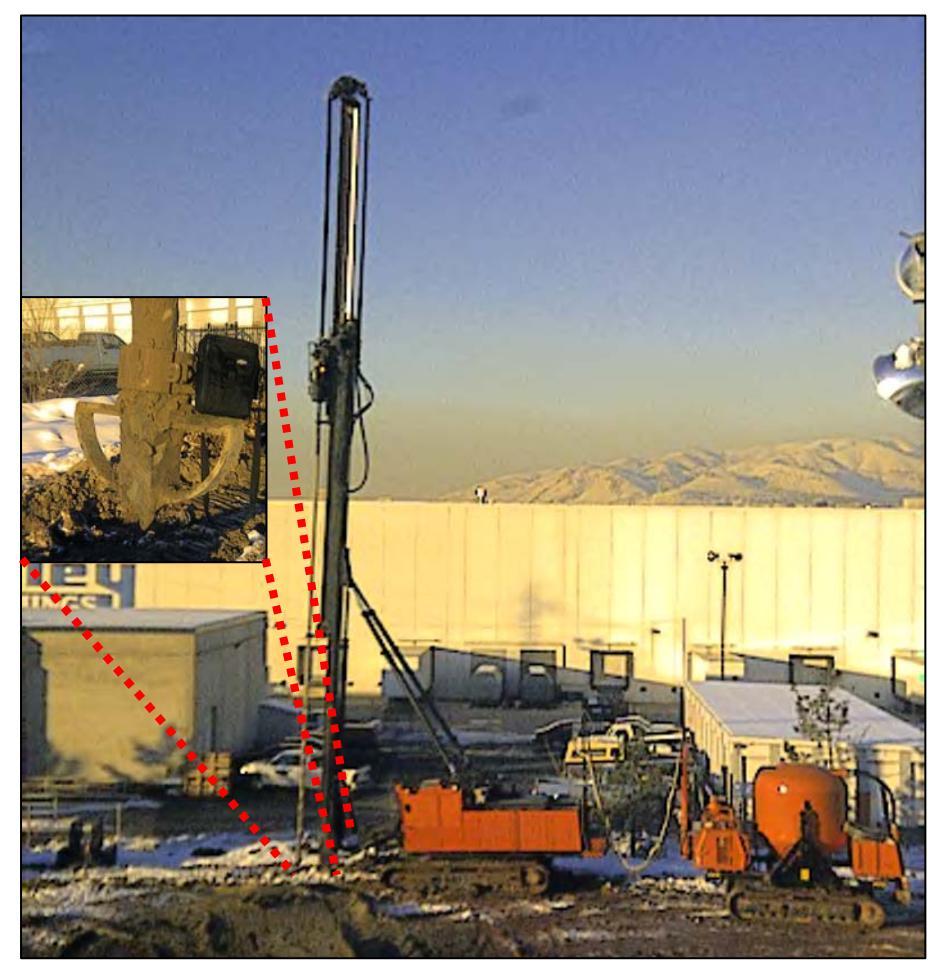
Figure 2-2. Lime cement column installation on the I-15 Reconstruction Project including inset of mixing tool.

The lime cement columns used on the I-15 Reconstruction Project were constructed with a reagent admixture of 15 percent lime / 85 percent cement and injected at a mass concentration of 125 kg/m<sup>3</sup>  $(7.8 \text{ lbs/ft}^3)$  of untreated soil. The columns were constructed by inserting a mixing tool to the target depth (Figure 2-2), and while withdrawing the tool, injecting the dry lime and cement within the soil to be mixed in-situ. For this project, the columns were installed to a depth of 20 m (65.6 ft) and were either 0.8-m (2.6 ft) or 0.6-m (2.0 ft) in diameter. The overall spacing pattern of the columns was guite complex as shown in Figure 2-3. In general the LCC spacing consisted of either 0.8-m (2.6 ft) diameter intersecting columns that created panels of reinforced soil with panels spaced 2 m (6.6 ft) apart or individual 0.6-m (2.0 ft) diameter columns spaced approximately between 1 to 2 m (3.3 to 6.6 ft) apart in either a triangular or rectangular pattern. This spacing pattern is further described in Bartlett and Farnsworth, 2002.

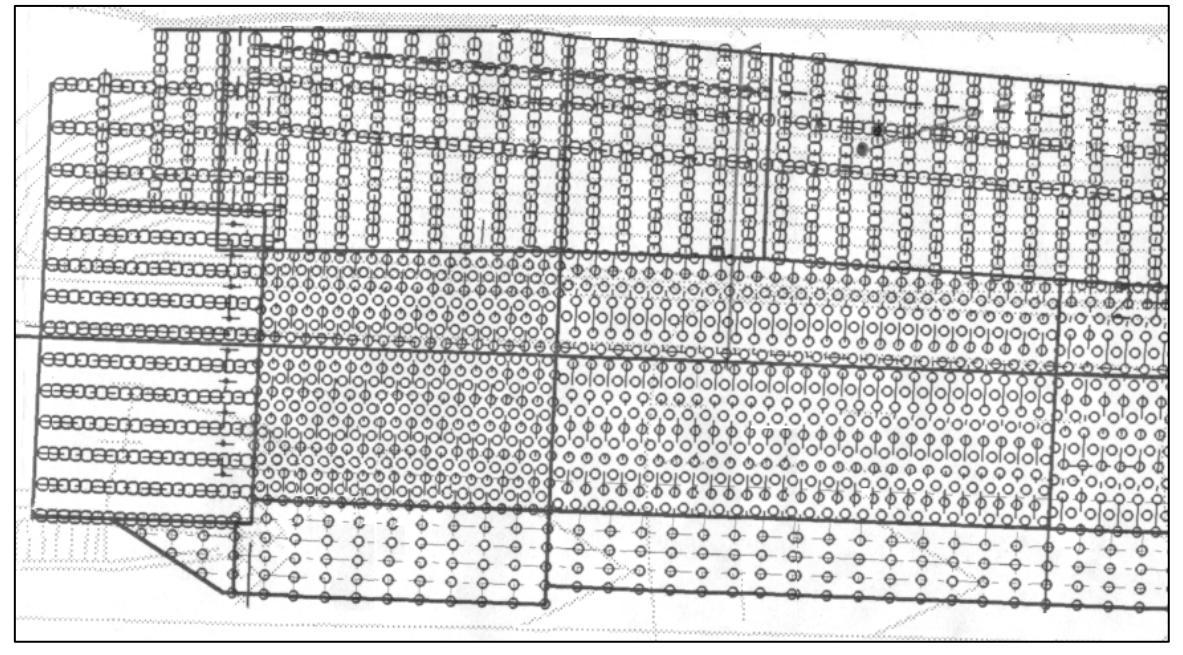
Figure 2-3. General lime cement column layout used on the I-15 Reconstruction Project showing 0.8 m diameter intersecting columns and 0.6 m diameter individual columns.

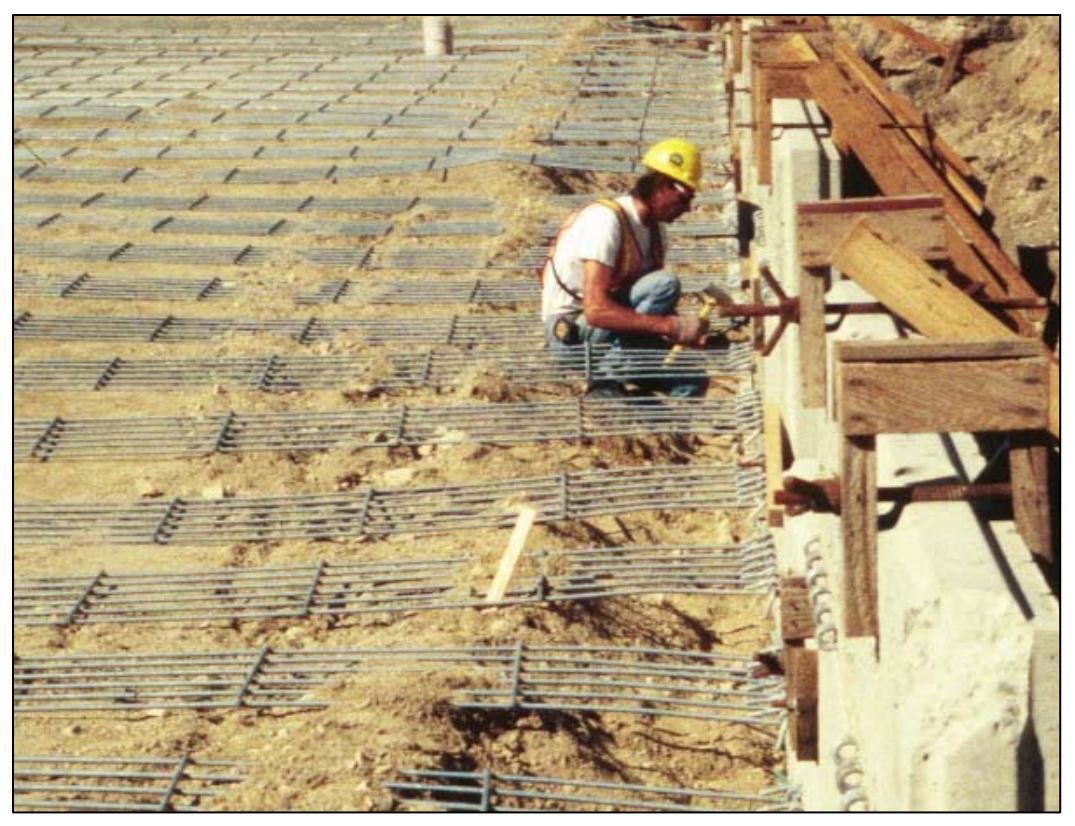
Figure 2-4. One-stage MSE wall construction over lime cement column treated foundation.

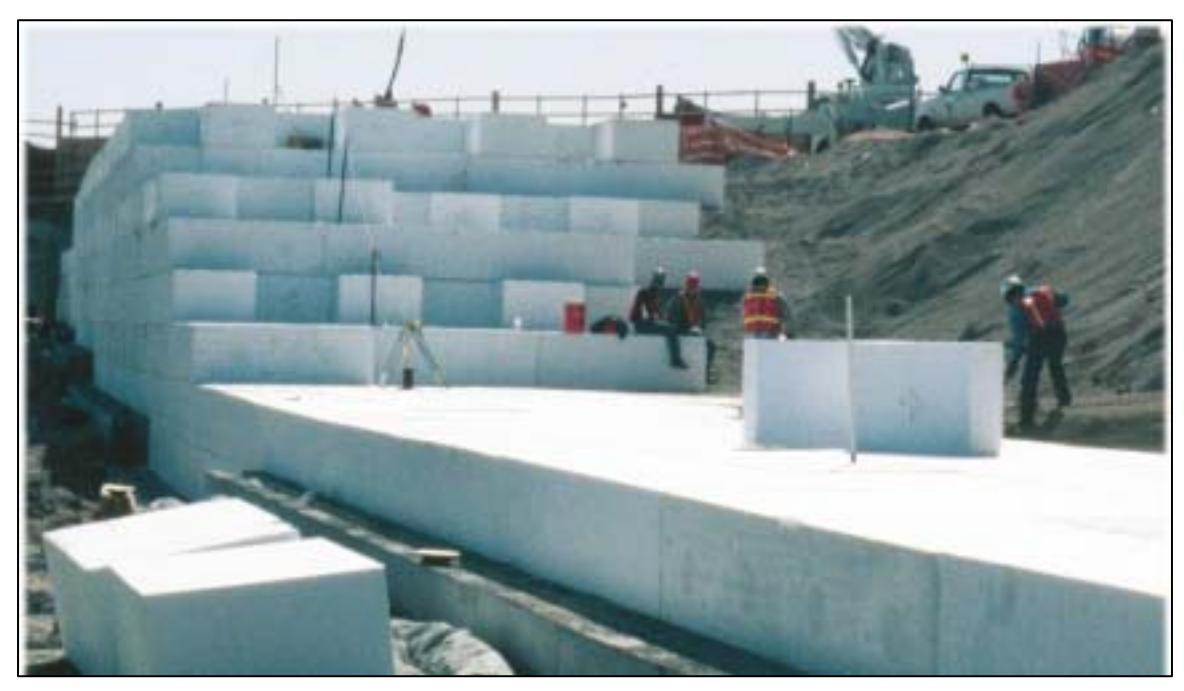
Figure 2-5. Geofoam block placement.

Constructing with geofoam blocks as lightweight fill embankment is a fairly straightforward process. The site is first leveled and a layer of bedding sand is placed. Geofoam blocks are then stacked (Figure 2-5) with additional bedding sand filling the gap between the geofoam and the backslope. A load distribution slab consisting of reinforced concrete is constructed atop the geofoam (Figure 2-6), followed by a small layer of fill and finally the pavement section. A tiltup panel wall is placed to cover and protect the exposed face (Figure 2-7).

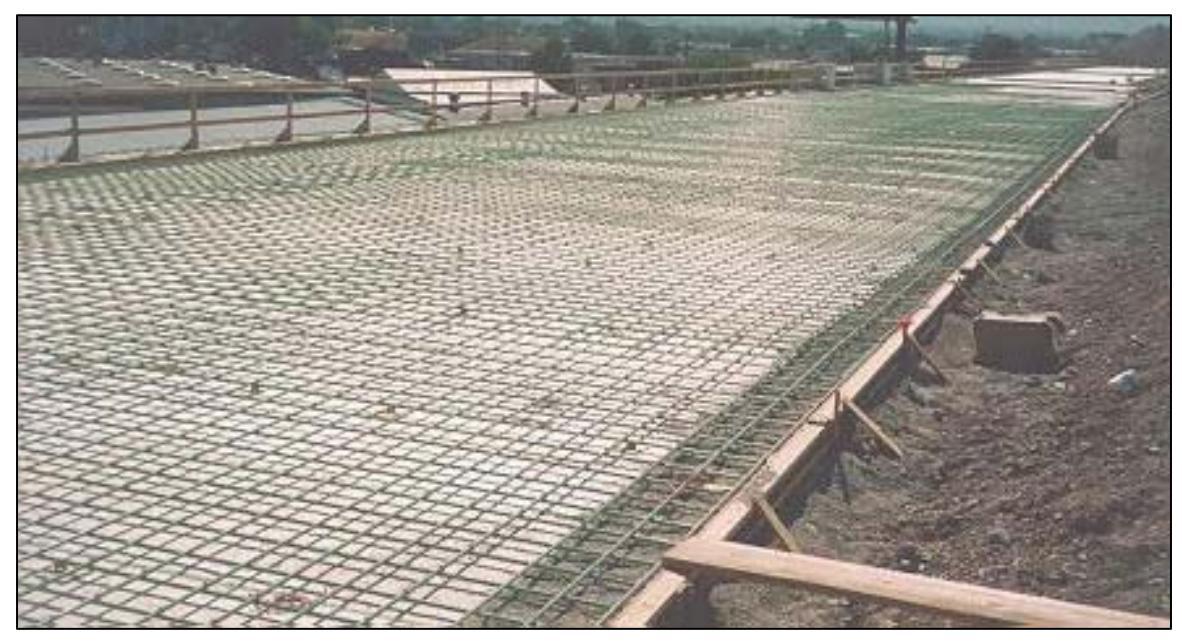
Figure 2-6. Load distribution slab being constructed over geofoam blocks.

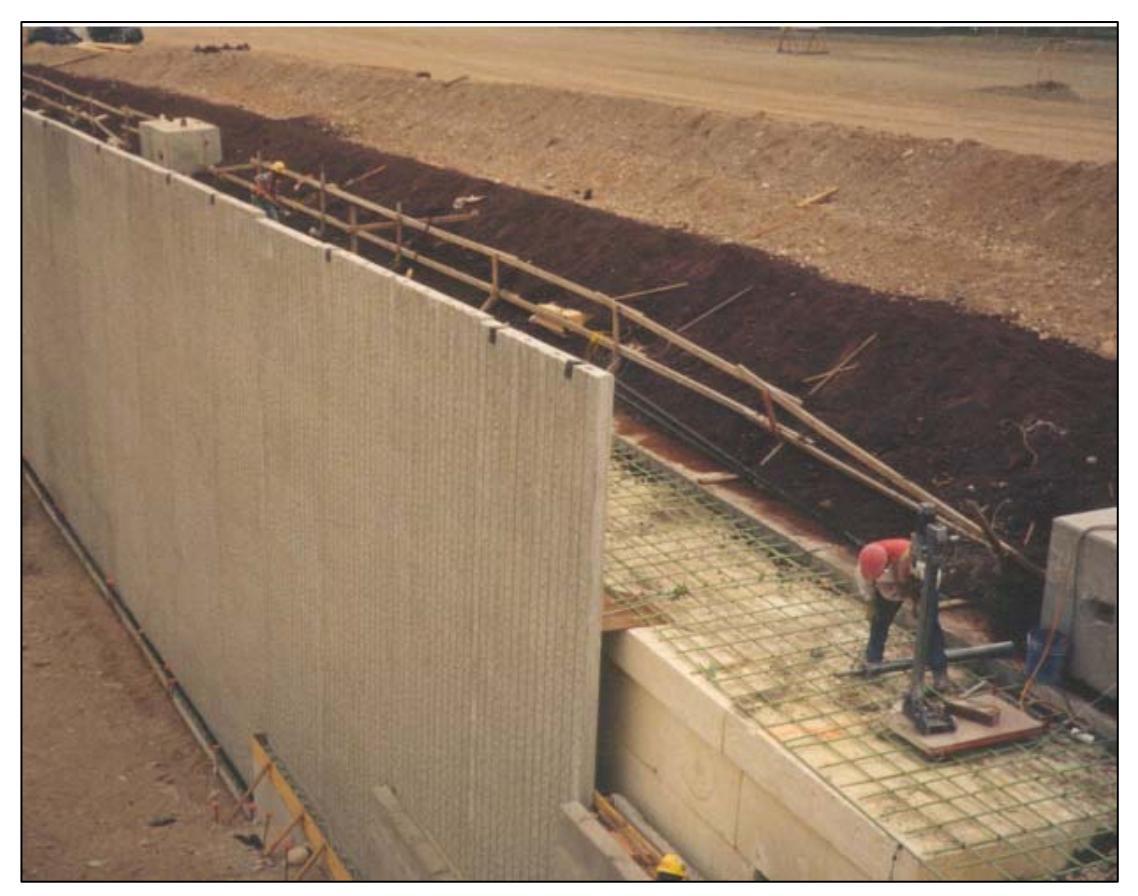
Figure 2-7. Placement of geofoam tilt-up panel wall with fill over load distribution slab prior to construction of pavement.

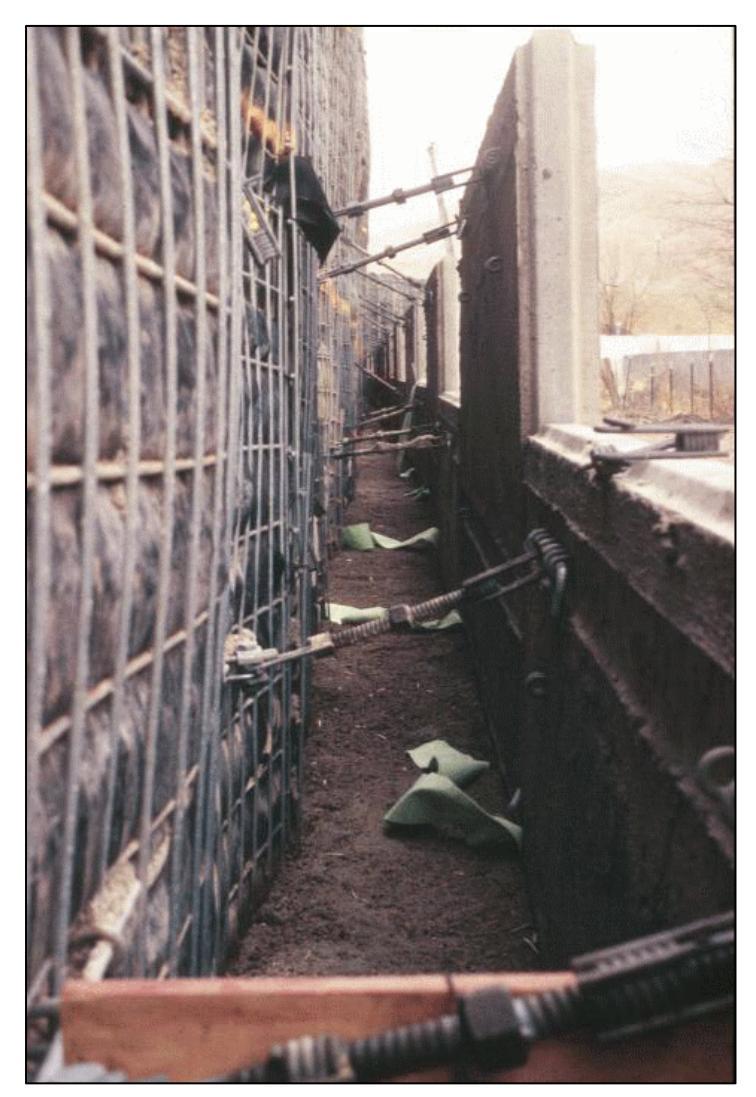
Figure 2-8. Typical two-stage MSE wall construction including geofabric and welded wire face from first stage and panel placement with threaded couplers in second stage.

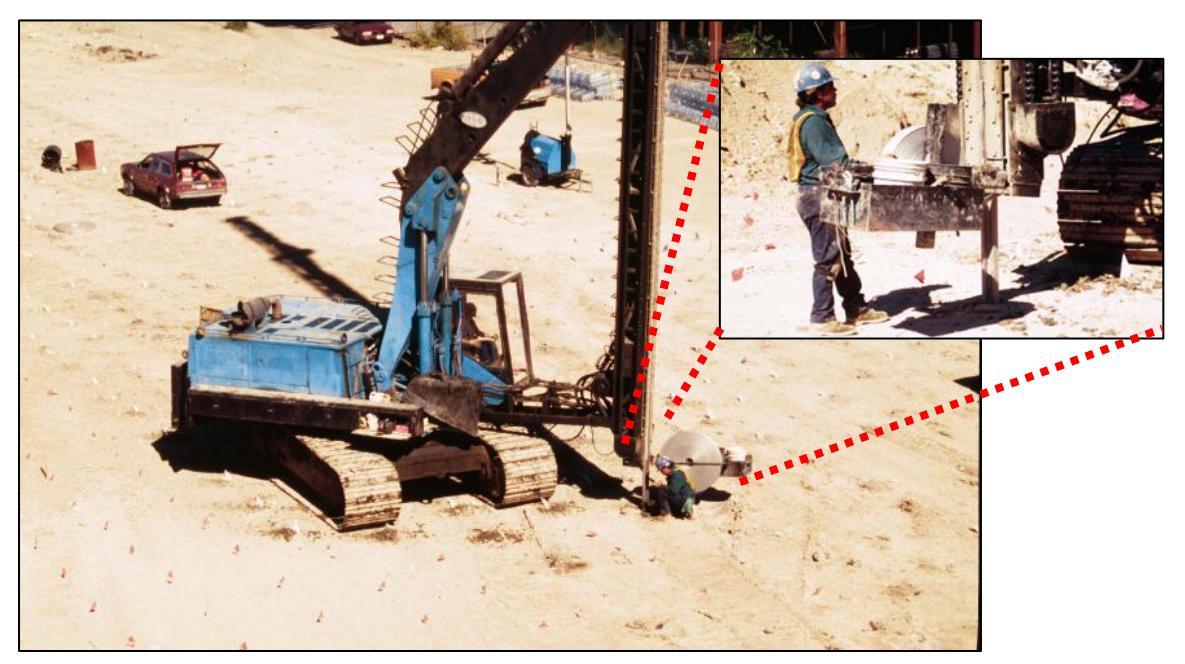
Figure 2-9. PV drain installation.

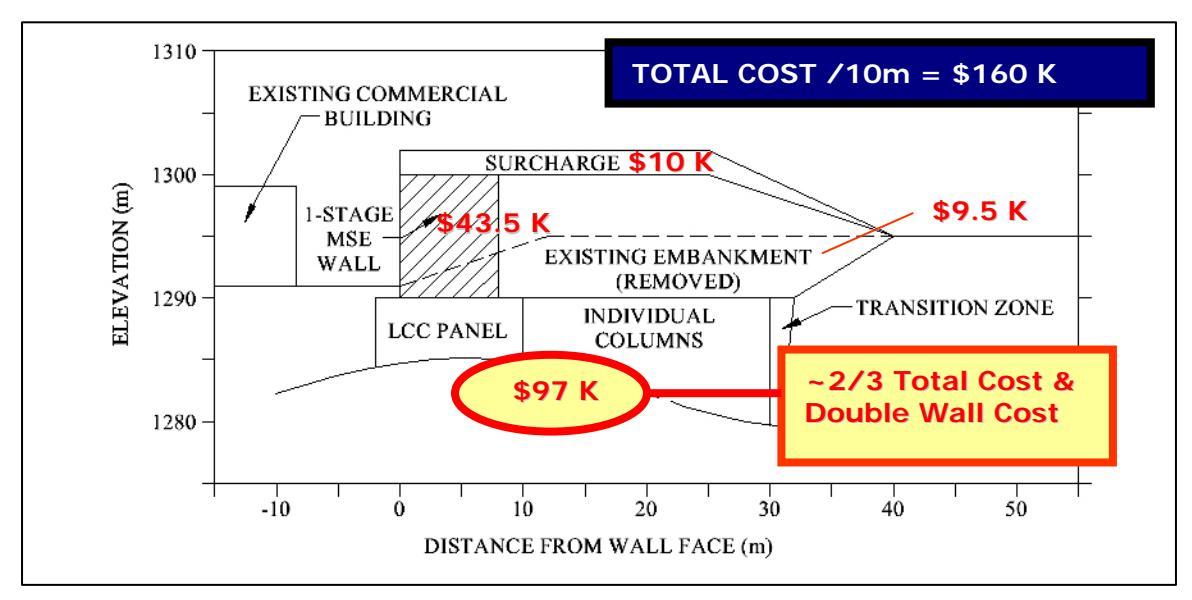
Figure 3-1. Lime cement column with one-stage MSE wall cross section including summary costs for major construction components.

Table 3-2 shows the breakdown of the cost for the lime cement column treated foundation with a one-stage MSE wall constructed above. The total cost of the LCC treated soil and one-stage MSE wall was about \$160,000 per 10-m (32.8 ft) length of wall/embankment. The unit costs of the major construction components are shown in Table 3-2. Prior to the LCC treatment, the existing embankment was removed. The column installation pattern was somewhat complex and included 20-m (65.6 ft) long columns of two diameters [0.8-m and 0.6-m (2.6 ft and 2.0 ft]. The columns in the panel and individual column zones were installed to a depth of 20 meters (65.6 ft) and to shallower depths in the transition zone (Figure 3.1). Based on the actual

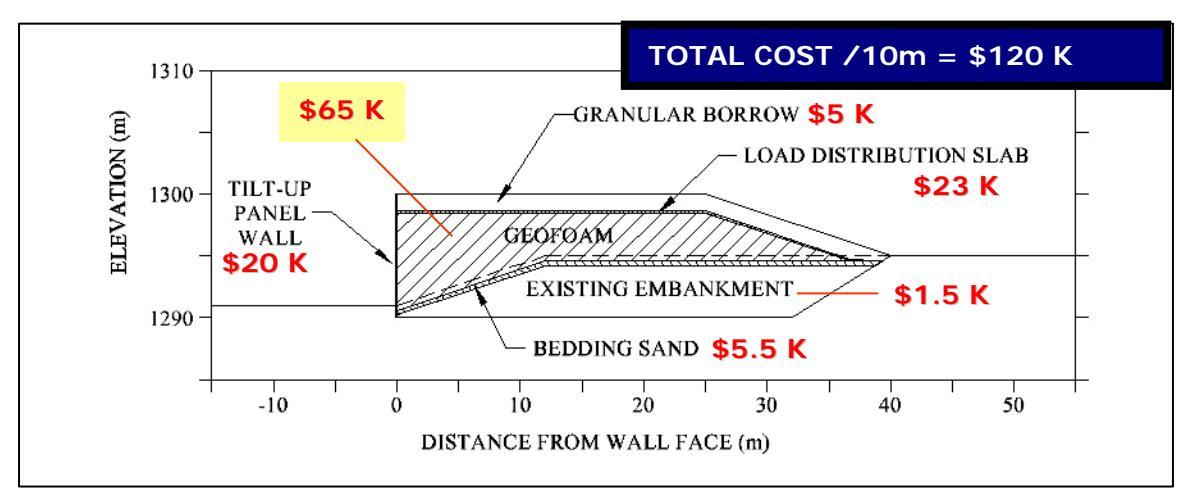
Figure 3-2. Geofoam embankment cross section including summary costs for major construction components.

Table 3-3. Geofoam embankment cost and time of construction for 10 meters of wall/embankment length using typical cross-section (Figure 3-2).

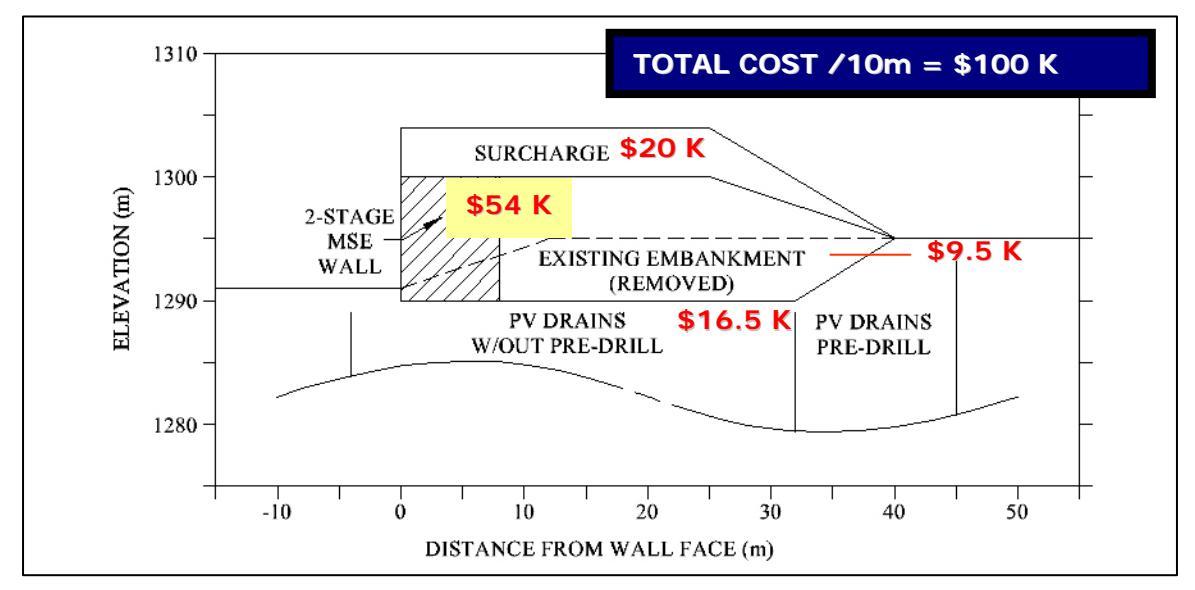
Figure 3-3. Two-stage MSE wall with PV drains cross section including summary costs for major construction components.

Table 3-4. Two-stage MSE wall cost and time of construction for 10 meter
of wall/embankment length using typical cross-section (Figure 3-3).

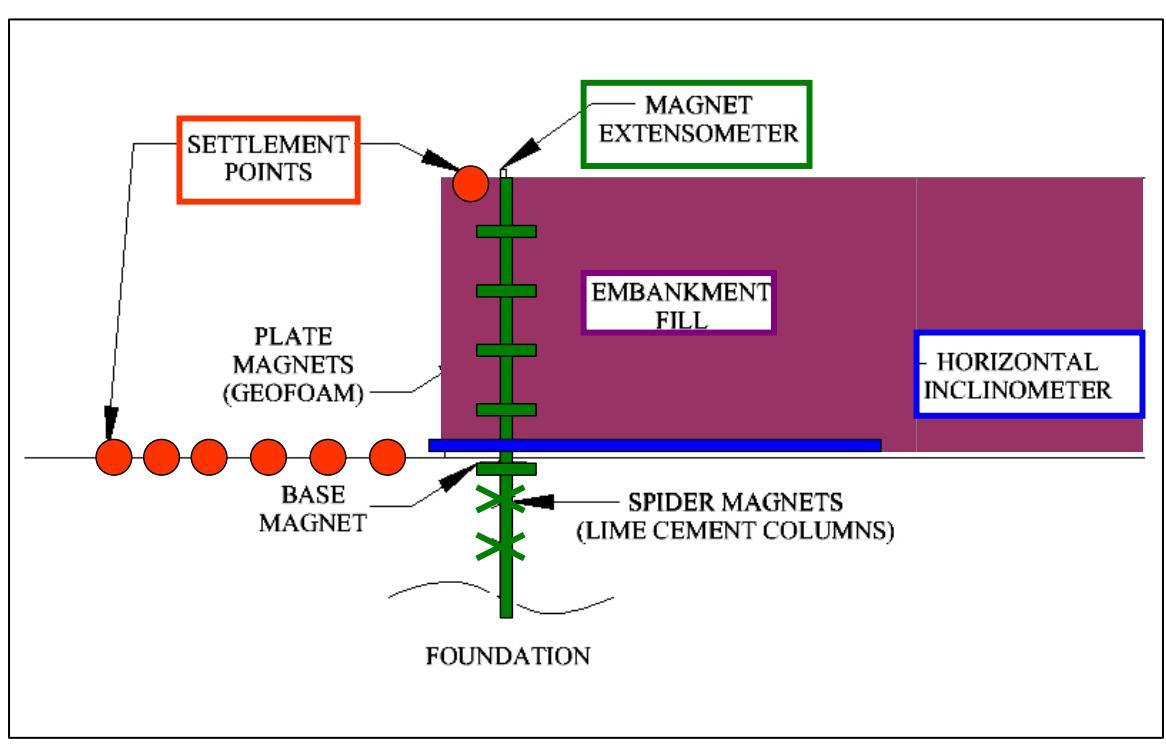
Figure 5-2. Typical instrumentation setup for construction and long-term settlement monitoring of a wall.

inclinometers were installed at the base of the wall to provide information on foundation movement. Finally, magnet extensometers were placed in either the foundation or within the embankment to monitor relative compressive movement.

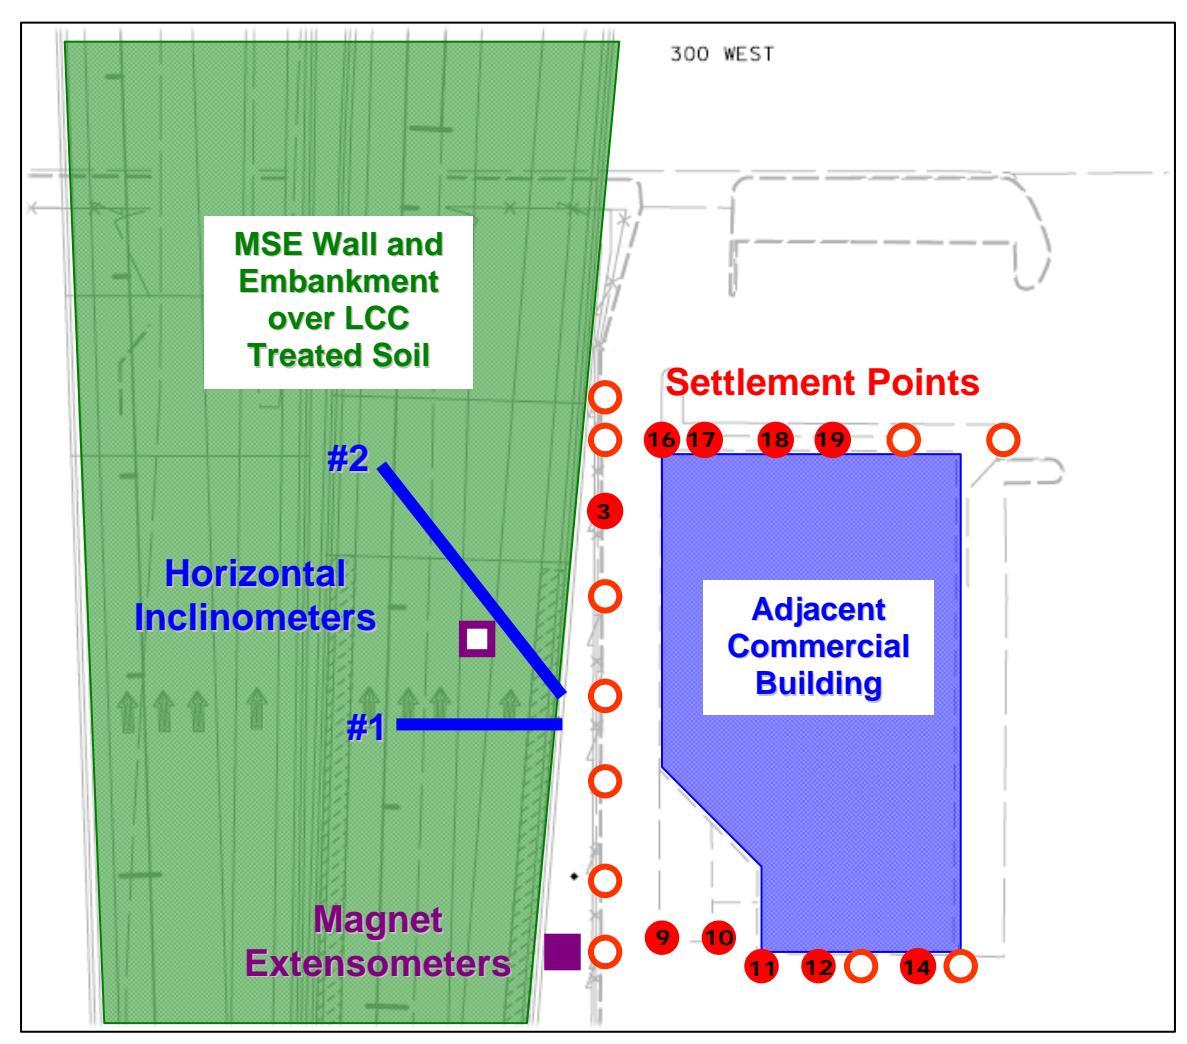
Figure 5-4. Instrumentation layout at the LCC stabilized foundation site.

The instrumentation at the lime cement column site was installed after column installation but before MSE wall/embankment construction. Figure 5-4 shows the instrumentation that was placed at this site. Two horizontal inclinometers were placed at the base of the MSE wall during construction. The initial magnet extensometer placed within the wall was lost during construction, and so a subsequent magnet extensometer was placed outside of the wall. Settlement points were placed around the adjacent commercial building, both parallel and perpendicular to the wall face. The settlement points and magnet

extensometer that have since been damaged and are no longer active are shaded white in Figure 5-4.

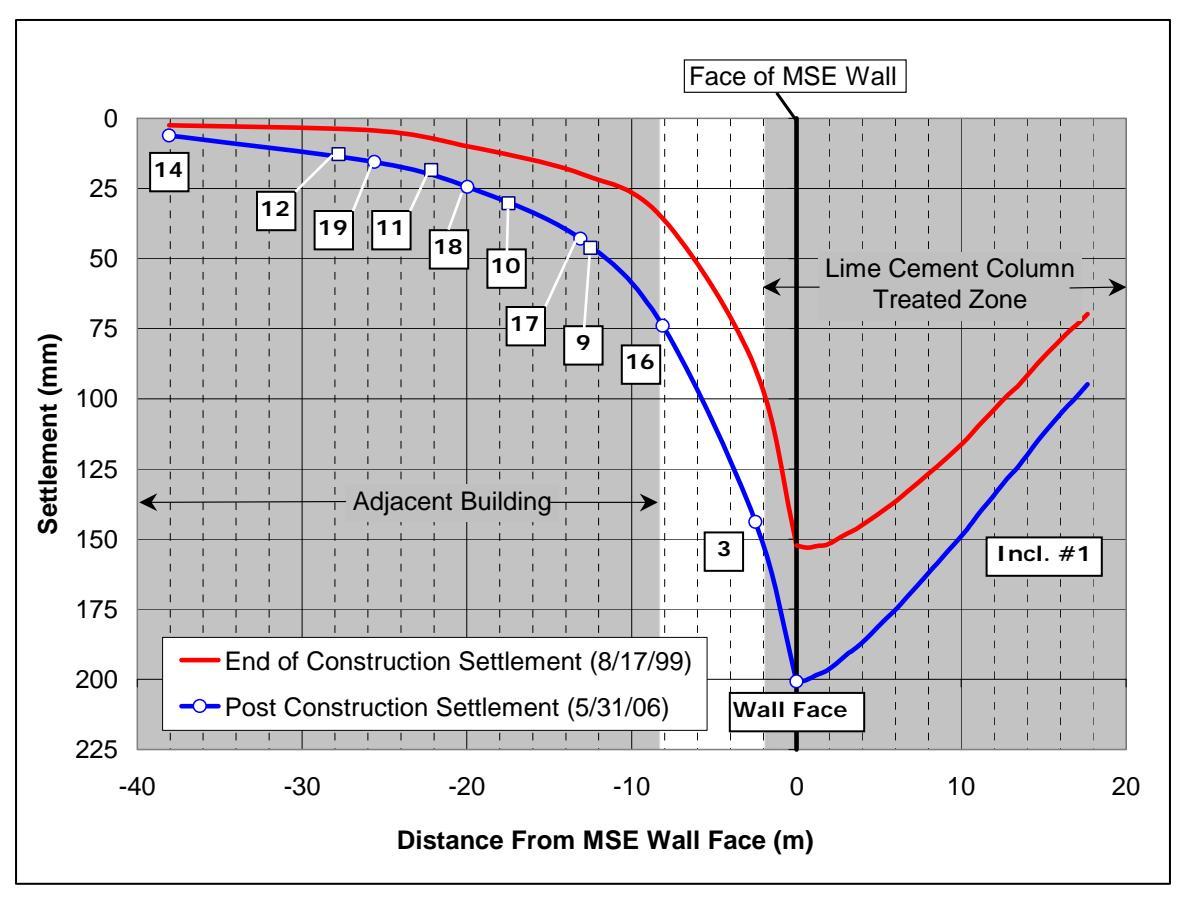
Figure 5-5. Construction and post construction settlement profile for the lime cement column area.

Figure 5-5 shows the end-of-construction and 7-year settlement profiles measured at this location using the settlement points placed around the building and the horizontal inclinometers that extended into the wall near the bottom of the reinforced zone. Although the settlement points were not located along a straight line perpendicular to the wall, the profile is obtained by plotting the settlement for each point with the corresponding perpendicular distance to the wall face. Each point has been labeled and the corresponding location can be seen in Figure 5-4. The resultant profile is a combination of all the active settlement points and horizontal inclinometer #1. Although only one horizontal inclinometer is actually shown on the profile, the settlement profile within the wall was nearly identical for both. The largest settlement occurred at the MSE wall face, which was about 150 mm (6 in) at the end of the construction period. The amount of settlement measured by the horizontal inclinometer decreased with increasing distance into the wall. This occurred because the pre-existing I-15 embankment preloaded the foundation soils in this zone.

It should be noted that the wall and non-reinforced embankment behind the wall has undergone some angular distortion, as shown in Figure 5-5. The angular distortion across this zone is approximately 1/210 and 1/160 after construction and 7-years of post-construction settlements, respectively. However, these values are measured at the base of the wall. The surface fill was leveled after removal of the surcharge so that the pavement was placed at the appropriate elevation and drainage slope. Taking this into consideration, the 7year post-construction angular distortion of the surface pavement is considerably smaller at around 1/720. Additionally, the MSE wall reinforced zone extends only about 8 m (26 ft) behind the wall face with unreinforced embankment fill placed behind that (Figure 2-1). The settlement profile in Figure 5-5 shows that there is not any noticeable settlement difference across this transitional zone. It does not appear that the angular distortion has had any significant impact on the performance of the MSE wall or the surface pavement.

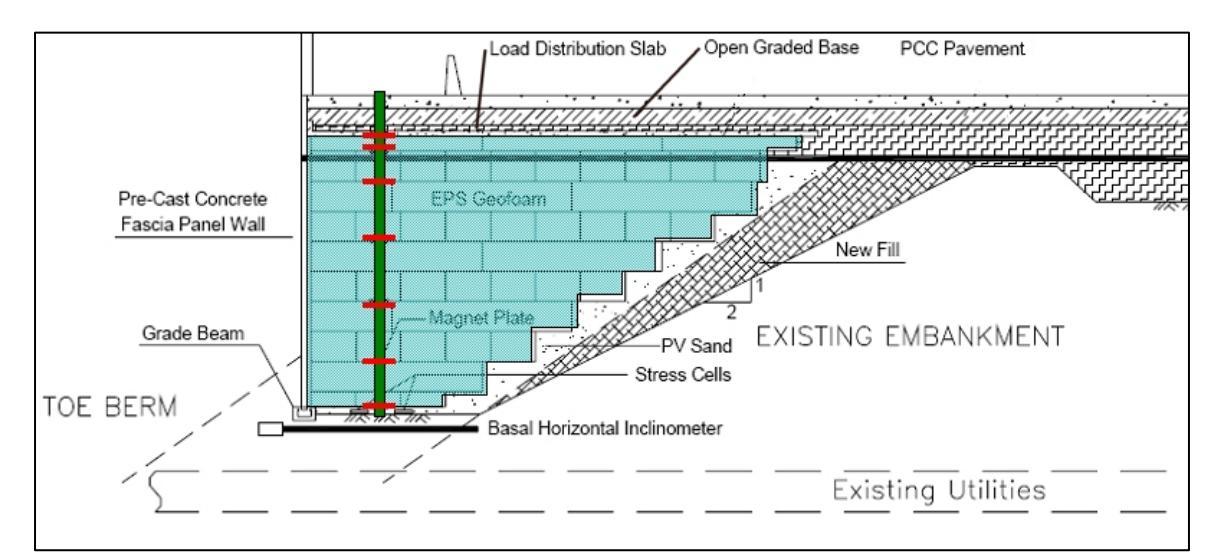
Figure 5-6. 100 South Geofoam Embankment with Magnet Extensometer.

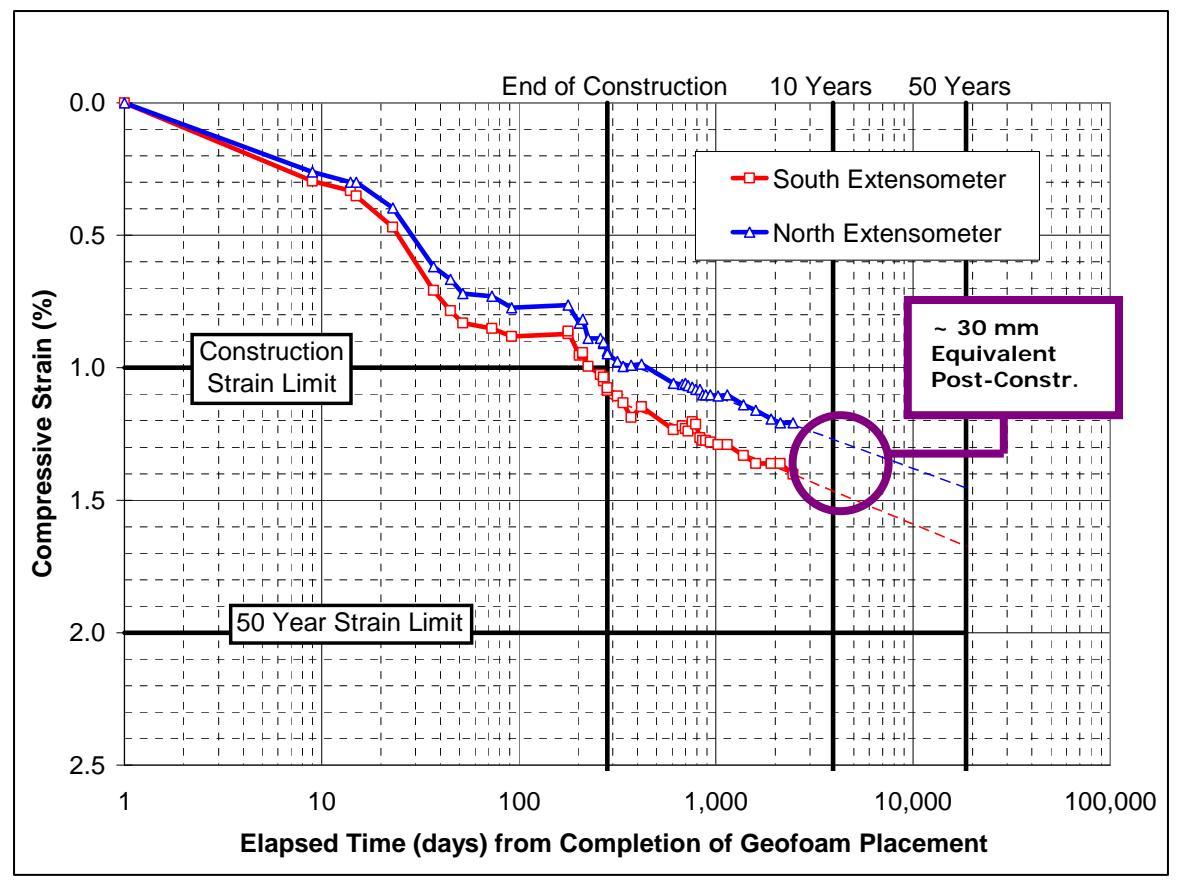
Figure 5-7. Compressive strain for magnet extensometers within the geofoam embankment at 100 South.

Settlement arrays were installed at two large geofoam embankment/walls located at 3300 South and 100 South Streets in Salt Lake City. The first location is a large approach fill for an interstate bridge that crosses a railroad line and the second location is a buried utility corridor that crosses perpendicular to I-15. At 3300 South Street, the design-build contractor selected geofoam embankment to expedite construction. By working a day and a night shift at this location, the geofoam embankment construction, including placement of pavement, was completed within about 3 months. At 100 South Street, the geofoam embankment was selected to minimize settlements of existing buried utilities across the I-15 alignment. The geofoam embankments at both locations were about 7.5 m (24.6 ft) in height but more material was placed above the load distribution slab at 100 South Street. At this location the subbase material over the load distribution slab consisted of scoria and at 3300 South Street the subbase material consisted of conventional fill. In all cases, the design required that the bearing pressures on the geofoam from the load distribution slab, subbase, base, and pavement section be below the 40% working stress criterion. This loading caused approximately 70 and 80 mm (2.8 and 3.1 in) compression of the geofoam fill during construction, at 3300 and 100 South Streets, respectively, as measured by magnet extensometers located about 2.4 m (7.9 ft) from the vertical wall face (Figure 5-6). The corresponding construction induced strain is approximately 1% (Figure 5-7).

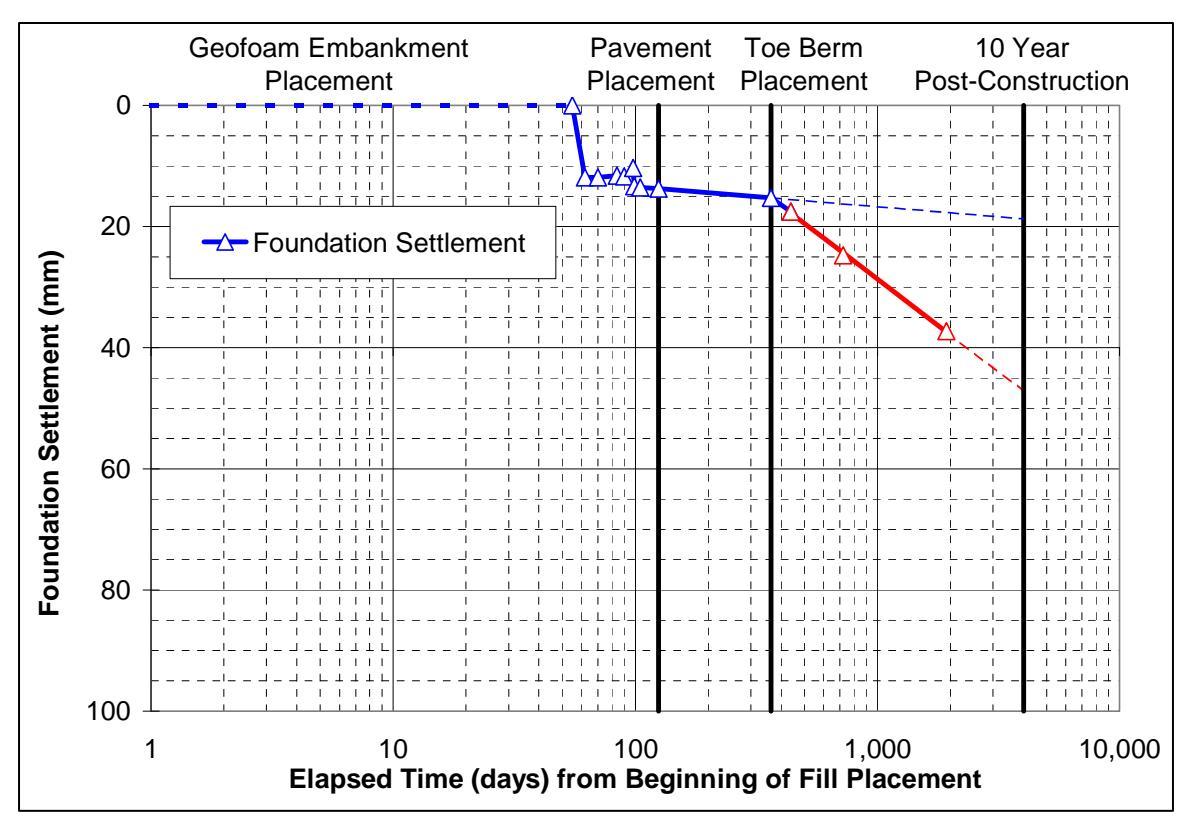
Figure 5-8. Foundation settlement versus time for the 3300 South geofoam embankment.

Figure 5-8 shows that about 15 mm (0.6 in) of foundation settlement occurred from placement of the roadway materials and pavement atop the geofoam at 3300 South Street. The foundation settlement was measured at this location by surveying the top of the magnet extensometer casing. Although measured at the surface, this represents the actual foundation movement because the bottom of the magnet extensometer is located at the base of the embankment fill and the extensometer casing is not free to compress. At about 300 days after completion of the pavement structure at 3300 South Street, the design-build contractor placed a 1.5-m (5 ft) high toe berm at the base of the geofoam wall (Figure 5-9). This new load produced an

additional 25 mm (1.0 in) of post-construction foundation settlement (Figure 5-8). With this additional loading at the toe, the total foundation settlement (construction and 10-year post-construction) is expected to be about 45 mm (1.8 in). However, if the toe berm had not been placed, the expected foundation settlement would have been about 20 mm (0.8 in) for the same period (Figure 5-8). Nonetheless, this additional settlement was not consequential at this location because there were no nearby utilities. The construction of large toe berms such as this was not typical for other I-15 geofoam walls.
