#### UDOT RESEARCH & DEVELOPMENT REPORT ABSTRACT

1. Report No.	JT- <mark>XX.XX</mark>	2. Government Accession No.	3. Recipient's Catalog No.
4. Title and Subtitle Evaluation of Rapid Constru-	iction and Settlement of	5. Report Date December 2007	
Embankment Systems of S	Mbankment Systems on Soft Foundation Soils         6. Performing Organization Code		n Code

15. Supplementary Notes			
16. Abstract The I-15 Reconstruction Project in Salt Lake City, Utah required rapid embankment construction in an urban environment atop soft lacustrine soils. These soils are thick, highly compressible, have low shear strength and require significant time to complete primary consolidation settlement. Because of this, innovative embankment systems and foundation treatments were employed to complete construction within the approved budget and demanding schedule constraints. This report evaluates and compares the construction time, cost, and performance of three embankment/foundation systems used on this project: (1) one-stage MSE wall over lime cement column treated foundation, (2) expanded polystyrene (geofoam) embankment with tilt-up panel fascia walls, and (3) two-stage MSE wall with PV drain ins

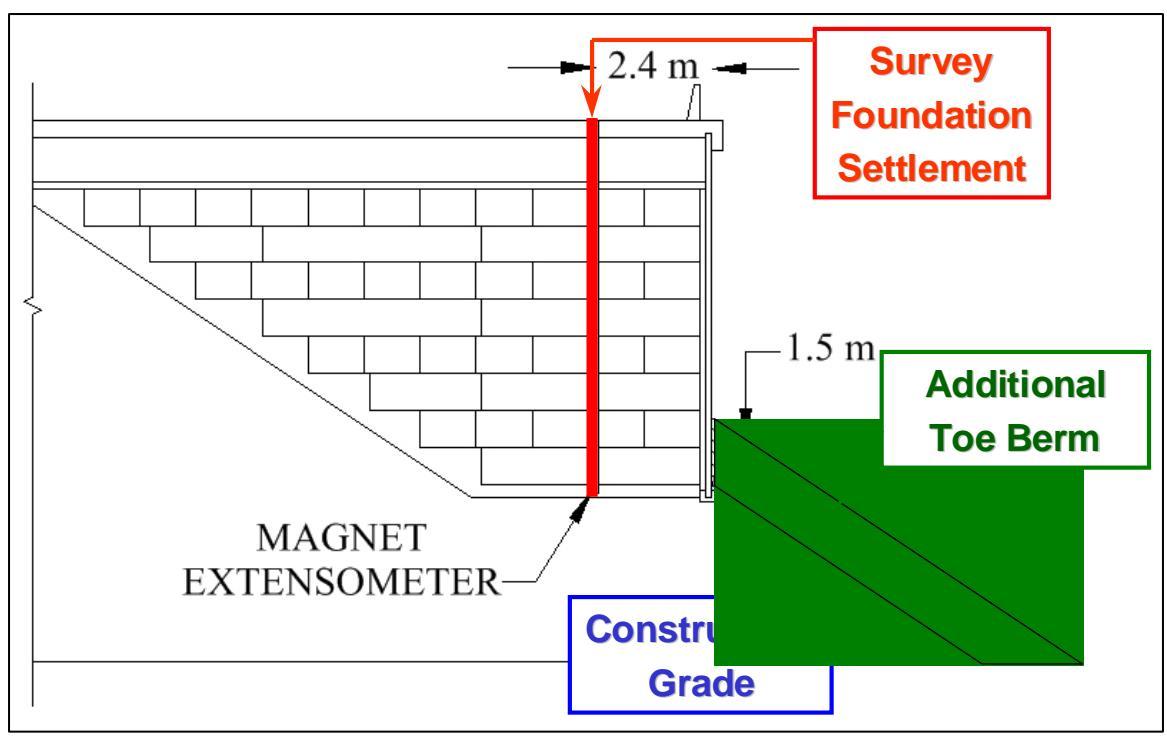
Figure 5-9. Profile for 3300 South geofoam embankment, including the addition of a 1.5 m toe berm.

Figure 5-8 shows that about 15 mm (0.6 in) of foundation settlement occurred from placement of the roadway materials and pavement atop the geofoam at 3300 South Street. The foundation settlement was measured at this location by surveying the top of the magnet extensometer casing. Although measured at the surface, this represents the actual foundation movement because the bottom of the magnet extensometer is located at the base of the embankment fill and the extensometer casing is not free to compress. At about 300 days after completion of the pavement structure at 3300 South Street, the design-build contractor placed a 1.5-m (5 ft) high toe berm at the base of the geofoam wall (Figure 5-9). This new load produced an

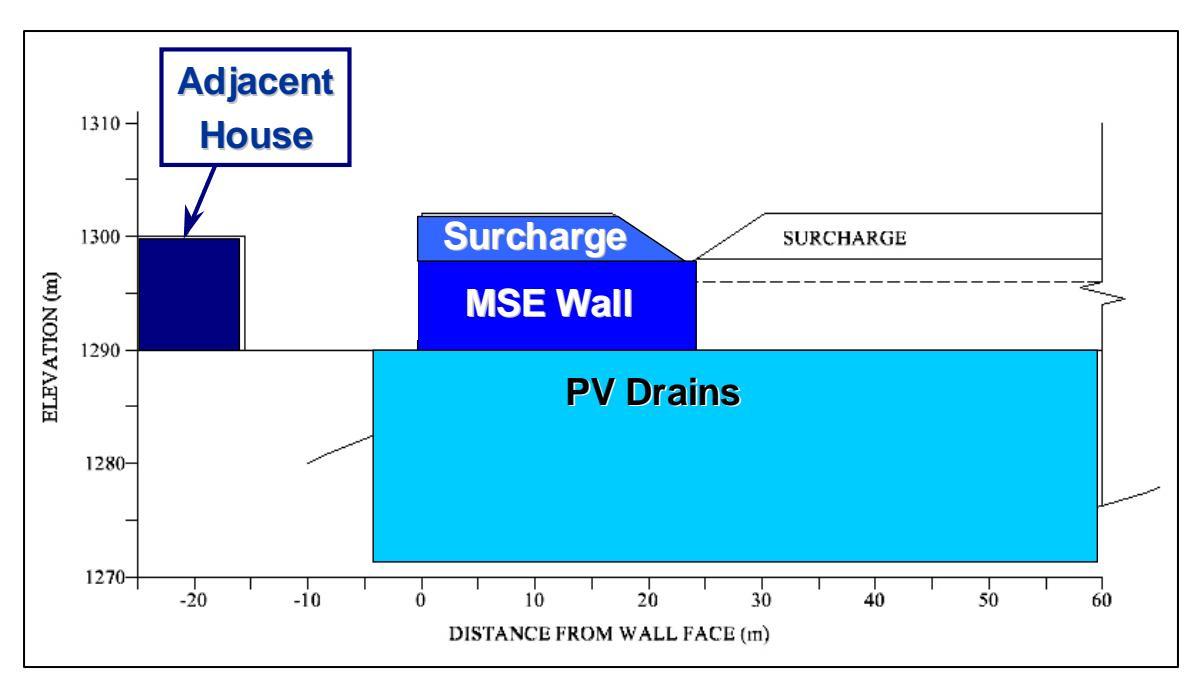
Figure 5-10. 200 South MSE wall and PV Drain profile.

The two-stage MSE wall and surcharge fill at 200 South Street, shown in Figure 5-10, induced 1,100 mm (43.3 in) of consolidation settlement at the wall face over the construction period. The amount of consolidation settlement that this wall underwent was typical of what the two-stage MSE walls over PV drain treated soil throughout much of the project experienced during the I-15 Reconstruction Project. Furthermore, these values echo the settlement values of 1 to 1.5 m (3.3 to 4.9 ft) that were typical of embankment construction during the original I-15 Construction in the 1960s. The large magnitudes of settlement can be directly attributed to building large embankments over the soft thick Lake Bonneville clay layers. Furthermore, it should be noted that by using the PV drains, the settlement time was shortened considerably, from around 2 to 3 years to about 8 months to construct the embankment/wall and allow for the majority of the consolidation settlement occur.

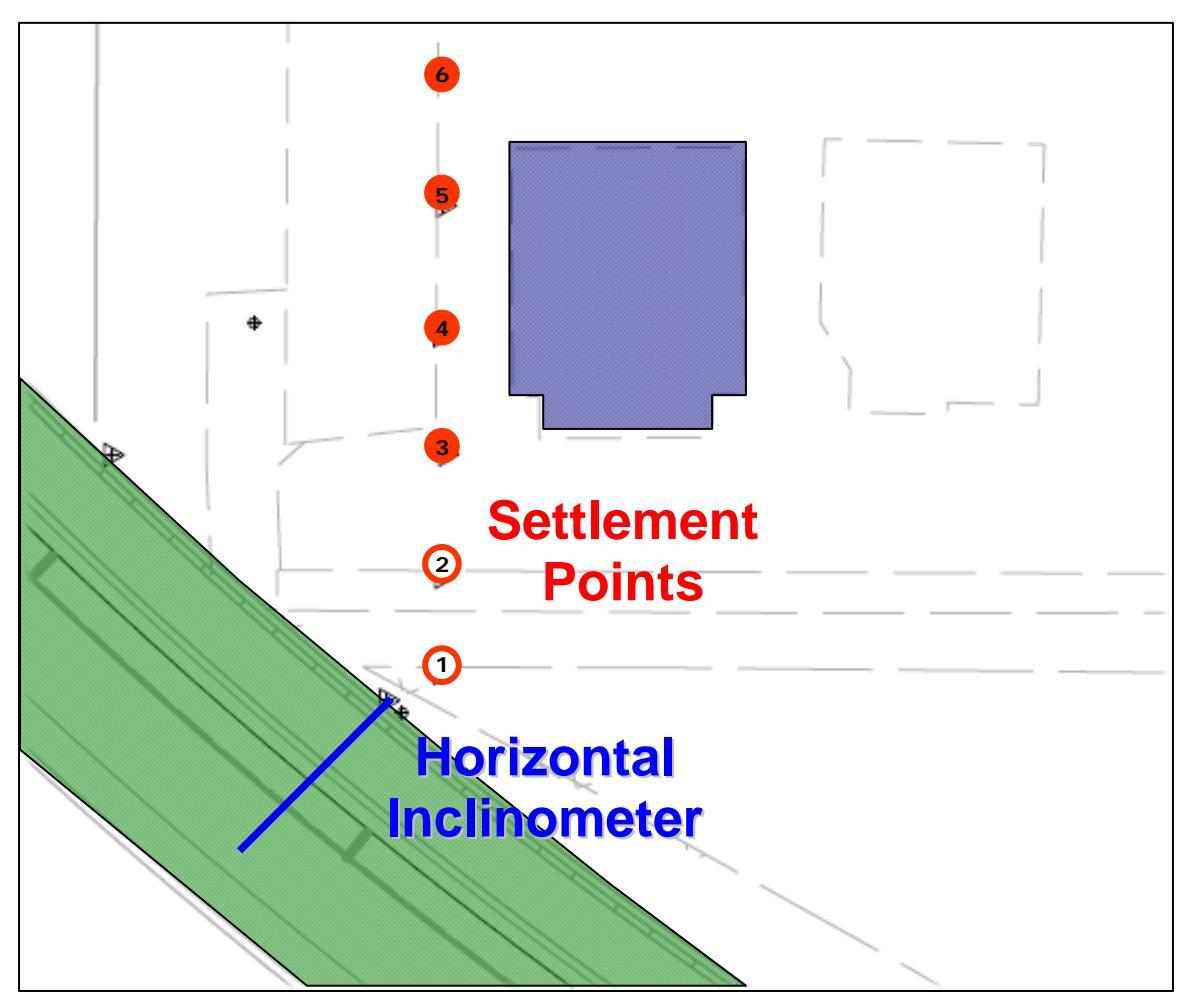
Figure 5-12. Instrumentation layout at the 200 South MSE wall.

Figure 5-12 shows the instrumentation that was placed at the 200 South MSE wall. A horizontal inclinometer was installed near the base of the MSE wall. Six settlement points were placed in a straight line adjacent to the fence from the nearby residential property. The horizontal inclinometer remained active through construction, but due to the large amount of foundation settlement, ended up below final ground surface and was buried. The first two settlement points were also lost near the end of construction. The remaining four settlement points have continued to be actively read.

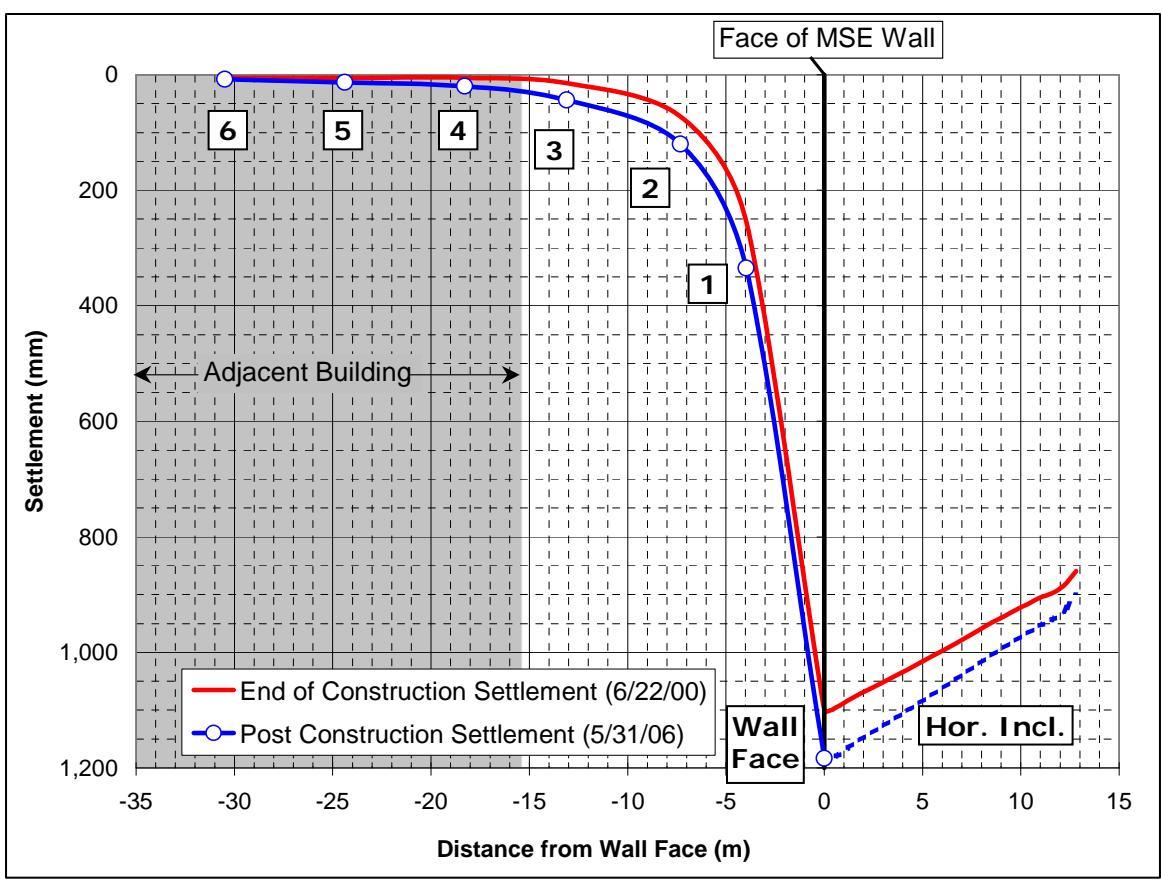
Figure 5-13. Construction and post construction settlement profile for the 200 South MSE wall site.

location, this wall also experienced some angular distortion due to the pre-existing embankment. The angular distortion across this zone is approximately 1/50 and 1/40 after construction and 6-years of postconstruction settlements, respectively. Again, these values are measured at the base of the wall. The surface fill was leveled after removal of the surcharge so that the pavement was placed at the appropriate elevation and drainage slope. Taking this into consideration, the 6-year post-construction angular distortion of the surface pavement is considerably smaller at around 1/260. Furthermore, the pre-cast facing panels were placed in the second construction stage following consolidation settlement. Therefore, the welded wire wall facing would be effected by the full angular distortion. According to the Federal Highway Administration (2001), walls with welded wire facings should have limiting differential settlements of 1/50. The construction settlements essentially reach this target value, with the post-construction settlements exceeding it. At this time, there are not any visible signs that the behavior of the wall is being negatively effected by this angular distortion.

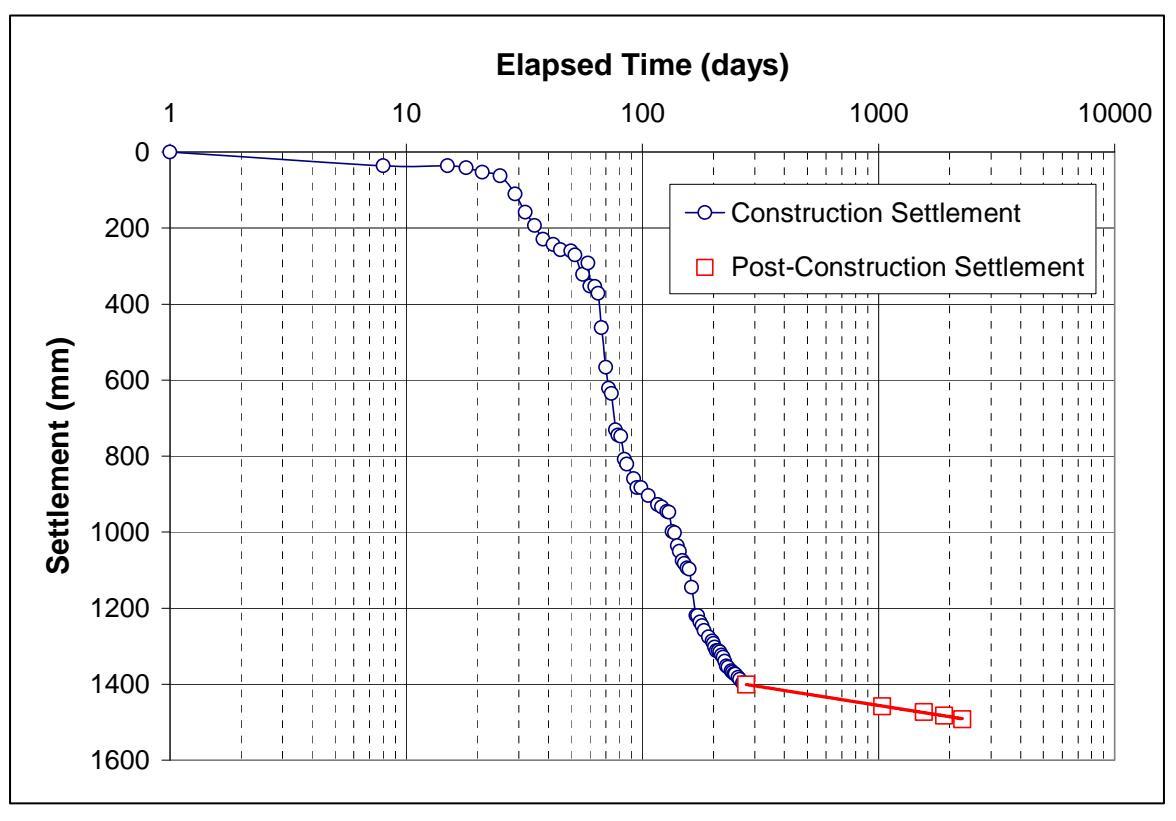
Figure 5-14. 2400 South construction settlement record with back extrapolation of post-construction settlements.

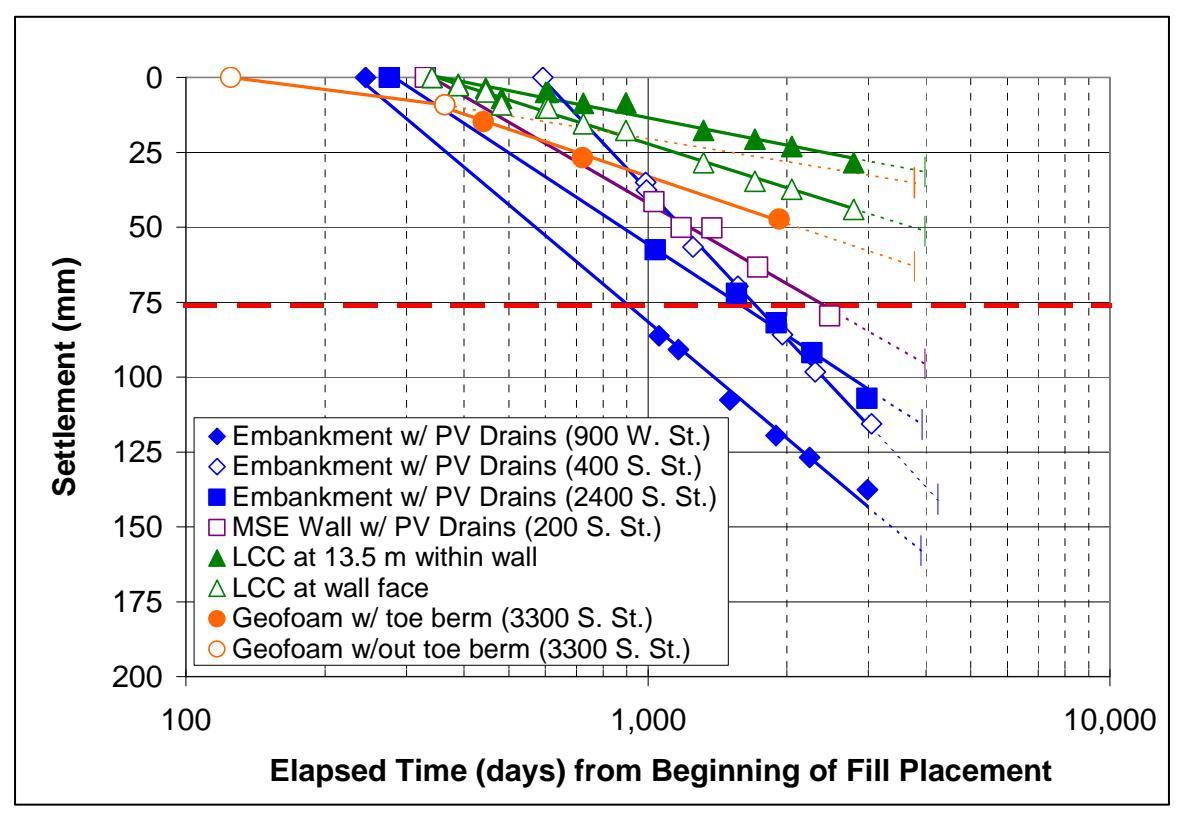
Figure 5-15. Rate of foundation creep extrapolated to 10 years postconstruction (dashed lines) compared to the design criteria of 76 mm of post-construction settlement over 10 years for lime cement columns, geofoam fill, two-stage MSE wall at wall face, and large earth embankments with PV drains at full height.

Figure 5-15 presents a summary of post construction settlements at the various embankment locations and for the alternative geotechnologies. To ensure that the rates are shown appropriately, the creep settlement plots are shown with the settlement plotted against the elapsed time (in days) from the beginning of the fill placement. All technologies are compared within this section with the general 76 mm (3.0 in) over a 10 year post-construction settlement goal.

Post-construction settlement performance trends at 2400 South, 900 West and 400 South Streets suggest these large earthen embankments have already exceeded the 76-mm (3.0 in) in 10-year post-construction settlement goal (Figure 5-15). These embankments were primarily constructed in areas of new alignment or where preexisting embankment had not significantly preloaded the foundation soils. Therefore, locations over pre-existing embankment may not see post-construction settlement rates of this magnitude.

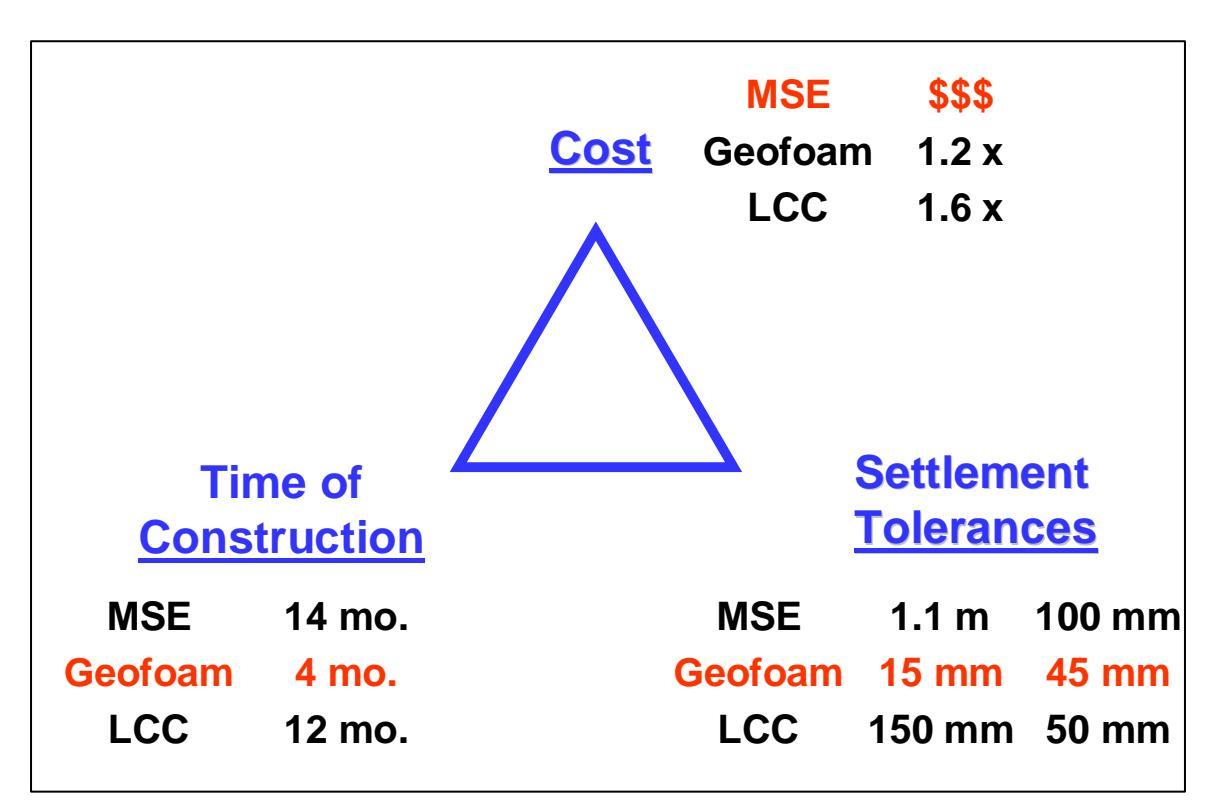
Figure 6-1. Summary of cost, time of construction, and construction and post-construction settlements for three different geotechnologies utilized for the I-15 Reconstruction Project, Salt Lake City, Utah.

The I-15 Reconstruction Project provides a good case history illustrating the challenges of constructing large embankments and MSE walls over soft soil sites in an urban setting. The construction method utilized throughout much of the project for soft soil locations consisted of constructing two-stage MSE walls over PV drain treated soils. However, due to the large primary consolidation settlements [often greater than 1 m (3.3 ft)] induced in the underlying Lake Bonneville clay deposits by such construction; other technologies were used at locations where utilities and/or adjacent structures could not tolerate such large settlements. These consisted of LCC foundation treatment and lightweight geofoam embankment which were designed to reduce both primary and secondary consolidation settlement. This paper has highlighted the settlement performance, cost and time of construction of these technologies as applied to the I-15 Reconstruction Project. A brief summary of the results is shown in Figure 6-1.

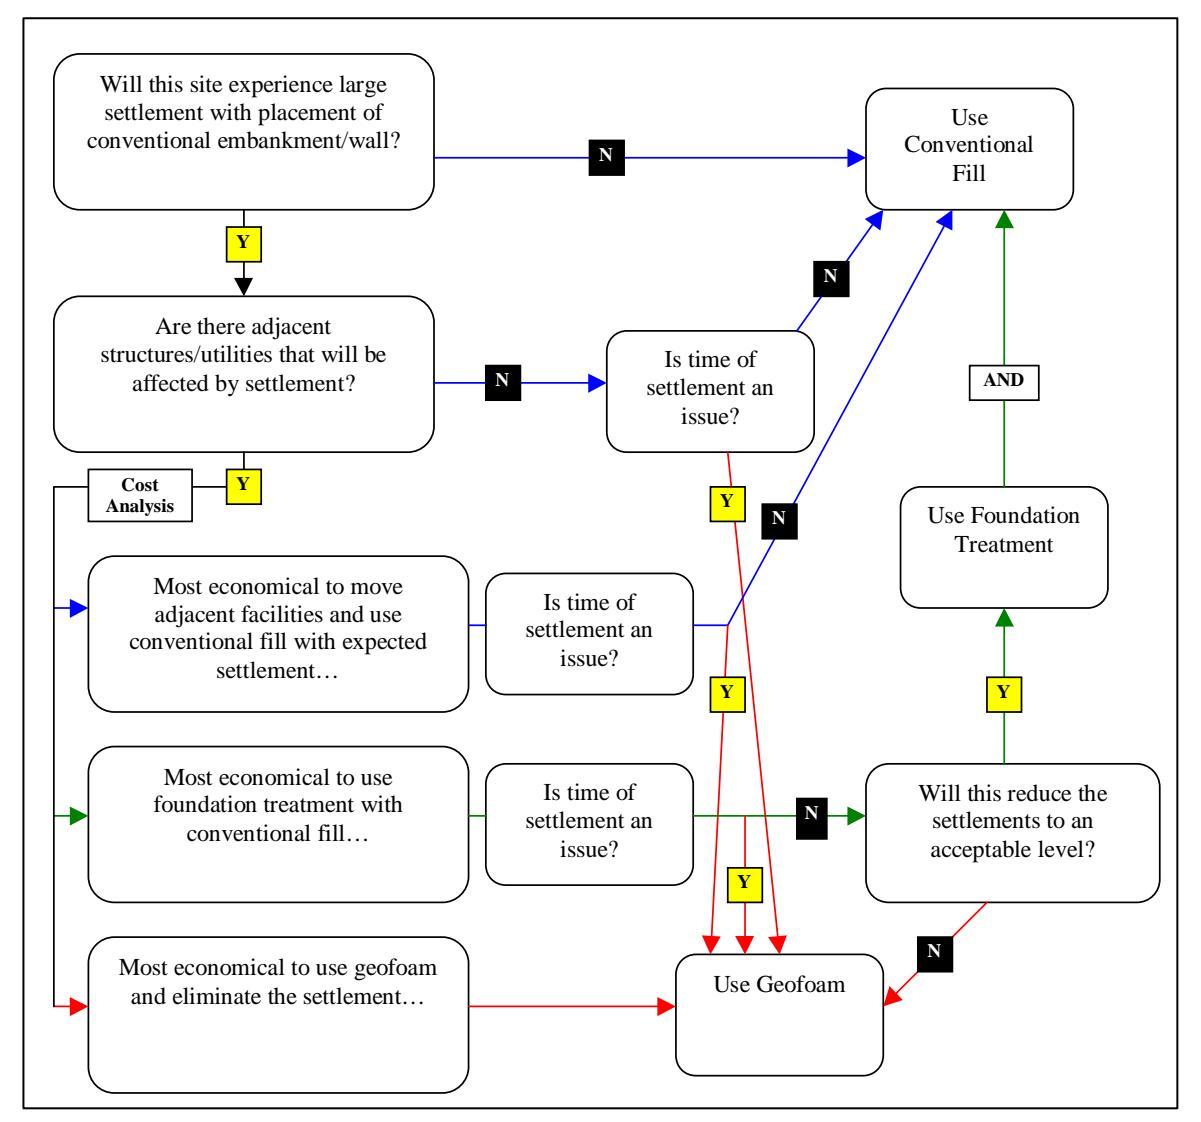
Figure 6-2. Generalized flowchart for selection of geotechnology type based on settlement, time, and cost.
