Geofoam Research Center

Use of Geofoam for I-15 Reconstruction in Salt Lake City, UT

Steven Bartlett, Utah Department of Transportation, Salt Lake City, UT
 Dawit Negusse, Geofoam Research Center, Syracuse University, Syracuse, NY
 Mark Kimble, Wasatch Constructors, Salt Lake City, UT Michael Sheeley, Geofoam Research Center

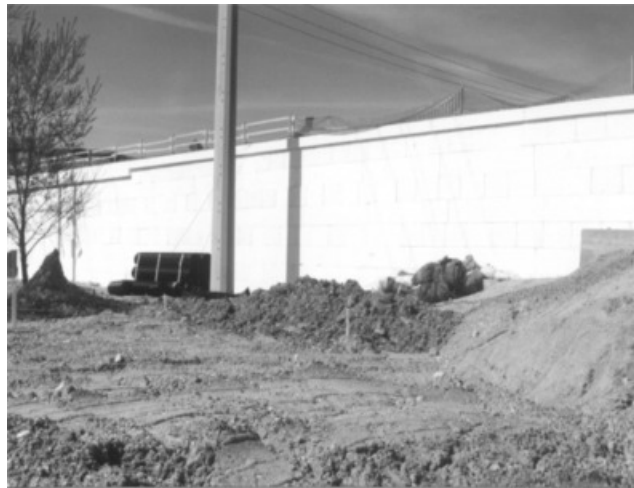
Figure 2: A Geofoam Embankment at 100 South Utility Corridor Crossing of I-15.

One primary application of geofoam is to minimize settlement of underground utilities. Many existing utility lines traverse areas of raised mainline or ramp embankments. These utilities consist of high pressure gas lines, water mains, and communication cables, which must remain in-service during construction. MSE embankments were predicted to induce primary settlements of up to 1 meter, exceeding strain tolerances for these buried utilities. However, when the soil mass of the MSE walls was replaced by low density geofoam the predicted settlements became minimal. This application of geofoam enabled buried utilities to remain in-place, eliminating possible expensive interruption, replacement, or relocation. Figure 2 shows a photo of a completed geofoam embankment, before installation of the tilt-up fascia panel wall at the 100 South utility corridor.

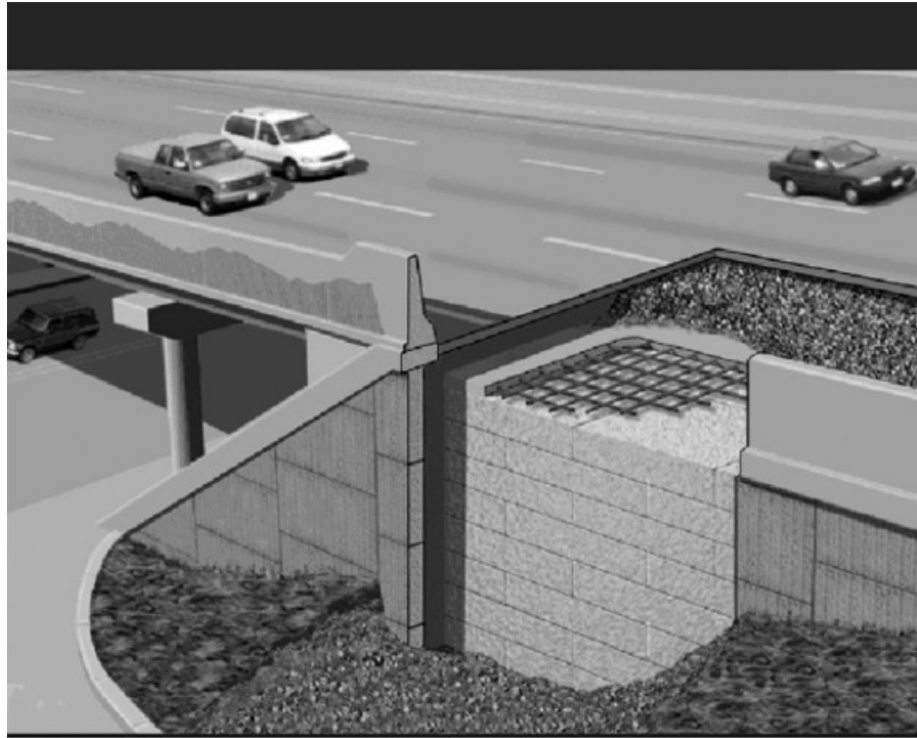
Figure 3: Typical Bridge Abutment with Geofoam Backfill.

Another important use of geofoam on the I-15 project was to improve the stability of embankments. At some bridge locations high embankments were required and the associated safety factors against base failure were low. Such embankments are usually constructed with geotextile reinforcement and stage loading that require several months of delay to allow excess pore pressure dissipation and shear strength gain. Construction of embankments with geofoam provided higher safety factors against instability and allowed the construction to proceed within the critical path for the bridges. Figure 3 shows a typical bridge abutment with geofoam placed behind the abutment wall.

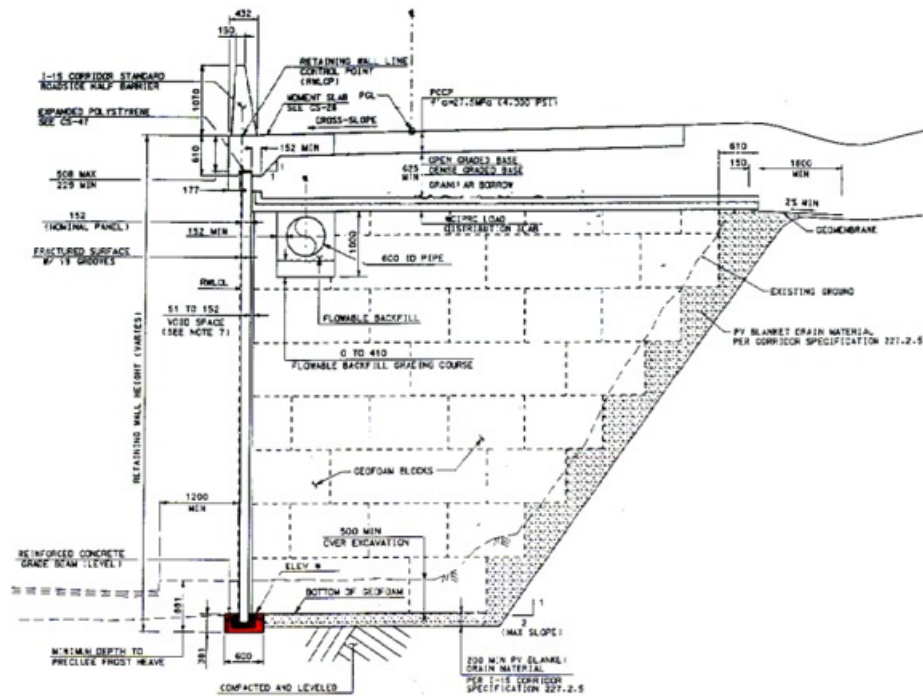
Figure 4: Details of a Typical I-15 Project Geofoam Fill.

This application of geofoam eliminated stability concerns at the bridge abutments and reduced the construction time by up to 75%. In addition, geofoam approach fills induce essentially no lateral pressure on retaining structures provided the soil to geofoam fill transition is maintained at close to a self supporting repose angle, as shown in Figure 4.

Standard Drawings and specifications were developed for geofoam applications on the I-15 corridor by Wasatch Constructor's Design-Build team. Figure 4 shows details of a typical section through a geofoam fill. The fascia panel, roadside barrier as well as details for a utility trench and pipe are also shown. Table 1 lists all the geofoam standard drawings that are currently available. Copies may be obtained by request from the Research Division, Utah Department of Transportation, 4501 S. 2700 W., Salt Lake City, Utah, 84114-8410.

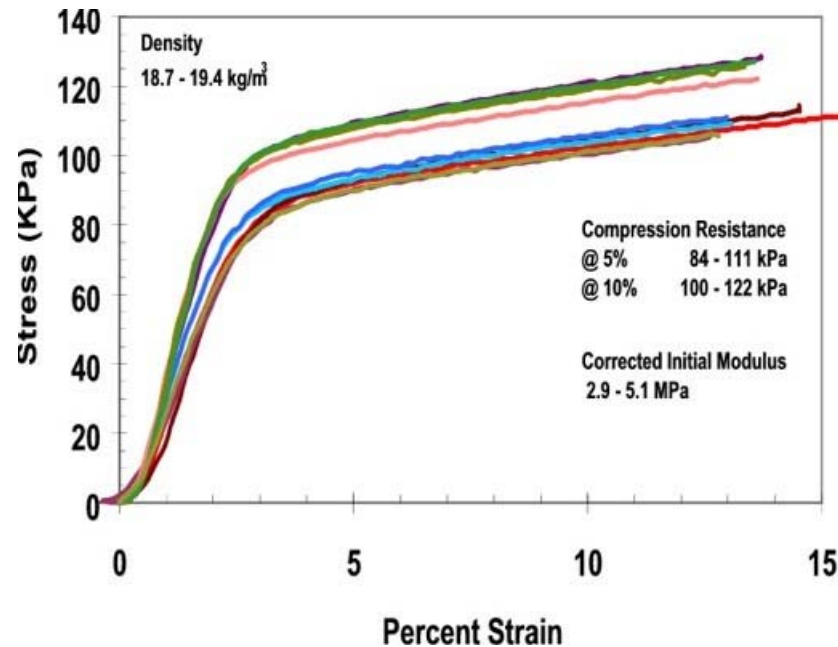
Figure 5: Stress-Strain Curves for Type VIII Geofoam, 50-mm Samples at 10% Strain Rate.

10 percent strain of 90 kPa for the specified Type VIII geofoam under ASTM-C-578. Actual tests performed at a strain rate of 10 percent per min on a series of standard 50 mm side cube samples, Figure 5, indicate the density consistently exceeded the 18 kg/m³ of the specification. The initial lag in the stress strain curves is due to uneven contact and must be adjusted. Corrected initial Young's moduli from these tests were in the range of 2.9 to 5.1 MPa. The compressive resistances at adjusted 5 and 10 percent strain were on average 97 and 111 kPa, respectively, with both exceeding the specification level for Type VIII geofoam in ASTM-C-578.

The range of densities and compression resistances at 5 percent strain represented in Figure 5 are shown in Figure 6.

Corrected initial modulus values that are derived from standard tests as in Figure 5, are generally too low and over predict settlements when used in analyses (Frydenlund et al, 1996). Recent results on large block samples tested at Syracuse University now show that end effects unduly influence data from small specimens. Provided the imposed stresses are confined to induce predominantly elastic strains, the deformation that occurs in the geofoam will mostly take place during construction and post-construction deformation will be small. Thus the more meaningful modulus for practical purposes is the dynamic or resilient modulus. Because of the depth of pavement and load distribution of the concrete slab, stress increments that develop in the geofoam due to live loading are relatively small. Dynamic moduli from large block samples are of the order of more than double to triple the initial value obtained from conventional monotonic tests. Comparable initial moduli are also beginning to be observed in monotonic tests on full height samples obtained from laboratory testing and with local measurement of deformations.

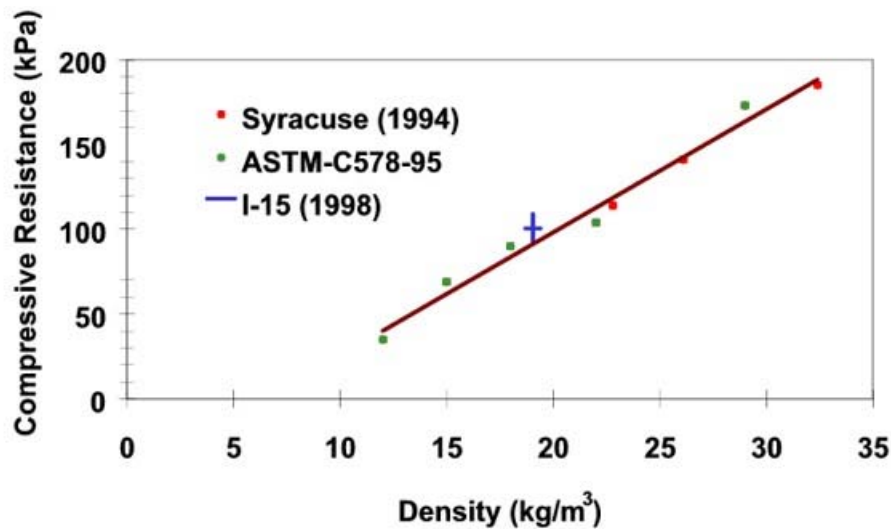
Figure 6: Compressive Resistance versus Geofoam Density.

The best fit line, equation (1), predicts compressive resistance for other densities of geofoam. A similar expression is given, equation (2), in the new European Standard (1998) for compression resistance at 10 percent strain.

$$\text{Sigma}_d = 7.3 \cdot D - 47 \quad (1)$$

Where Sigma_d is compressive resistance in kPa and D is density in kg/m^3 . The 5 percent criteria generally results in a compressive resistance that is about 10 percent lower than that for the 10 percent strain level. To limit long term creep deformation of the geofoam blocks, working stress levels due to dead load were limited to 30 percent of the compressive resistance for Type VIII geofoam with an additional of up to 10 percent allowed for live load due to traffic. Such criteria have been used widely before and are believed to result in no more than 2 percent creep strain in 50 years (European Standard, 1998). An alternative approach used in Japan is to limit working stress levels to compressive resistance at 1 percent strain (Miki, 1996). The two methods can be shown to be equivalent.

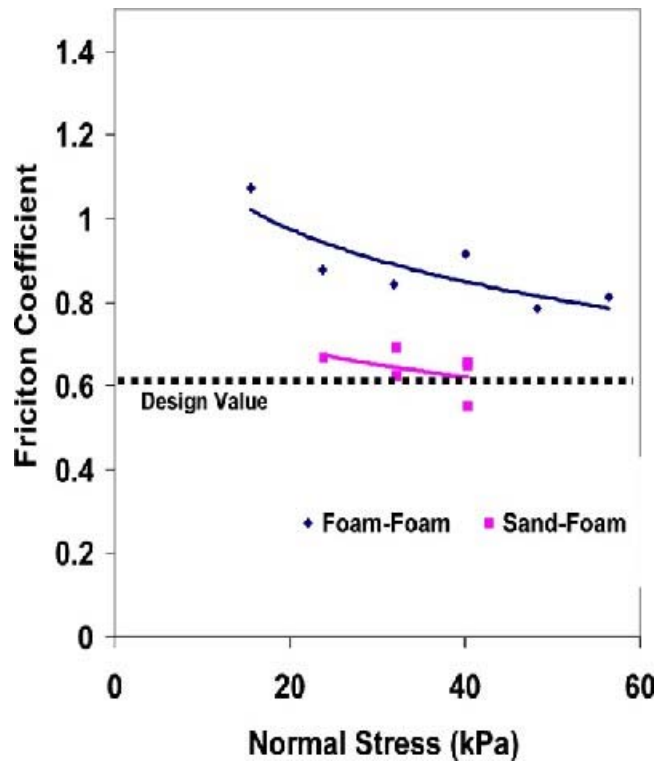
Figure 7: Interface Coefficients for Type VIII Geofoam.

Interface shear strengths between geofoam blocks and between geofoam and bedding sand are shown in Figure 7. The test results are for a range of normal stresses due to the pavement load on the geofoam. Also shown as a lower bound envelope is the interface friction coefficient of 0.6 used in the I-15 design. The lower coefficients for the sand to foam interface imply failure at the interface would be localized to occur within the sand. Coefficients for both the foam to foam and foam to sand interfaces slightly decrease with increasing normal stress.

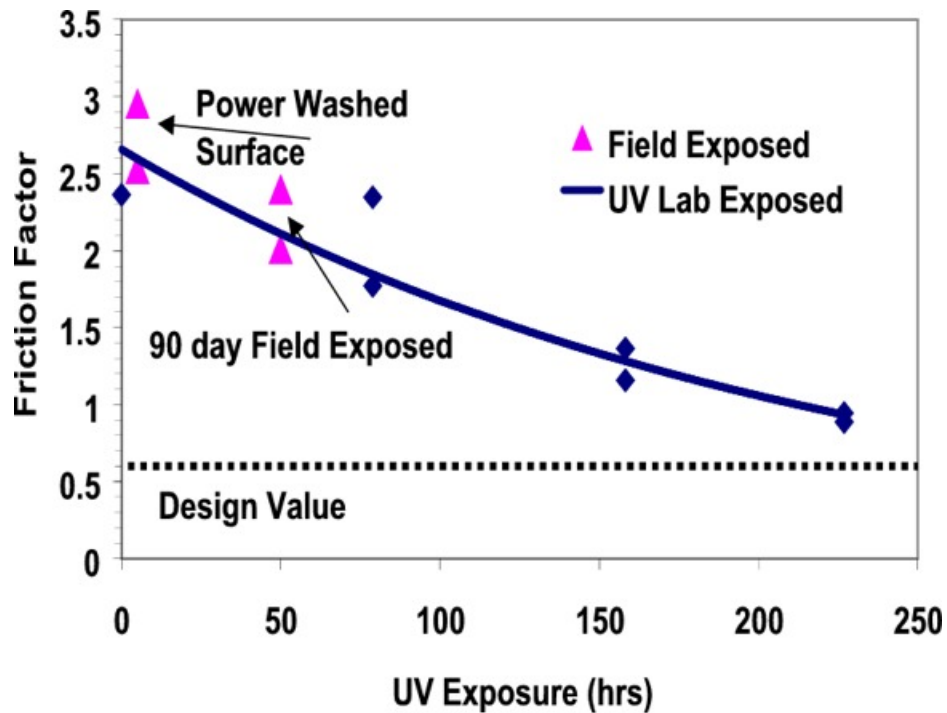
Figure 8: Interface Coefficients for Geofoam - Cast in Place Concrete with UV Exposure Duration.

The load distribution concrete slab over the geofoam fill was cast in place. A relatively strong adhesion bond and a rough texture develops between poured in place concrete and geofoam surfaces resulting in a much higher interface strength than between foam to foam. In some cases, the scheduling of the load distribution slab construction fell behind the geofoam fill completion. The geofoam surface was exposed to prolonged duration of sunlight. Discoloration and dusting of the surface occurred due to UV degradation. The effect of surface degradation on interface strength between geofoam and cast in place concrete was investigated. Samples were subjected to accelerated UV exposure in a weatherometer and field samples exposed to the 90 days specification limit were recovered. Interface strengths determined for fresh foam, UV lab exposed surfaces and field degraded samples are shown in Figure 8.

Also shown are results for field degraded but power washed geofoam to cast in place concrete interfaces. On the time scale, the 90 days of field exposure is approximated as being equivalent to 50 hours of UV exposure in the weatherometer. The design interface coefficient of 0.6 that was assumed for all interfaces involving foam is also shown as a lower bound for all of the test data. Interface strengths between geofoam and cast in-place concrete decrease with the level of UV exposure and surface degradation. Power washing before concrete pouring was effective in removing the degraded surface and enabled full regain of interface strength to a value comparable for a fresh geofoam interface. Analyses indicate the interface strength demand due to braking or acceleration of trucks can be met by a friction coefficient of less than 50 percent of the design level of 0.6. The specification requirement for covering geofoam with plastic sheeting for exposure duration beyond 90 days can be relaxed. The sheeting was an additional expense and securing for protection against wind was necessary. If desired, reconditioning of UV degraded load bearing surfaces by power washing was a better alternative.

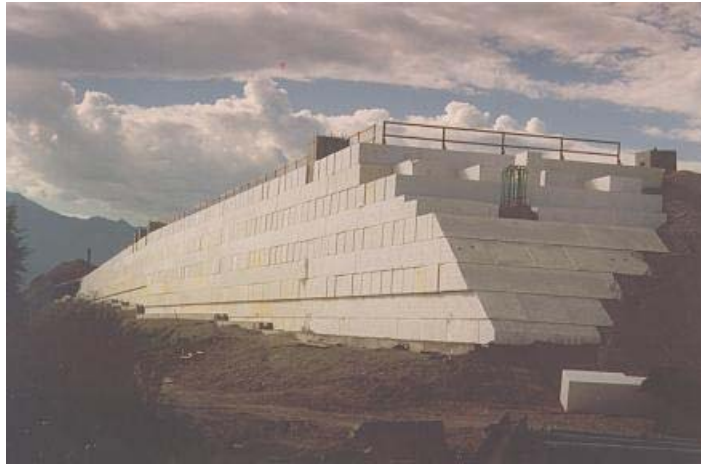
Vertical EPS geofoam embankment fill.

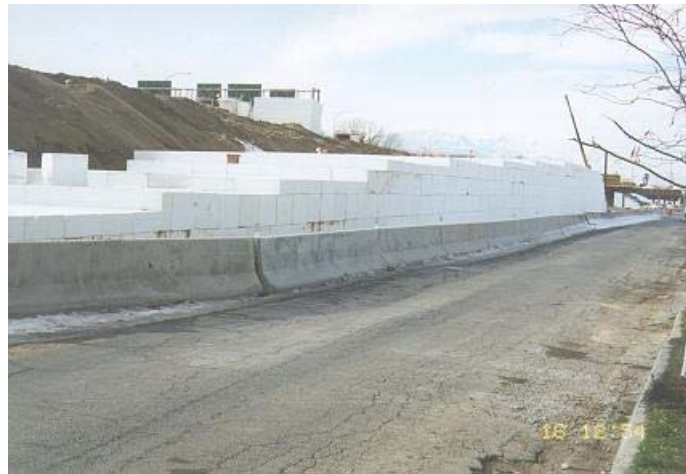
Embankment Widening.

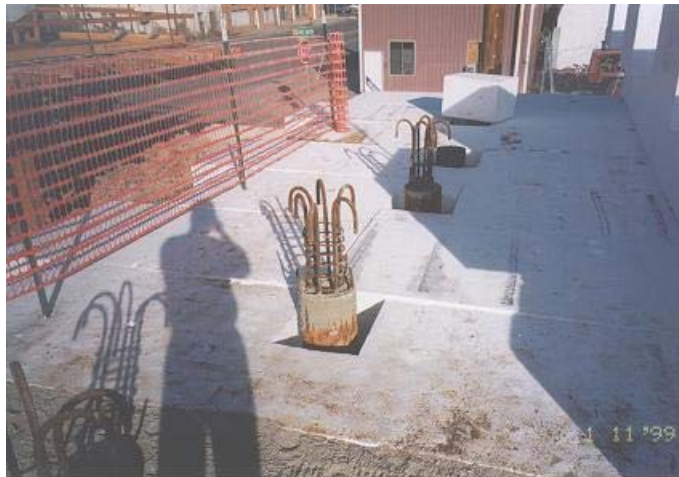
Bridge pier extending through EPS geofoam fill.

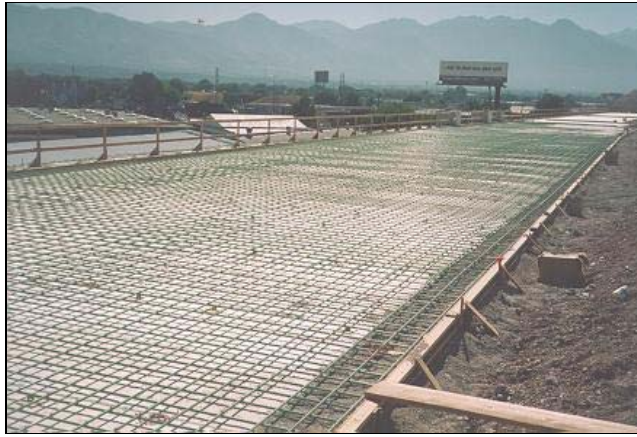
Load Distribution Slab Reinforcement.

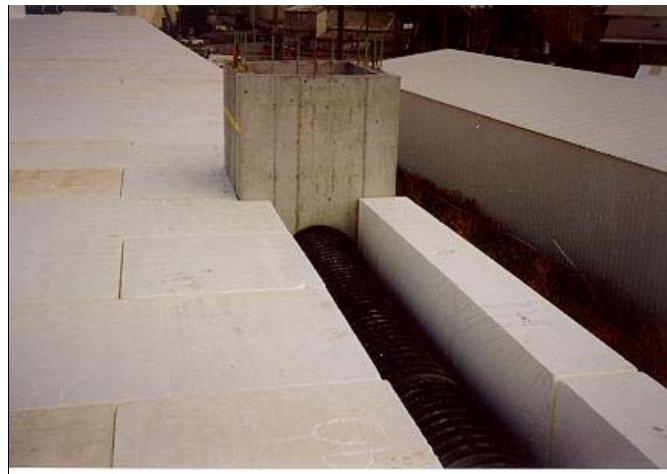
EPS geofoam fill adjacent to storm drain.
